**SAFETY BULLETIN
STANNAH LIFTS LTD.**

Stannah Lifts Safety Bulletin

Issue No: M20

LIFT TYPE: - Stannah Hydraulic Passenger Lifts with 2:1 Roping

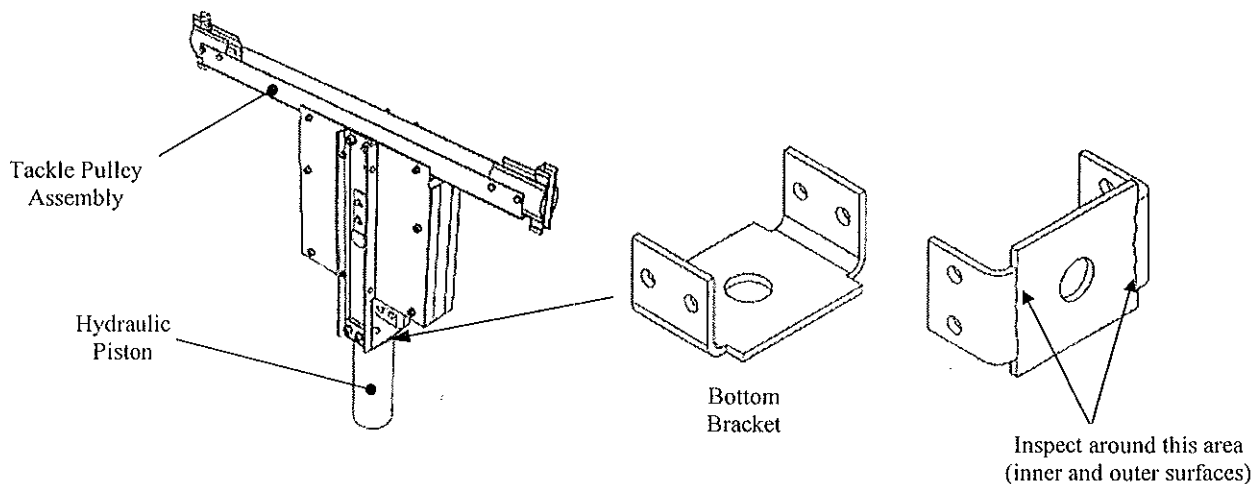
We have experienced a problem with a steel bracket on a 4 year old lift, which appears to have cracked before eventually failing. The bracket design has been in use since 1986.

The bracket is fitted at the base of the tackle pulley assembly which supports the main suspension ropes and secures the top of the piston to the tackle pulley assembly (*see picture below*).

During the next service visit, inspect the bottom bracket carefully for any signs of cracking, distortion or other imperfection on any Stannah Hydraulic Passenger Lift with 2:1 roping.
