National Association of Lift Makers

Stannah Lifts Ltd, Hydraulic Lift Rope Diverter Pulley

IMPORTANT SAFETY NOTE

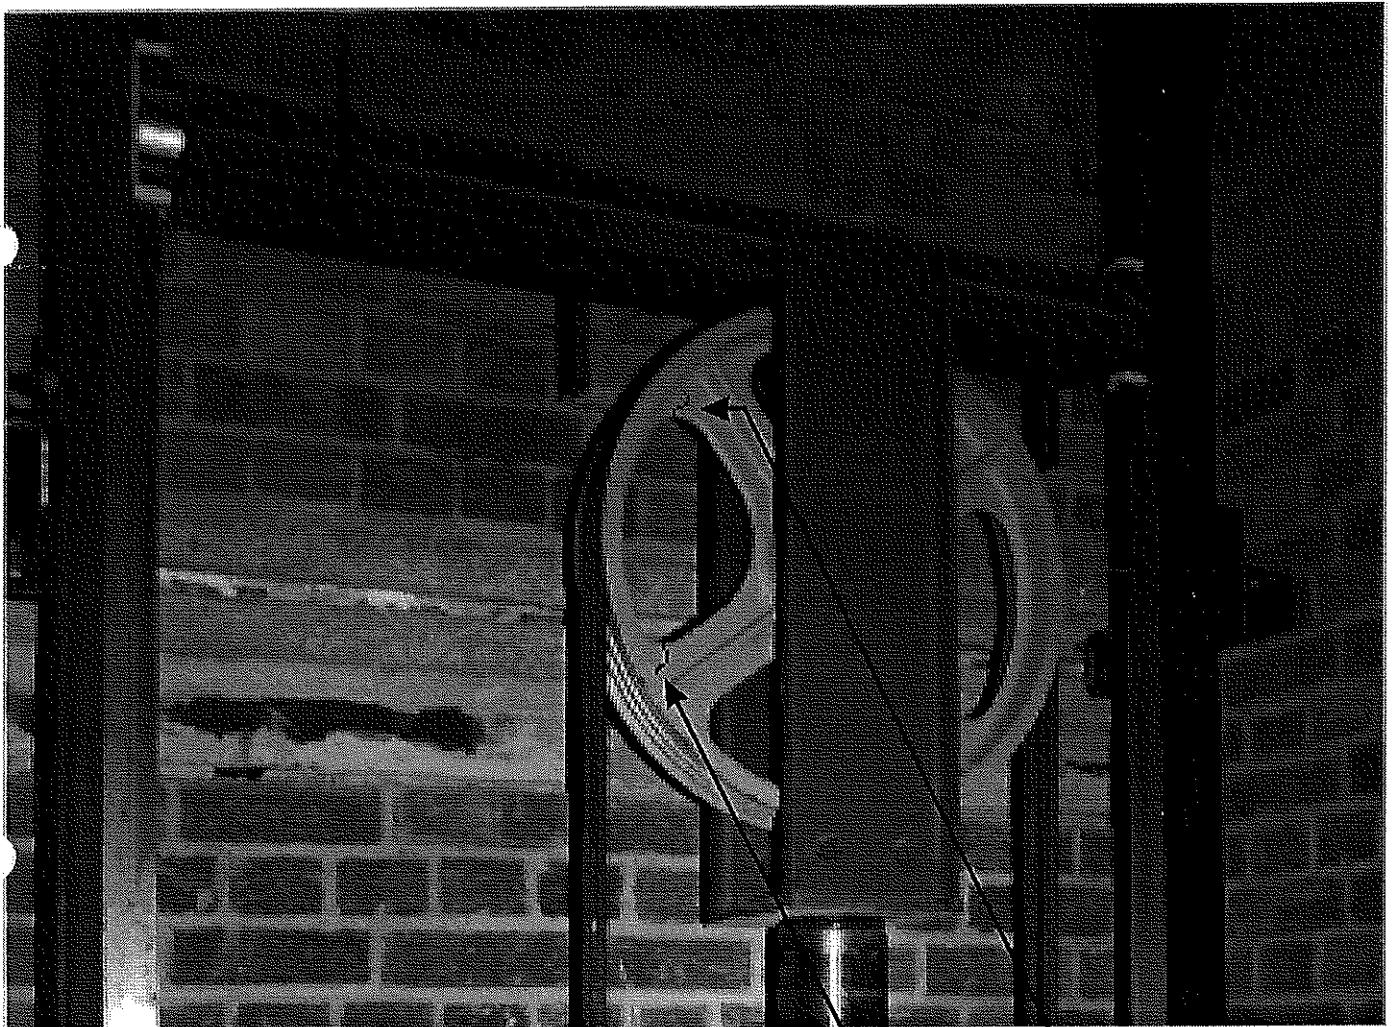
After carrying out site inspections no identical problems were found, however, the inspection did highlight that hairline fractures of a different nature were present in two further pulleys (see picture attached). This represents a very small percentage of installed equipment. The hairline fractures were very minor in nature when compared with the original problem.

Tests have been carried out on the faulty pulleys and it has been established that the fracture in the pulleys was caused by cooling the pulley too quickly after casting. The manufacturer has indicated that it is not possible to give information on batch numbers due to poor traceability procedures on these particular pulleys.

Hairline cracks found here

It is recommended that all Stannah Lifts installed prior to September 1992 are inspected. Any pulleys with visible cracks should be replaced.

Guard removed for illustrative purposes only.
Ensure it is replaced afterwards.
