Lift and Escalator Industry Association

EVANS CONTROLLER FITTED WITH EUROTHERM INVERTER

Re: Evans Controller fitted with Eurotherm Invertor

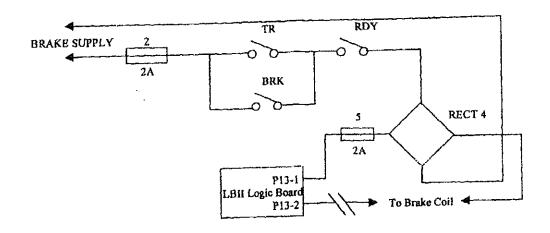
Fig 1 CORRECT BRAKE CIRCUITRY

On all Evans controllers fitted with Eurotherm Invertors, the controller wiring for the brake must be checked against the circuitry, as shown in the attached diagram. If the circuitry is as Fig.2, then please correct it to be in accordance with the circuitry in Fig.1.

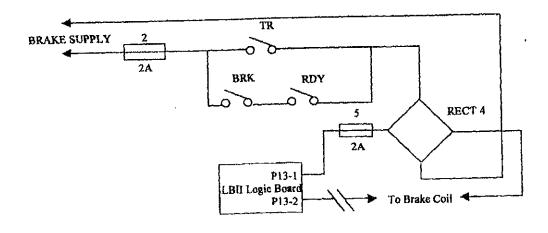
We would like to inform you of a potential safety hazard that has been reported to Otis Limited concerning a problem with the Evans Controller with a Eurotherm Invertor resulting in an uncontrolled movement of the lift car. This problem occurs when the car top control direction buttons are being used with a delay of less than 5 seconds between operations.

The cause of the problem is that on certain units there is a controller wiring error that allows the brake to lift before the drive is enabled.

Fig 2 TYPICAL INCORRECT BRAKE CIRCUITRY
