BUCHER HYDRAULICS ELECTRONIC CARD ELEV-1 TO ELRV-1

SERVICE BULLETIN :

Product: Electronic card ELRV-1

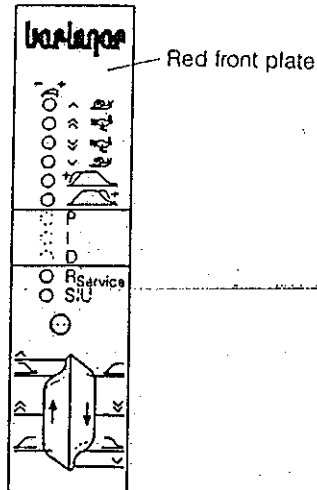
1. Electronic Card ELRV-1 Identification

This concerns all ELRV-1 electronic cards supplied since 1997, which were installed according to our wiring diagram 2.1.20E. Visually these are recognizable by a red, plastic front plate. Attached you will find instructions for the modification, with which corrections at the connectors of the power module can be undertaken.

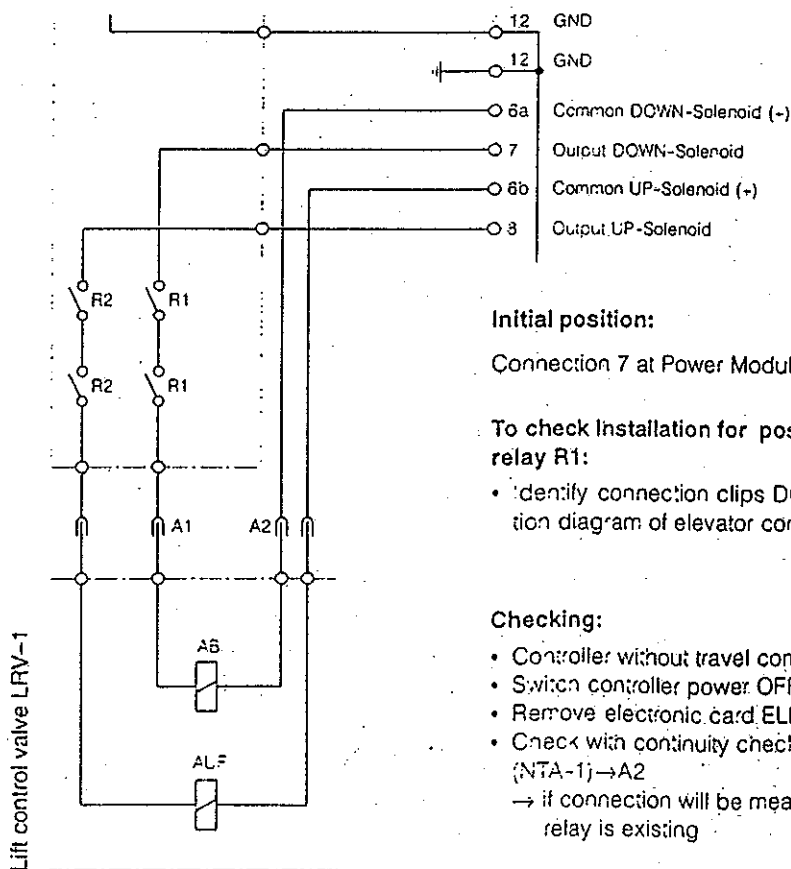
2. Inappropriate wiring of safety relay R1 at DOWN Solenoid

Connection 7 at Power Module NTA-1 leads to safety relay R1.

- Controller without travel command / car at floor level
- Switch controller power OFF
- Remove electronic card ELRV-1 from power module
- Check with continuity checker or ohmmeter the connection 6a (NTA-1j) → A2
→ if connection will be measured, inappropriate wiring of safety relay is existing

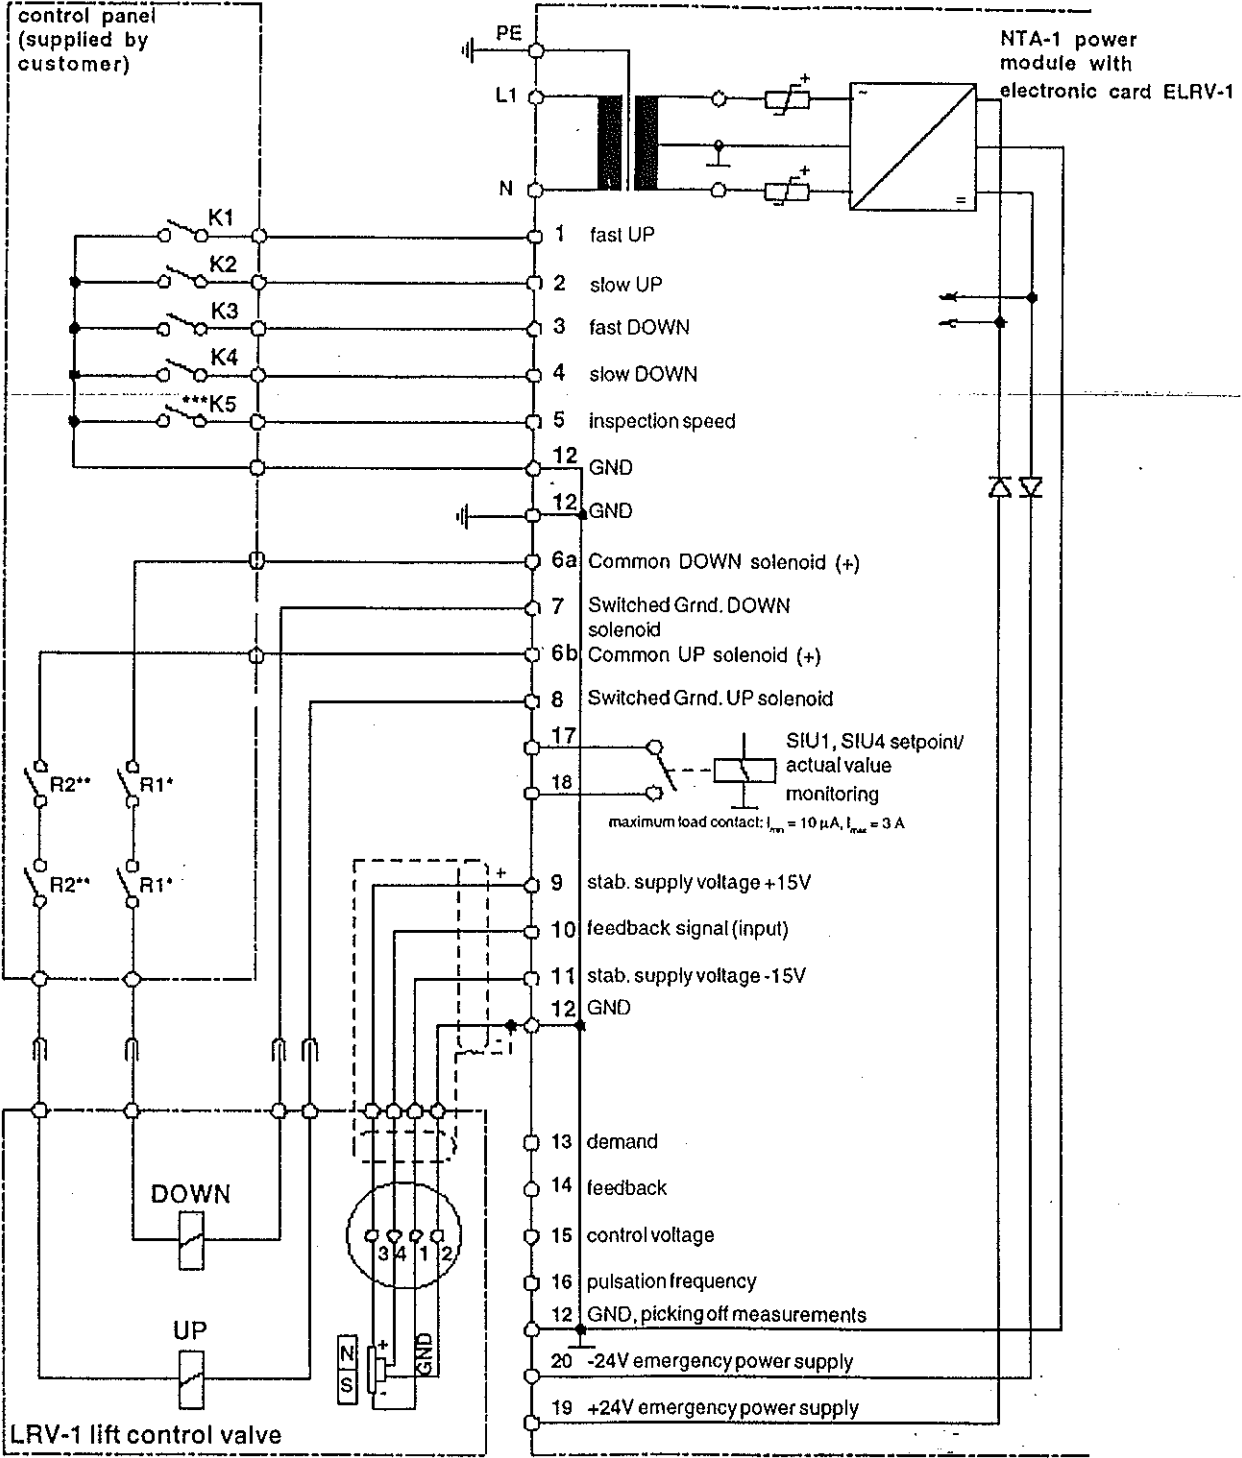
Power supply unit connection with electronic card ELRV-1 / wiring

- * R1 "Safety relay DOWN", required twice acc. to TRA 262.2 and EN 81.2
- ** R2 "Safety relay UP", required twice acc. to EN 81.2
- *** When contact K5 is closed, all 4 speeds are reduced on the ELRV-1 to 12 - 80 % of rated speed depending on the setting of RService
