**Stannah Model GL 229/228 - Requirement for Modification
Fitting of Halfen Bolts - Stannah Straight Stairlifts**

FITTING OF HALFEN BOLTS - STANNAH STRAIGHT STAIRLIFTS

"HALFEN" FIXING BOLT PROCEDURE

STANNAH MODEL GL 229/228 - REQUIREMENT FOR MODIFICATION

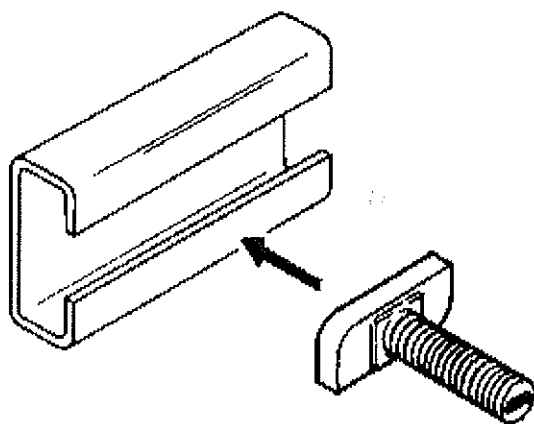
A recent safety incident on a 215 seat has highlighted the need to ensure that all "Halfen" fixing bolts are correctly fitted in order to make them fully effective.

Orientation before insertion into channel

The following diagram shows the correct orientation of the "Halfen" bolt head with respect to the "Halfen" channel.

It also shows the orientation indicator on the end of the threaded stud which **MUST ALWAYS BE AT A RIGHT ANGLE** to the "Halfen" channel before, during and after the nut is tightened.

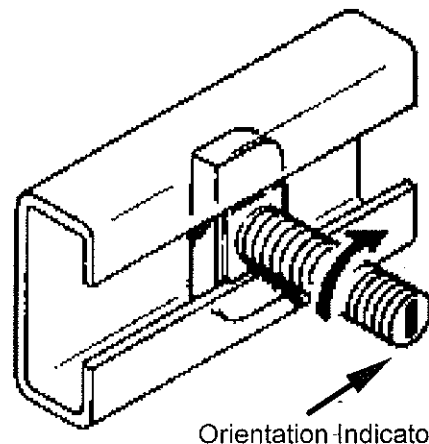
90° rotation after insertion into channel.
Note orientation of indicator

This procedure applies to all "Halfen" fixings on all Stannah models.

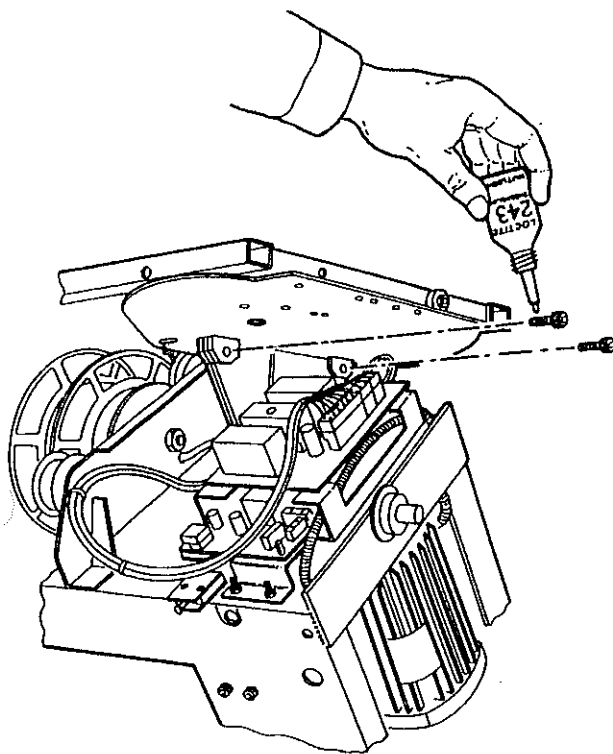
Fig 1.

Following an incident where the seat fixings came loose and the chair tilted, we have reviewed the design and concluded that all 229 and 228 units sold since introduction in 1991 need to be checked and modified.

1. Unless this retro-fit is being carried out during a normal service, there is no need to remove the covers.
2. Remove one of the M8 Cap Screws that secures the chair to the carriage and discard the screw.
3. Replace with an M8x 25 long Tufloc Cap Screw (Part No. 2294566). This screw must be assembled with Loctite 243 and tightened to a torque of 30Nm (22lbf. ft), see Figs 1 & 2.
4. Repeat steps 2 & 3 for the remaining chair fixing screw.
5. Ensure that any excess Loctite is cleaned away.
6. Fit a chair fixing bolt label (Part No. 2294567) to the top of the covers as shown on Drawing No. 2294568.
