**SCHINDLER RF1, GK1-W or GK2 SAFETY GEAR ON INSTALLATIONS  
USING I14 GUIDE SHOES**

# Schindler Field Information No.110

## Mandatory Corrective Action

Product Code: 1-11 540 (Car sling/Safety gear)  
Product: I14 Guide shoe  
Title: **I14 Guide Shoe in Collision with Pull Rods of Safety Gear**  
Number of pages: 1 (enter total number of pages after checking in print preview)

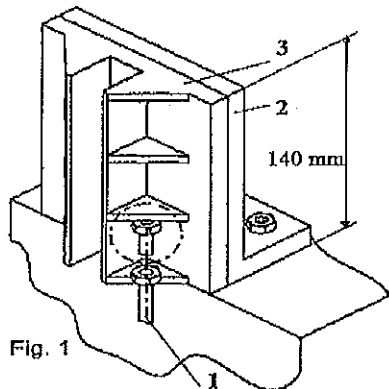
Fig. 1

Acceptance tests showed, that the locking nut at the pull rod end can touch the reinforcement ribs of the guide shoe when the safety gear is actuated over the governor lever. (Fig. 1).

**CAUTION: SAFETY COMPONENT**  
**Blocking of the pull rods can cause a safety gear failure**

This problem concerns all installations with I14 guide shoes, Ident No. 582812 (BFK 10) and 582813 (BFK 16), in combination with RF1, GK1-W and GK2 safety gears.

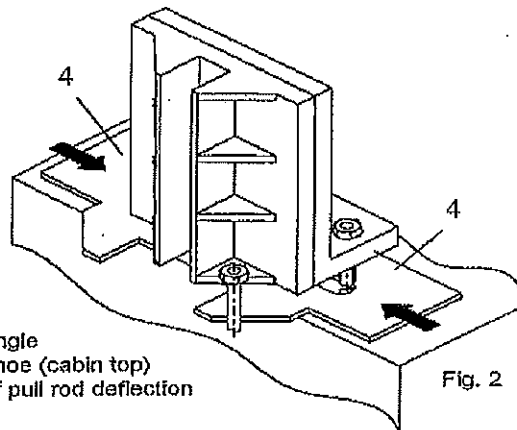
Fig. 2

1 Pull rod  
2 Mounting angle  
3 I14 guide shoe (cabin top)  
4 Mounting of pull rod deflection

All elevators with I14 guide shoes in combination with RF1, GK1-W or GK2 safety gears have to be equipped with the new pull rod deflections. These metal sheets are to be mounted under the guide shoe on the top of the cabin and keep away the pull rods from the guide shoe ribs (Fig. 2).

- Installations in the field have to be retrofit during the next regular maintenance service.
- For installations outside of the Schindler maintenance portfolio the corresponding KGs have to take the necessary steps for the described rework.
