Lift and Escalator Industry Association

STANNAH STAIRLIFT, SAFETY BULLETIN

STAIRLIFT SAFETY BULLETIN

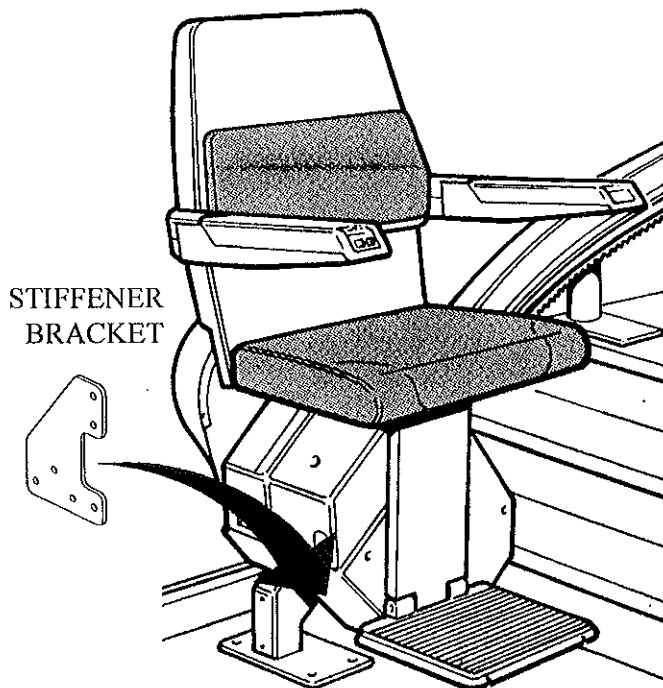
Carriage Modification

Effective to all Model 209's manufactured from April 1982 to May 1983.

The carriage and chair can become loose on the rail under extreme circumstances of overload, abuse or excessive use. This is due to fatigue and has occurred on one stairlift permanently in use since 1982.

Stannah are recommending inspection of all Model 209 stairlifts manufactured between these dates and stiffener brackets fitted to the carriage where appropriate.

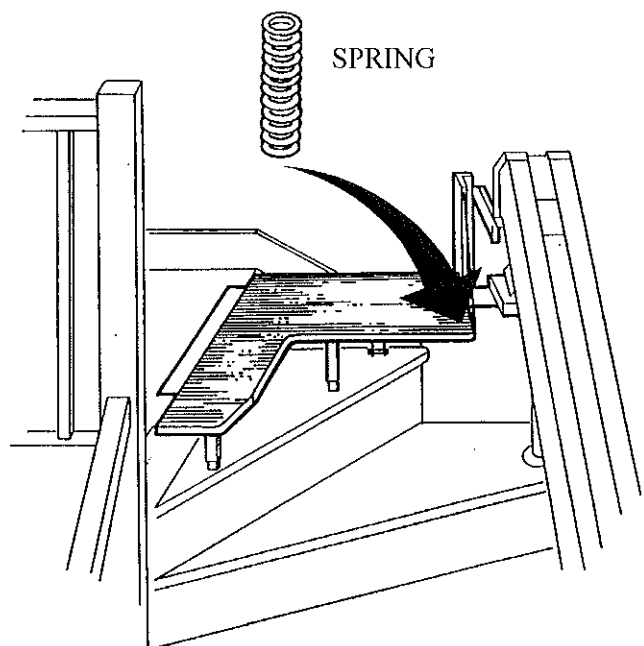
Automatic Platform Modification

Effective to all straight Models 230 manufactured from December 1995 to June 1998.

The wire cable controlling the lowering of the platform can be prone to wear thus causing the platform to lower in an uncontrolled manner.

Stannah are recommending the replacement of this cable at each service and also the replacement of a small spring.

Stannah will supply all the parts required together with full instructions. The modification should be fitted to all stairlifts which could be prone to this problem.

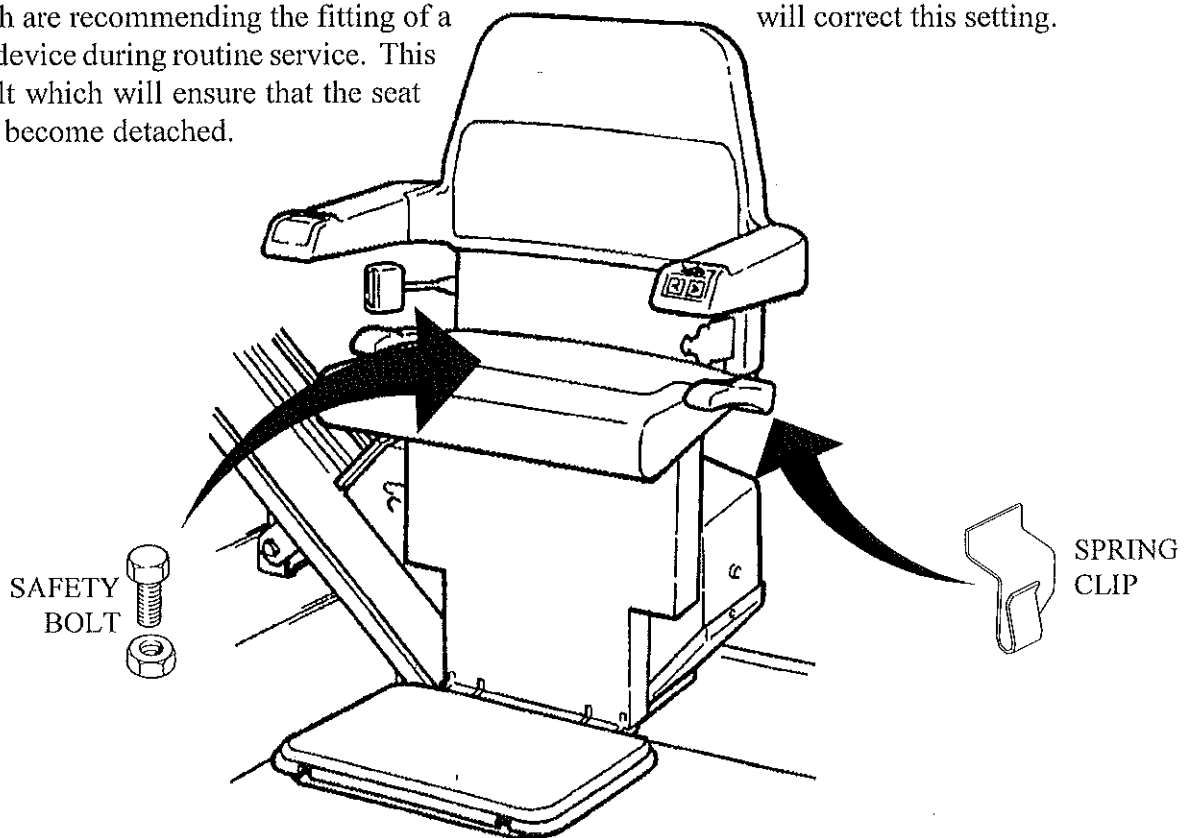
Swivel Seat Safety Modification

Effective to all straight Models 225 and 230 manufactured from March 1991 to September 1998.

The swivel seat can become detached from the carriage under extreme circumstances of overload, abuse or excessive use. This is due to fatigue and has occurred in a few instances with stairlifts permanently in use since 1993.

Stannah are recommending the fitting of a safety device during routine service. This is a bolt which will ensure that the seat cannot become detached.

Stannah will supply all the parts required together with full instructions. The modification should be fitted to all stairlifts which could be prone to this problem.
