National Association of Lift Makers

Keighley Lifts Ltd Lock Cam Return Spring

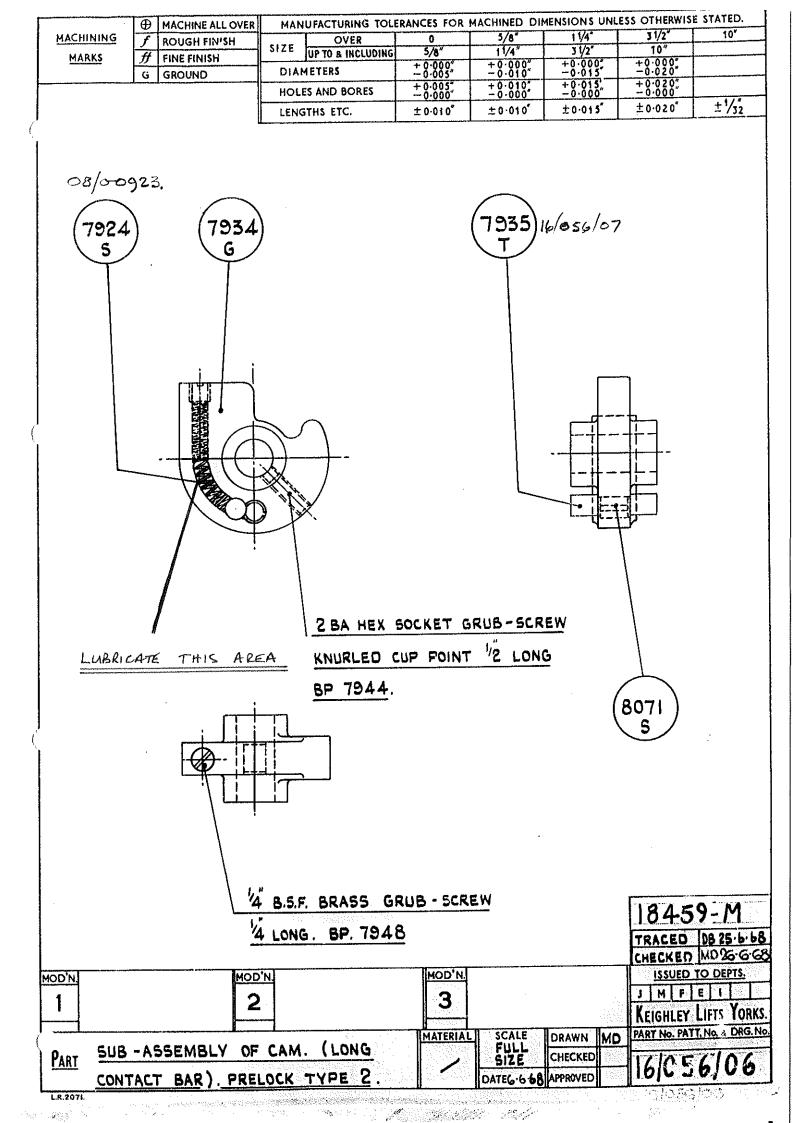
We have recently been advised of an incident where a lock cam return spring failed, the purpose of the spring is to keep the lock contacts in the open position as set by the removal of the lock beak when opening manual landing doors.

From laboratory tests carried out by Keighley Laboratories Ltd, report reference TS.113781-2 (copy available on request), the failure occurred due to wear of the spring within the cam assembly, which would have been prevented by lubricating the spring with a general purpose grease (see attached drawing) at yearly intervals. The replacement spring part number is 008/00923.
