**SAFETY BULLETIN : STANNAH LIFTS LTD**

**Product :** System 21 Passenger Lifts  
Model: Piccolo from 1988 to 1993

**Subject :** Welded Floor Assemblies

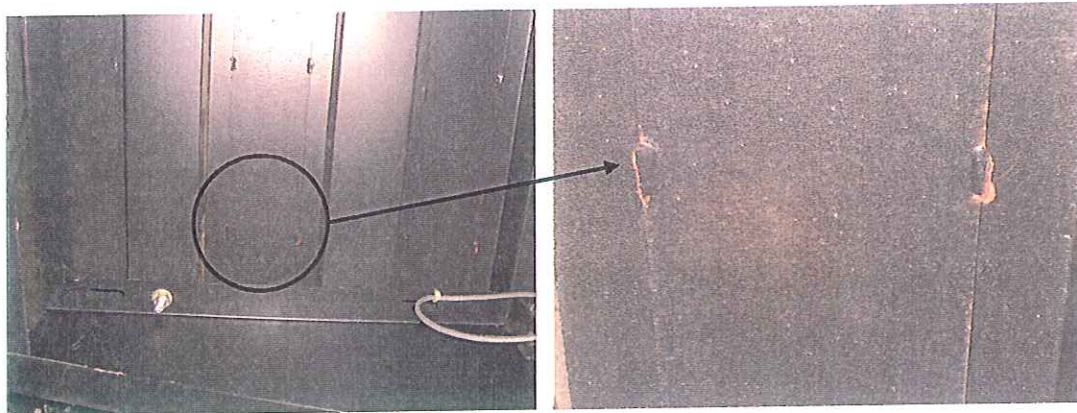
It has come to our attention that a S21 Piccolo Lift, Floor Assembly manufactured in 1991 has had some weld failures along the floor stiffener 'top hat' section where it attaches to the underside of the floor pan. 10 out of the 56 welds had failed. The purpose of this bulletin is to request that upon any individual Lift's routine inspection that the floor stiffeners are inspected for weld failures and the findings reported to Pete Jeffery at Stannah Lifts Ltd 01264 339090.

At present we know this as an isolated occurrence and we want to confirm this with the site surveillance. If any welds are found to be broken the floor pan is to be fixed to the stiffener using a CSK rivet under the floor covering.
