Lift and Escalator Industry Association

OTIS 10 ATL GEARED MACHINES – SAFETY ALERT

Subject: Otis 10 ATL Geared Machines - Safety Alert

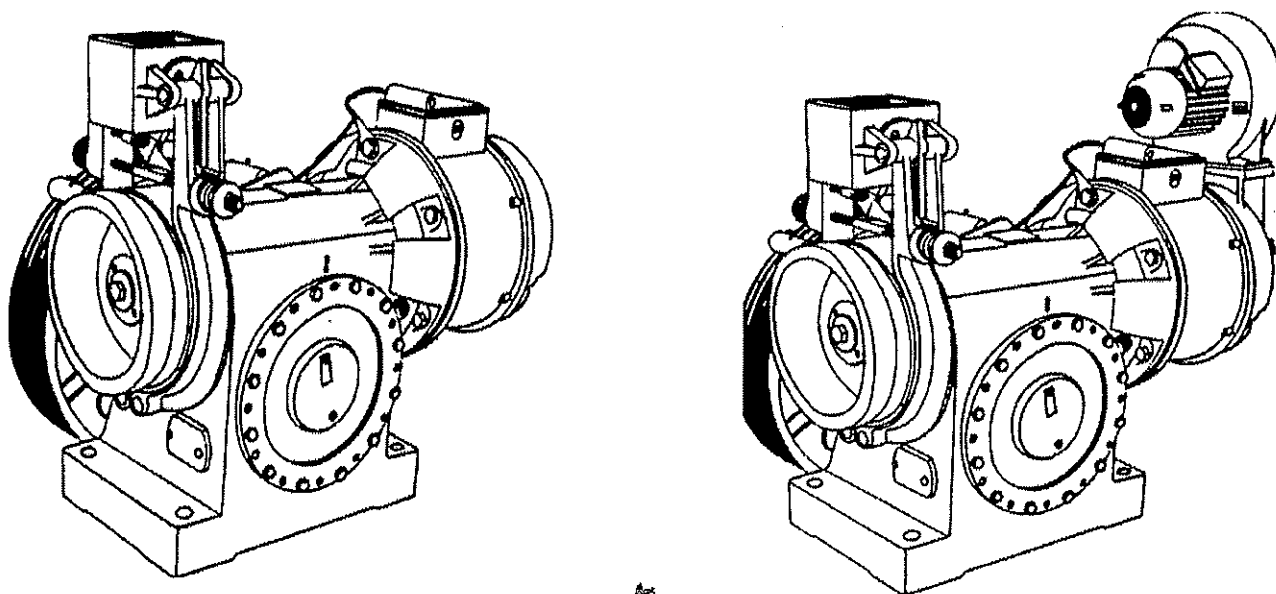
10 ATL Machine

Otis 10ATL machines have six (6) bolts that secure the worm gear wheel to the drive sheave shaft. Recent LGI Inspections have identified that over time these bolts may work loose or break. If enough securing bolts become disconnected from the worm wheel and the drive sheave shaft, the potential exists for the lift car to make uncontrolled movement into the overhead or pit, depending on load conditions.

- It is extremely important that each Company immediately implement a visual inspection of the worm gear securing bolts on all Otis 10ATL machines in their service portfolio.
- Immediately take out of service any elevator where securing bolts are found to be missing, loose, or damaged, and lock the elevator out of service until new securing bolts have been installed or the situation remedied.
