WARNING OF POTENTIAL SAFETY HAZARD
RE: W J FURSE AND FURSE STAIRLIFTS, MODELS 103 AND 185 -
MANUFACTURED BETWEEN 1982 AND DECEMBER 1988

**TECHNICAL BULLETIN FOR W J FURSE AND FURSE STAIRLIFTS,
MODELS 103 AND 185 STAIRLIFT MANUFACTURED BETWEEN 1982 AND 1988**

TITLE	GEARBOX SHAFT AND BEARING ASSEMBLY
SCALE	1:2.5
DATE	28.6.82

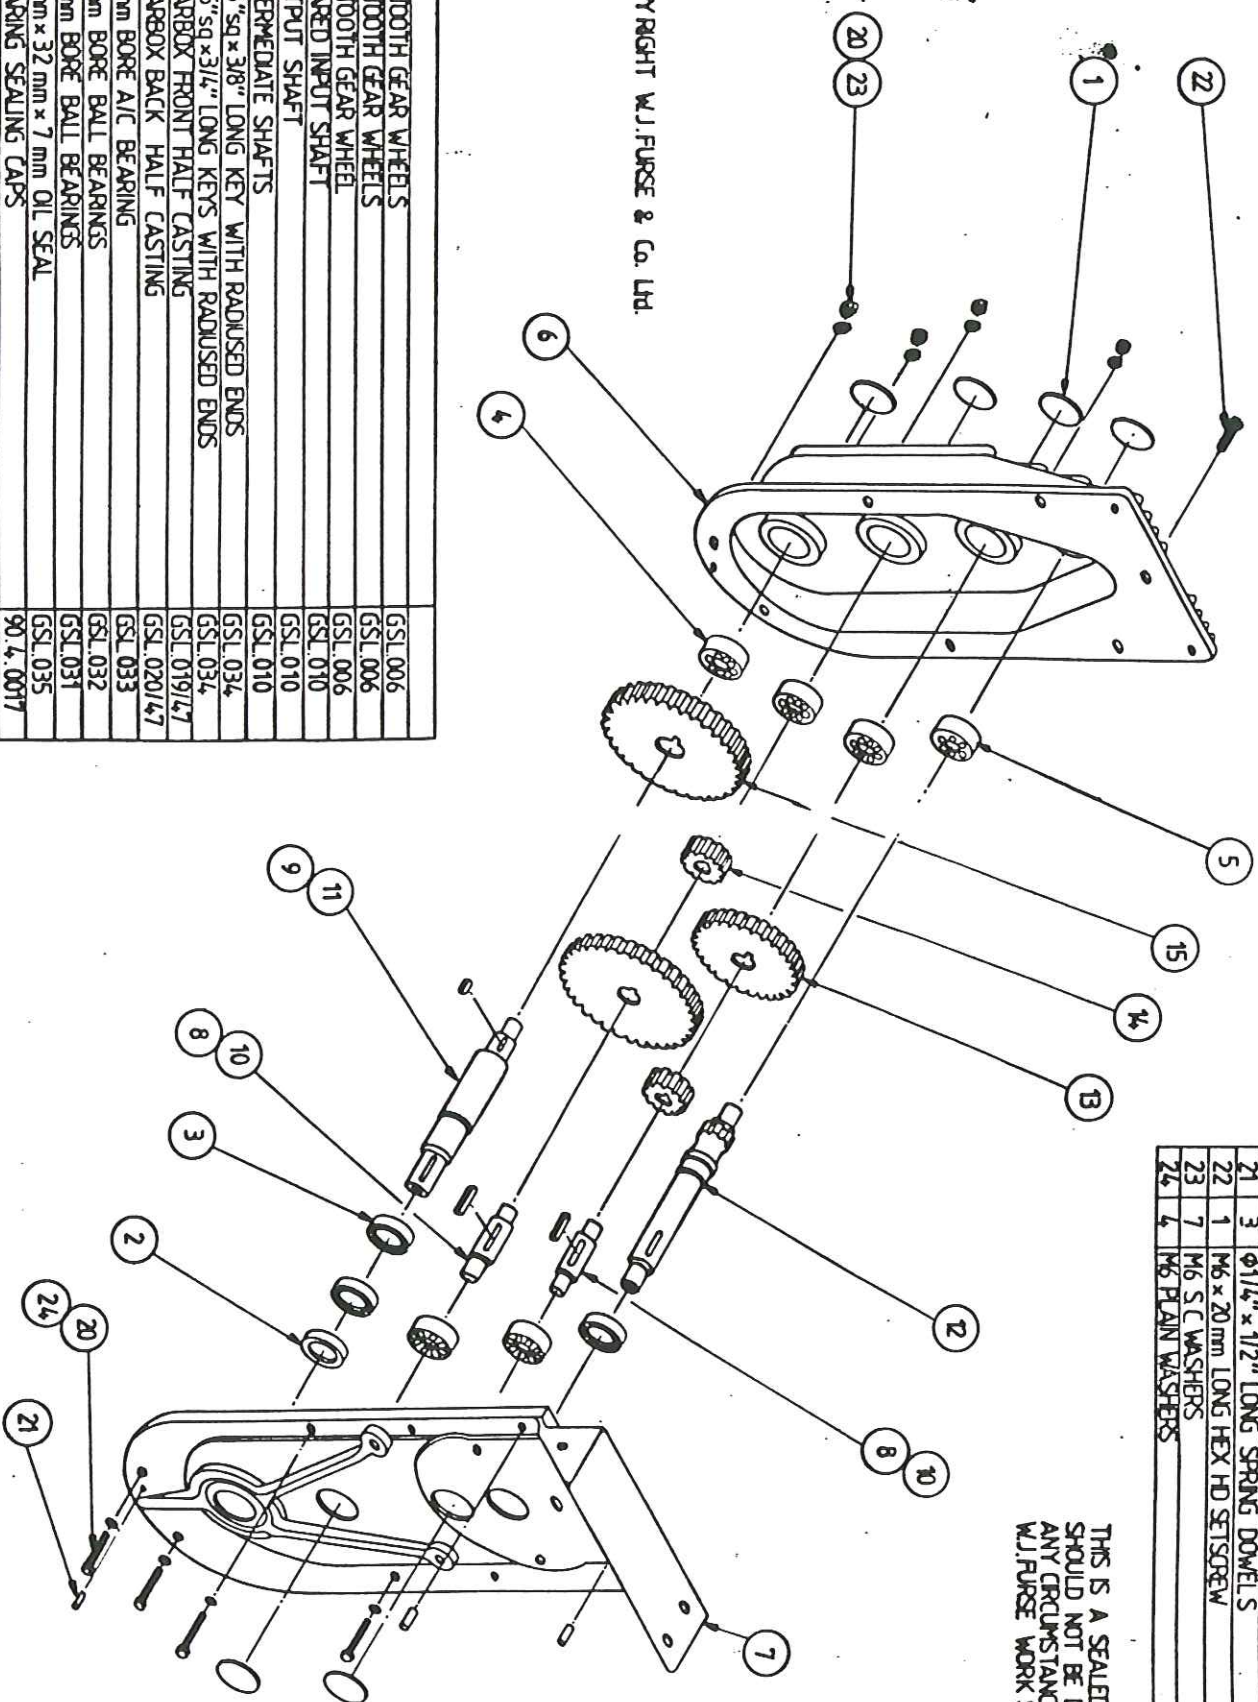
During the period of manufacture some 5,300 units were produced with a common gearbox design. We have 15 failures of the gearbox output shaft reported to us, 14 being sheared keys the other being a sheared shaft.

The components that have given cause for concern are the gearbox final drive shaft and the square key locking the final drive pinion to the shaft, numbered 9 and 11 on the enclosed diagram.

Indications of pending failure are minimal but in some circumstances an increase in the noise levels has been noted, and/or the presence of excessive backlash at the drive sprocket.

The reported failures occurred when the units moved from rest, at the lower position, which is the point of maximum load on the shaft.

The shaft and key have been marked on the enclosed drawing and you will see that the only way to inspect the components is to dismantle the gearbox.

Inspection of the Key and the Keyway is one of a visual nature but inspection of the shaft in a similar fashion will not reveal a possible failure. To determine the integrity of the shaft, crack detection equipment is required.

A more cost effective action is one of removing the gearbox and sending to ourselves for dismantling, inspection and, where required, fitting of replacement output shaft and keys. Alternatively, Gimson Stairlifts can supply a service exchange gearbox or visit site and fit a re-built unit on your behalf.
