Wadsworth Type 72 Lock and Retractable Lock Beak

QUALITY INSTRUCTION-

TION No 95

Wadsworth Type 72 Lock and Retractable Lock Beak CONCERNS YES SAFETY NO

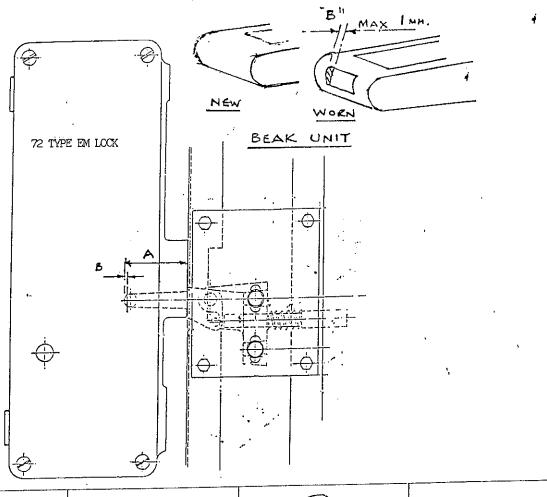
We have had a recent incident due to combined wear on the Wadsworth Retractable Lock Beak and internal parts of the Wadsworth Type 72 lock. This resulted in the lock contacts making without the lock beak secured inside the lock, thus allowing the landing gate to be opened with the lift away from that floor level.

- 1. Examine the front face of the lock beak and if there is 1mm or more wear, on the face of the beak ('B' on sketch below) replace the beak assembly. Part number 76462-900.
- 2. Check from the face of the lock at beak entry point, the distance to the lock opening claw ('A' on sketch below). This dimension is 32mm when the lock is new and should this measure 34mm or more the lock is to be totally refurbished internally or completely replaced.
- 3. DANGER!! If the equipment is found to be outside the dimensional tolerances as described in this document, the lift should be removed from service.
