**SAFETY BULLETIN : THYSSENKRUPP ELEVATOR UK**

Bulletin Number: TA-SH-002

Subject Galaxy MRL lifts - counterweight guide shoes  
Originator Keith Baucutt

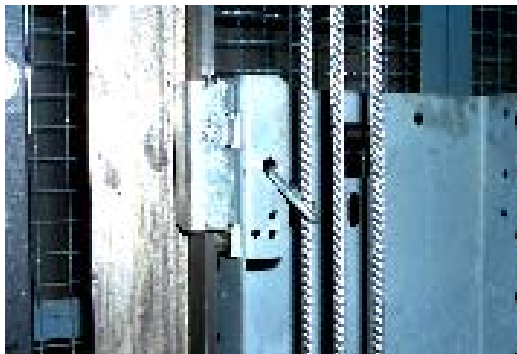
Photo 1

Despite these recommendations, we have seen broken lower guide shoe supports on two lifts in France due to the guide shoe lining and its metallic support being completely worn away.

- a 7 mm dia. quick link fitted at the top of the counterweight attached to the nearest traction rope. The counterweight is therefore held in the vertical position in all cases (photo 1 below).
- an extra bracket added at the bottom of the counterweight to hold the counterweight on the guide rail should the bottom guide shoe support break (photo 2 below).
