**SAFETY BULLETIN : OTIS**

EVANS MACHINE BRAKE FAILURE

Nº : 78-07-01

Date : 20/12/2006

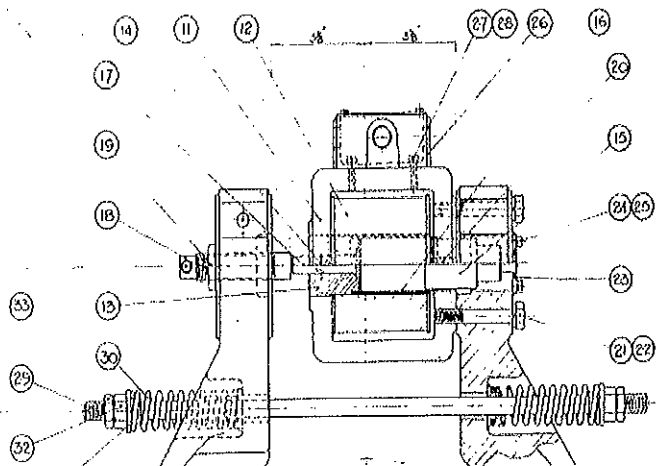
For identification of brake type see drawing below

On investigation it was found that due to repetitive use, the tip of the Brass Brake Plunger (Bullet) was worn causing mushrooming of the top. This increases the diameter allowing the plunger to jam the Brake in the open position. The condition was further compounded due to the base of the plunger being worn, which decreased the air gap between the core pieces allowing residual magnetism to add to the holding effect.

Strip the Brake Solenoid and closely examine the Brass Plunger (Bullet) and replace as necessary. The previous practice of dressing the Plunger when wear is detected must cease. In future when wear is detected the Plunger must be renewed as shown in Special Instructions
