STANNAH 250/260 STAIRLIFTS WITH CURVED RAILS

SAFETY NOTICE

Important Safety Upgrade on New Stannah Curved Stairlifts Installed between June 2001 and June 2007

PDN 08/5759

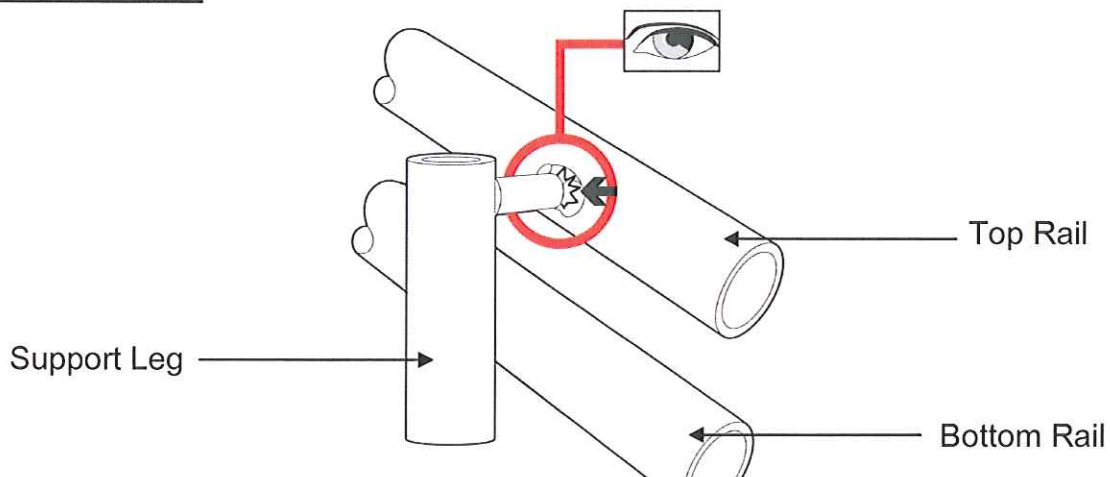
Details of Failure Mode

There have been a very small number of weld failures between the rail and the support leg. Each 250/260 curved stairlift has twin rails and five or more support legs. In most cases a failure of a weld between one of the rails and a leg will have no discernible consequence for a user. However in certain circumstances, if the weld fails between the top rail and either the first and last support leg, the rail can flex and the chair can tip forward.

Stannah has developed a simple safety upgrade kit to strengthen the first and last support legs. The complete installation can be completed in approximately 30 minutes. All parts and detailed fitting instructions are supplied in the safety upgrade kit.

1. Determine how many Stannah Model 250/260 stairlifts with curved rails that you have on service that were installed between June 2001 and June 2007.
2. Contact Denise Pidgeon on 01264 386783 or denise_pidgeon@stannah.co.uk in Stannah's Customer Services department for free of charge issue of the PL2601261 safety upgrade kit and fitting instructions.
3. The safety upgrade should be done in conjunction with a scheduled service visit within 12 months.

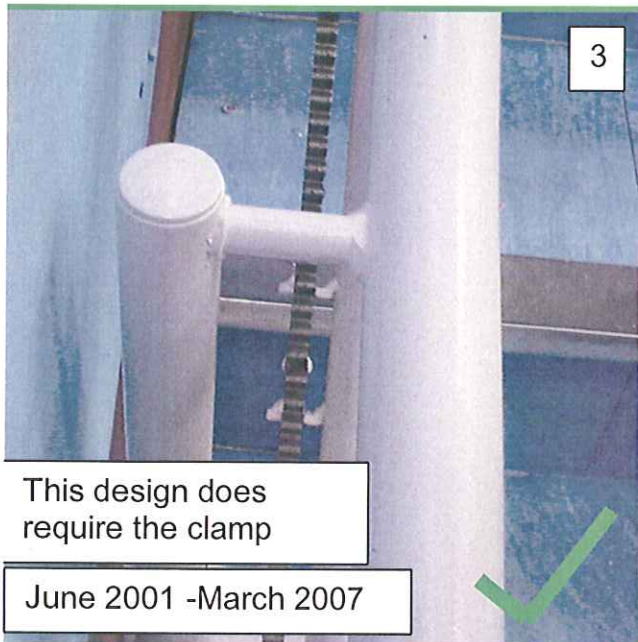
The images below show leg designs from 1997-2008. Only image 3 is suitable for the new clamp.
