National Association of Lift Makers

Sassi Brake Type 3040 supplied before 1st October 1993

Liftmaterial - Safety Bulletin.

SUBJECT: PROBLEMS CONCERNING THE MANUAL BRAKE RELEASE MECHANISM ON BRAKE TYPE 3040 FITTED ON GEARS MB 82, MB 91, MB 92, MB 94, MB 95.

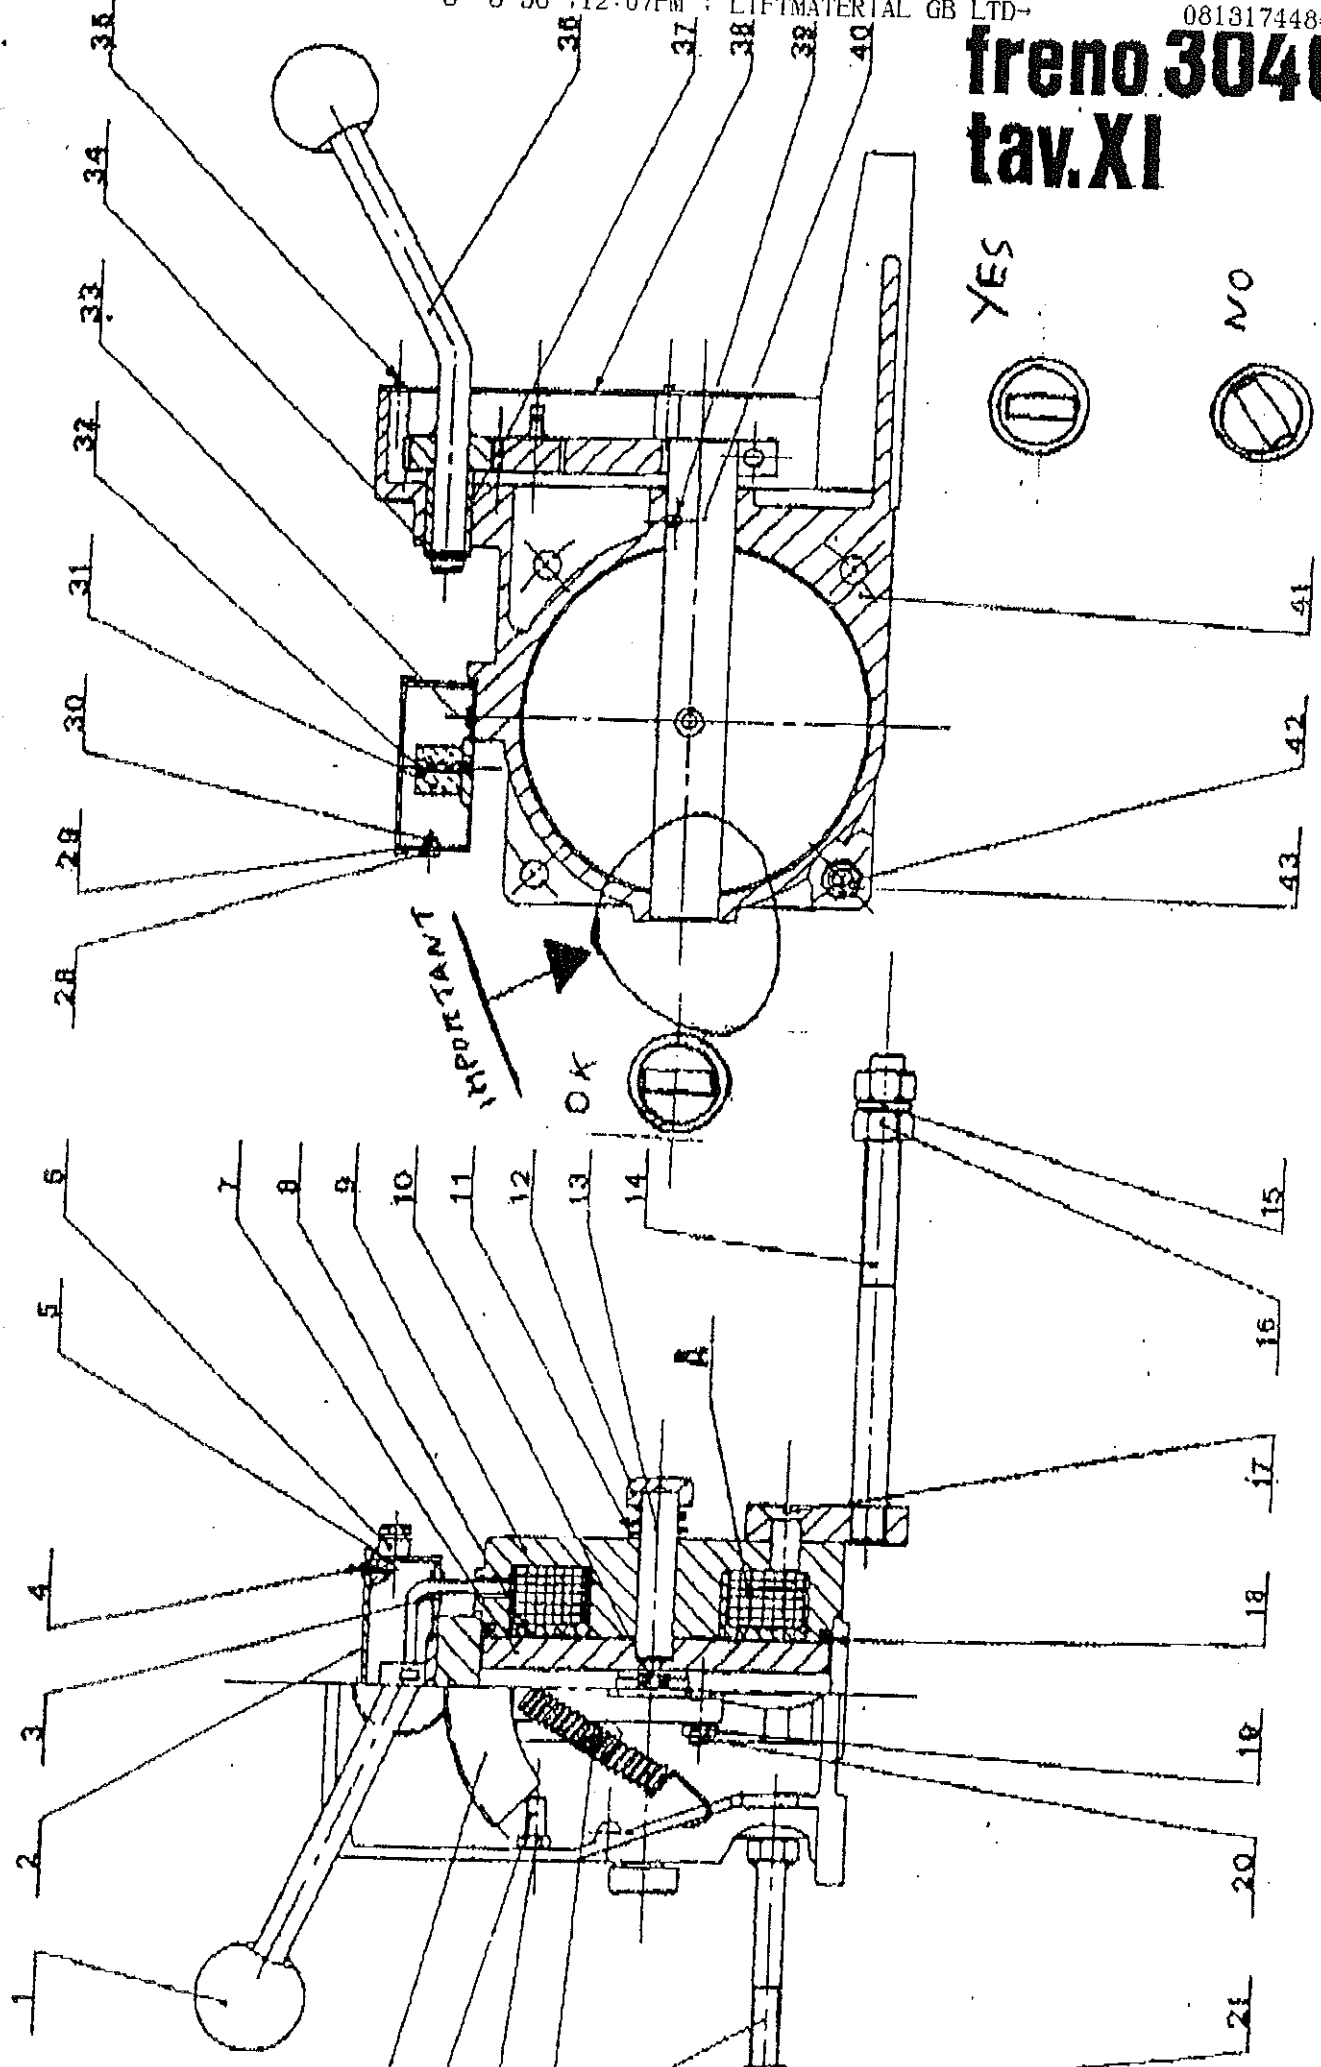
freno 3040 tav.XI

The above said problem is easily recognised by observing the position of the brake release lever (please see enclosed drawing). By observing the hole it will be noticed (without touching the release handle) that the lever is either in the vertical or diagonal position. If indeed the latter is observed then the internal components of the release mechanism are deformed and must be replaced.

REF. A = RIF. 7+8+9+11+12+13+18

If replacement component parts are required A. SASSI S.p.A. have a component kit available through LIFTMATERIAL (GB) LTD, Braintree, to replace internal components on gear units supplied before October 1993.

Customers will need to supply information to LIFTMATERIAL (GB) of the gearbox model and the serial number, to receive the required modification kit along with the relative instructions and drawings.
