Re: GAL Two Panel Side Opening Landing Door Spring Closer

SAFETY BULLETIN

RE: GAL Two Panel Side Opening Landing Door Landing Door Spring Closer

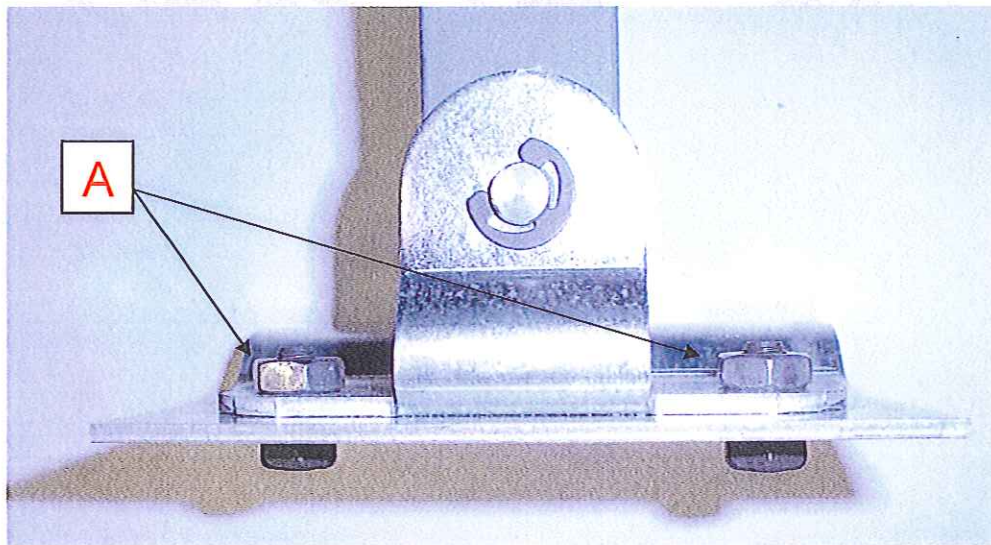
We have been advised by one of our clients of an incident that took place with the GAL two panel landing door spring closer. The problem arose from a failure of the fixings for the slow door link bracket to the slow door mounting plate and the fixings between the slow door mounting plate and the slow door. The fixing Sems screws (A) have been used since 1999. GAL confirms that there have been no similar incidents reported in their world wide sales in this ten year period. However they have taken our report which indicates that in this installation the Sems screws have become loose creating a potential hazard if the slow door is not picked up and driven by the fast door. The GAL interlock device creates a safety net for this but on this occasion had not been fitted.

In the event GAL have advised that fixings should be torqued up to 27.2 Nm (20ft/lbs) at time of installation. It is advisable that these fixings should be checked for torque value every 12 months. As a further precaution GAL have advised that as of October 1st 2009 fixing nuts are changing to a nylok type. This has no impact on cost or production to GAL who have offered this as a further safety net.
