KONE LIFTS LTD TYPE MR12 BRAKE BOW ARMS

,	Subject				CODE: SN 04.05.16
KONE LIFTS	MR12 BRAKE BOW ARMS.				Page 1 of 5
LID					SAFETY CATEGORY A
DEPT. TECH.SUPP	DATE 7.2.97	COMPILED BY A J Shiner	CHECKED V J Kaura	APPROVED	ISSUE A

FL-4.8.1

MR12 BRAKE BOW ARMS

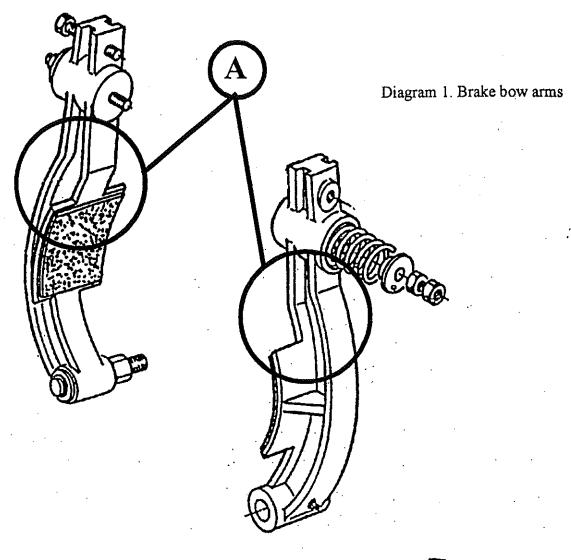
Appendix 1. Diagram of the MR12 and fracture points..

There have been some cases of the brake bow arm of the MR12 gear cracking or breaking. The cases are very rare approximately 1 in 15,000.

In the reported cases of the cracked and broken brake bow arms the fracture has occurred in the position marked A in the diagram 1 in Appendix 1.

The fractures that have been found originate from the casting process and not from normal service.

Each brake bow arm is to be inspected visually at the point marked A in diagram 1. If there are signs of fracture the brake bow is to be replaced.

- Stop elevator.
- Carry out inspection on one brake bow at a time.
- Open brake bow. Use service instructions as detailed in section 3.3.3. below.
- Inspect carefully (with a torch) the break bow surface for cracks in the area marked A in Appendix 1.
- Close brake bow arm Use service instructions as detailed in section 3.3.3. below.
