OTIS SAFETY WARNING NOTICES

Re: Otis Product Safety Warning Notice – 001.

LEIA Product Warning	Ref : 001	
	Evans Machine Brake	Page :	1/7
		ISSUE 27/03/2007	UPDATE 17/03/2009

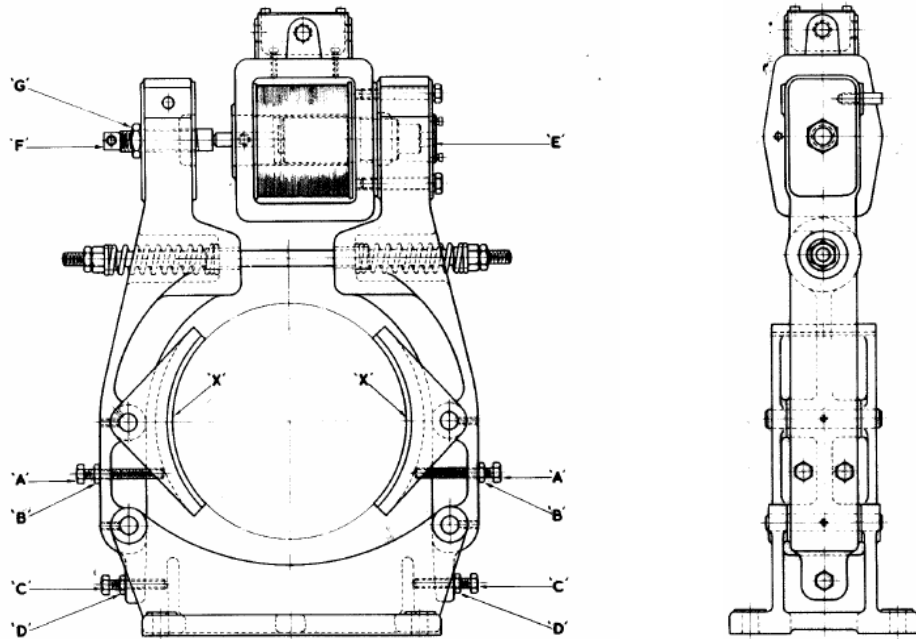
Figure1.

Figure 1 shows the Evans brake.

1. Clean the brake & magnet moving parts & lubricate before re-fitting.
2. Set up solenoid plunger movement (air gap) in accordance with instruction on end plate 'E' by adjusting stop screw 'F', and tighten lock nut 'G'. See Figure 1.
3. Take care not to over tighten the coil screws, only finger tight and tighten lock nut. The coil holding bolts should be checked as the coil has a tendency to move if too loose (rotate) and this can cause the bolts to wear through the card insulation and on to the coil winding.
Insulate, renew or rotate the coil to a different spot on the card and re-grip.
See Figure 11.

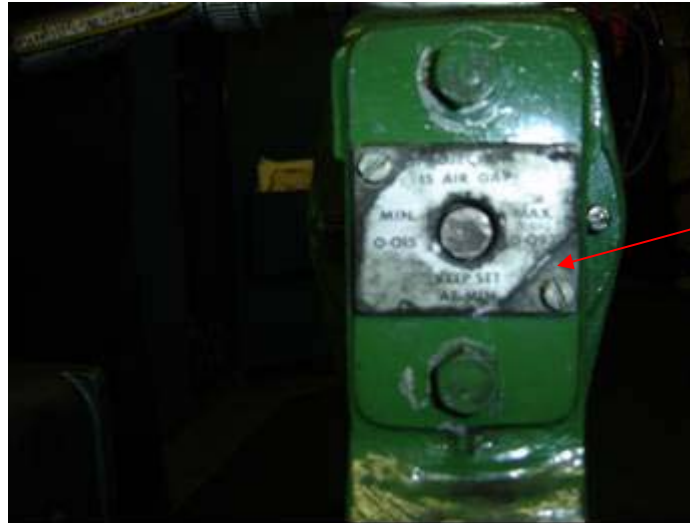
Figure 2

End plate

Air Gap Settings
Min 0.015"
Max 0.093"

1. Remove the two screws holding instruction end plate 'E'. See Figure 1 & 2.

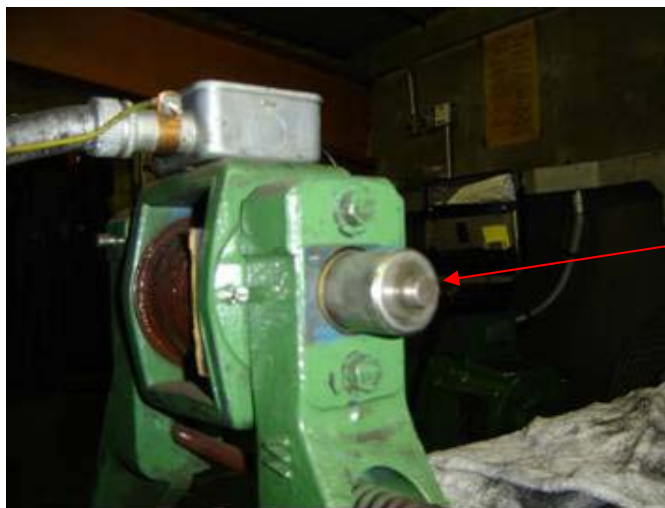
Figure 3

Solenoid plunger

2. Remove solenoid plunger. See Figure 3.

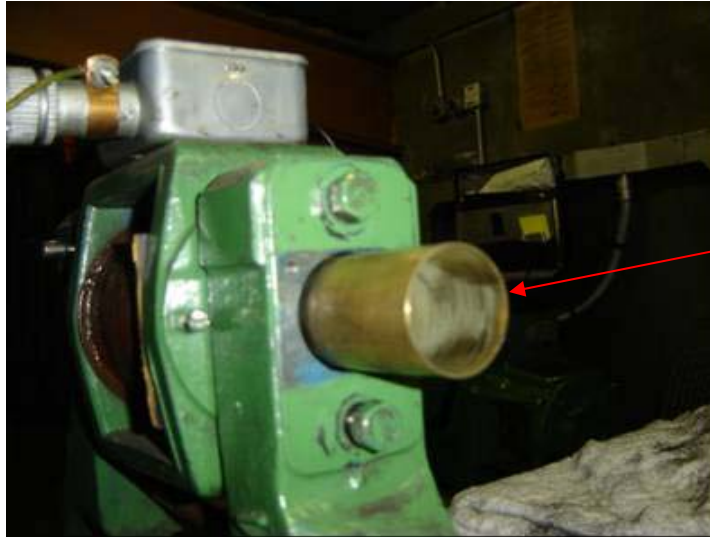
Figure 4

Solenoid plunger
sleeve

3. Remove solenoid plunger sleeve. See Figure 4.

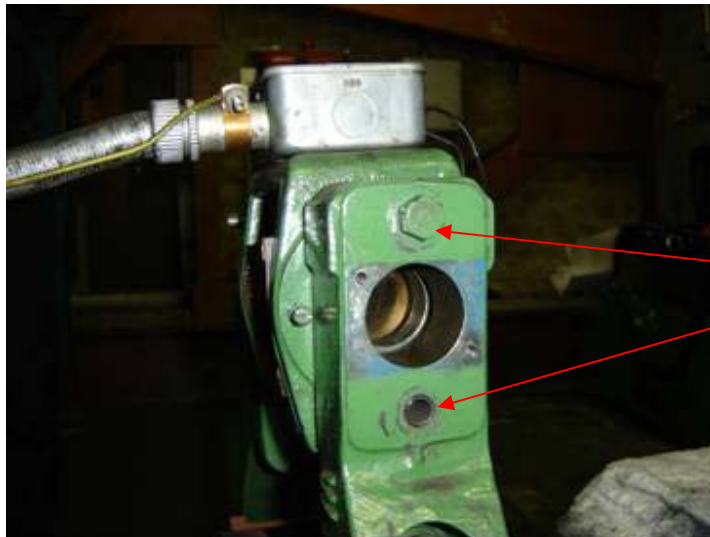
Figure 5

Remove these
two bolts

4. Remove the two bolts holding the brake coil housing to the brake arm. See Figure 5.

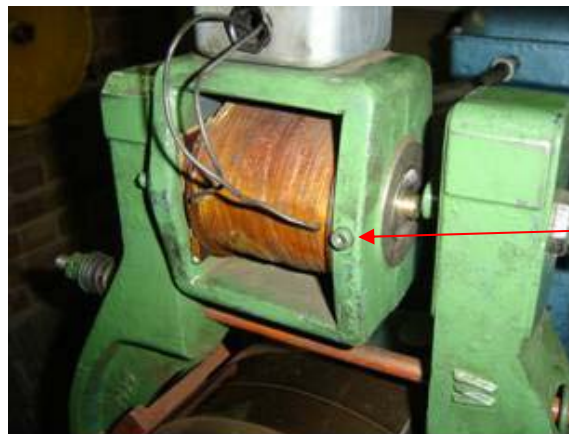
Figure 7

Remove brass bullet housing screw

6. Once the brake coil housing is removed from the brake arm, remove the brass bullet housing screw. It will now be possible to remove the bullet housing. See Figure 7.

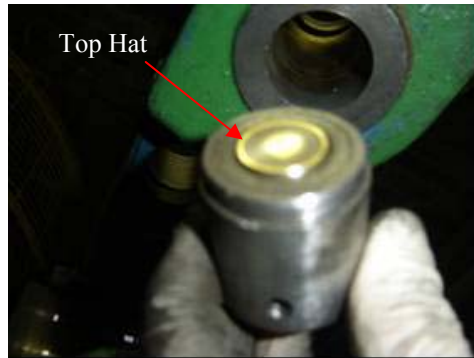
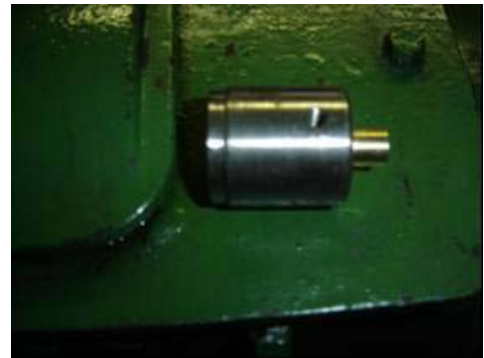
7. Check the condition of the brass bullet.
 If there are signs of excessive wear or mushrooming, that may affect the safe operation of the brake then it must be replaced before the lift can be returned to service.

Also inspect the brass bullet housing and the steel plunger to ensure that no damage has been caused, in particular as a result of the steel plunger contacting the bullet housing due to the top hat section of the bullet becoming unsatisfactory worn, also inspect the plunger brass sleeve.

Figures 8 & 9 show the brass bullet and housing. Figure 10 typical damaged parts.

If there is any evidence of damage, replacement parts should be obtained from Lift Components Ltd quoting the machine type and brake size.

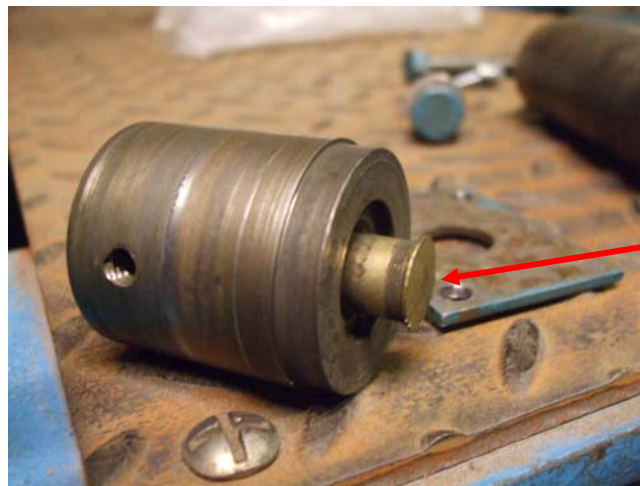
Figure 10

When incorrectly adjusted or subject to excessive wear this plunger can expand due to the continuous hammer action of the brake solenoid on the brake arms, with the result in the brake failing in the open position.

Typical signs of damage. Note the mushroomed plunger

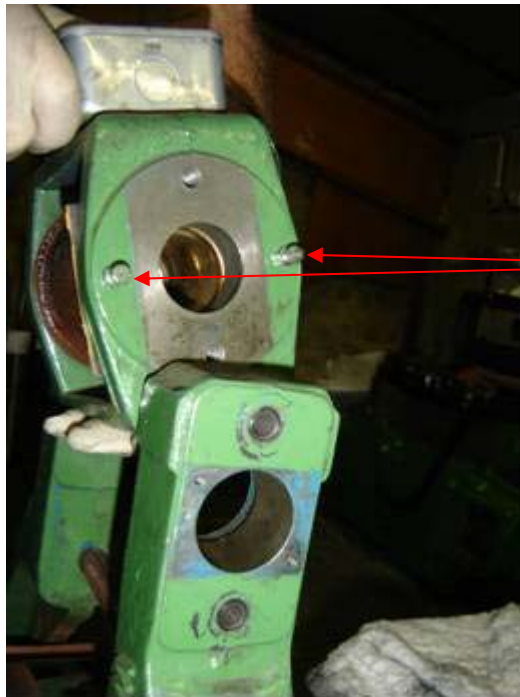
Figure 11

THESE SCREWS ARE ONLY TO HOLD COIL IN POSITION, DO NOT OVER TIGHTEN
