MODIFICATION TO MARRYAT & SCOTT ELECTRO-HYDRAULIC F.A.P.B., TWO FLOOR U.S.E. PUMP AND MAXTON VALVE, STAR/DELTA STARTING, WITH HARRIS PREBLE SHUTTER GATES

Modification to Marryat & Scott Electro-Hydraulic F.A.P.B. Two Floor U.S.E. Pump & Maxton Valve, Star/Delta Starting, with Harris Preble Shutter				CODE: SN 10.01.05  Pages: 1 OF 5  SAFETY CATEGORY A		
DEPT. TECH.SUPP	DATE 22.1.98		CHECKED V J Kaura	APPROVED	ISSUE	A

## Modification to Electro-Hydraulic F.A.P.B. Two Floor U.S.E. Pump & Maxton Valve, Star / Delta Starting, with Harris Preble Shutter Gates. Ref to Drawing LO 3673.

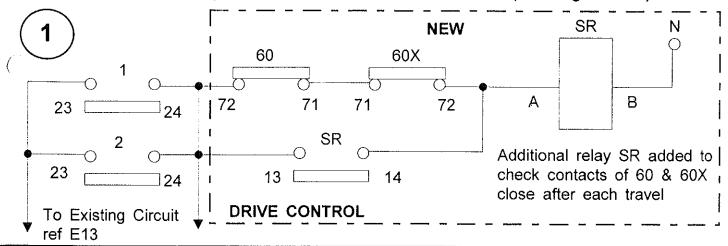
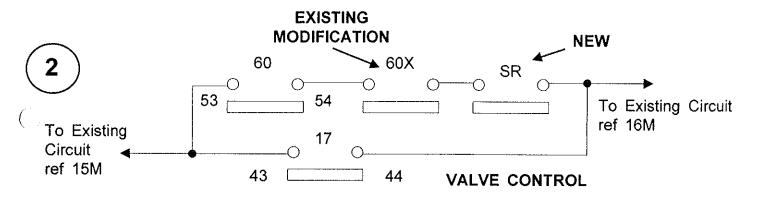
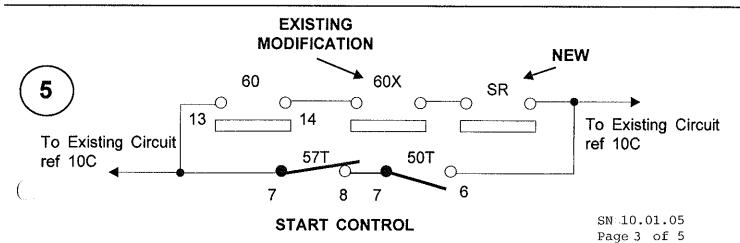
## Modification to Electro-Hydraulic F.A.P.B. Two Floor U.S.E. Pump & Maxton Valve, Star Delta Starting, With Harris Preble Shutter Gates. (Drawing LO3673)

These controllers have fitted a Harris Preble Shutter Gate, a fault was reported where the Lift ran normally with the Doors Open, caused by the relay 60 sticking IN.

A site modification was carried out which resulted in the Klockner- Moeller relay being changed to a different type and contacts of relay 60X added in the circuits shown on the diagram copy

This modification results in the requirement that two contacts of seperate relays need to fail before a similar fault could occur.

Stage 1 Addition to the circuit feeding Relays 60 & 60X.

Relay SR added and contacts of 60 (72-71), 60X (71-72) & SR (13-14) wired as shown. When ever a new call is allowed relays 1 or 2 energise, provided both 60 & 60X have dropped out from the last travel relay SR (Safe Relay) will energise. The contact of SR maintains itself for as long as relays 1 or 2 remain energised.

Stage 2 Addition of SR contact to the Valve Control circuit.

A modification has already been carried out adding a contact of 60X in series with relay 60 (53-54). Add an additional contact of SR in series with 60X & 60 as shown, making sure relay 17 (43-44) overconnects all of the 60X, 60 & SR contact.

All 60X, 60 & SR contacts must energise before the Valves can operate.

Stage 3 Addition of SR contact to the Star Delta Control circuit.

Add an additional contact of SR in series with 60 as shown, making sure relay 17 (33-34) overconnects both the 60 & SR contact. Both, 60 & SR contacts must energise before the Star Delta Control can energise.

Stage 4 Change of 60X (72-71) contact to a SR contact in the Call Control circuit.

By changing this contact it is not possible to move to a new call if the SR relay 'sticks IN, but Relevelling is still possible.

Stage 5 Adding additional contact of SR to the Start Control circuit.

If 60 or 60X remain energise it is not possible to move as the SR relay will not be energised.
