**Stannah Safety Bulletin – TB 97 Updated advice
re: Pawl device & replacement VMD Valves**

TECHNICAL BULLETIN

Product : Stannah MRLi - Hydraulic Passenger Lift

Subject : **Updated advice** - Pawl device and replacement down pilot valves

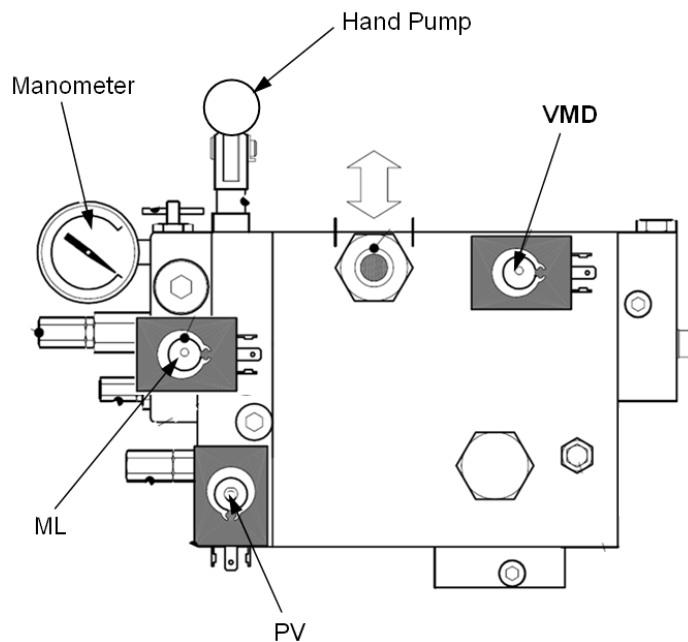
Figure 1 - Location of VMD

Identification of VMD:

By way of this bulletin we want to emphasise the importance of fitting the new design VMD, such that the valve upgrade must take place. New VMD valves are supplied free of charge with all necessary fitting instructions. Replacement should be undertaken before or at the next scheduled service interval. **This operation takes approximately 5 to 10 minutes.**

- All MRLi models with the old version VMD are to have the newer version VMD fitted before or at the next scheduled service interval.
- Action points of bulletin TB82 (fitting of pawl devices etc) are to be progressed for cases where additional safety, over and above requirements of EN81-2, is desired.

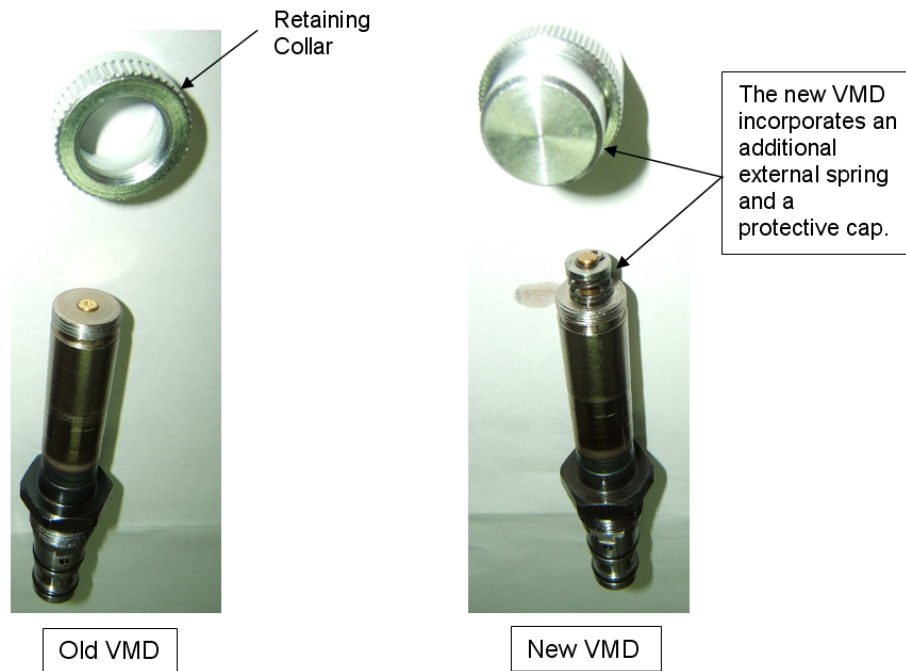
Figure 2 - Distinguishing features of old and new VMD valves

Those MRLi power units already equipped with the latest version VMD do not require a valve change. Appendix A lists contract numbers of those lifts recorded as requiring the VMD change.
