National Association of Lift Makers

GEARLESS MACHINES BRAKE LEVER PIVOT PINS

EXPRESS TYPE 'D' AND 'E' GEARS

GEARED MACHINE BRAKE SOLENOID
WASHER REPLACEMENT

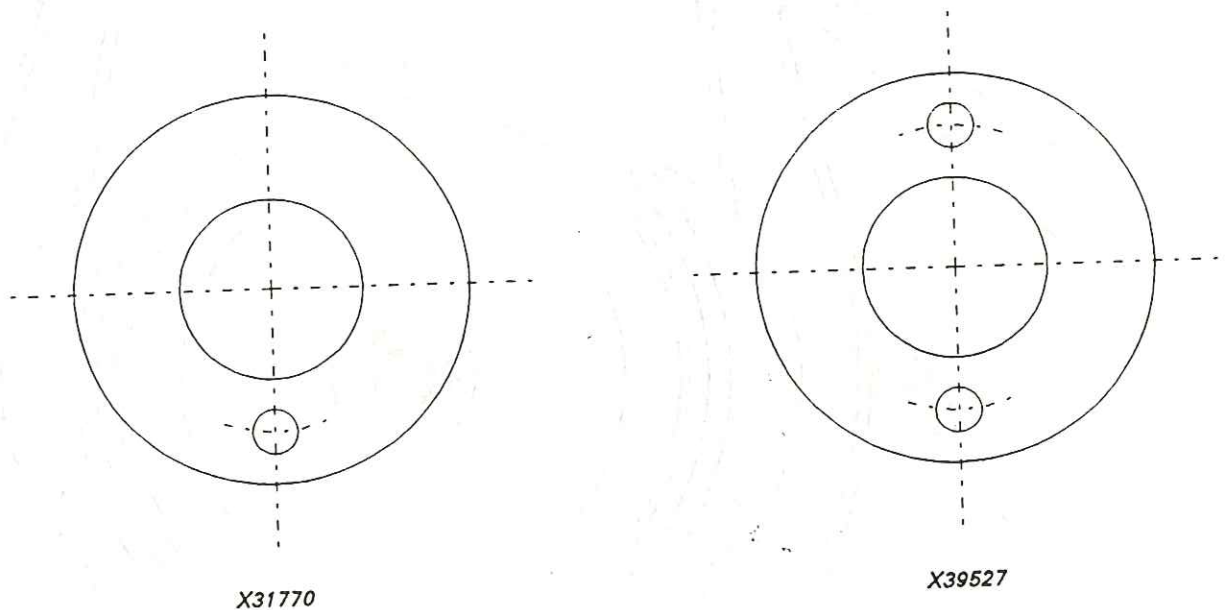
Figure 1 - Washer Identification

3.1 Disintegration of resilient stop washer inside brake solenoid causing operation of the brake to be retarded. (A batch of bought in stop washers have been supplied to an incorrect grade. These perish after prolonged contact with oil or grease).

4.2 Washers are identified as figure 1.

4.1 Replace stop washer X31770 with a new washer X39527 manufactured from Nitrile rubber as follows:

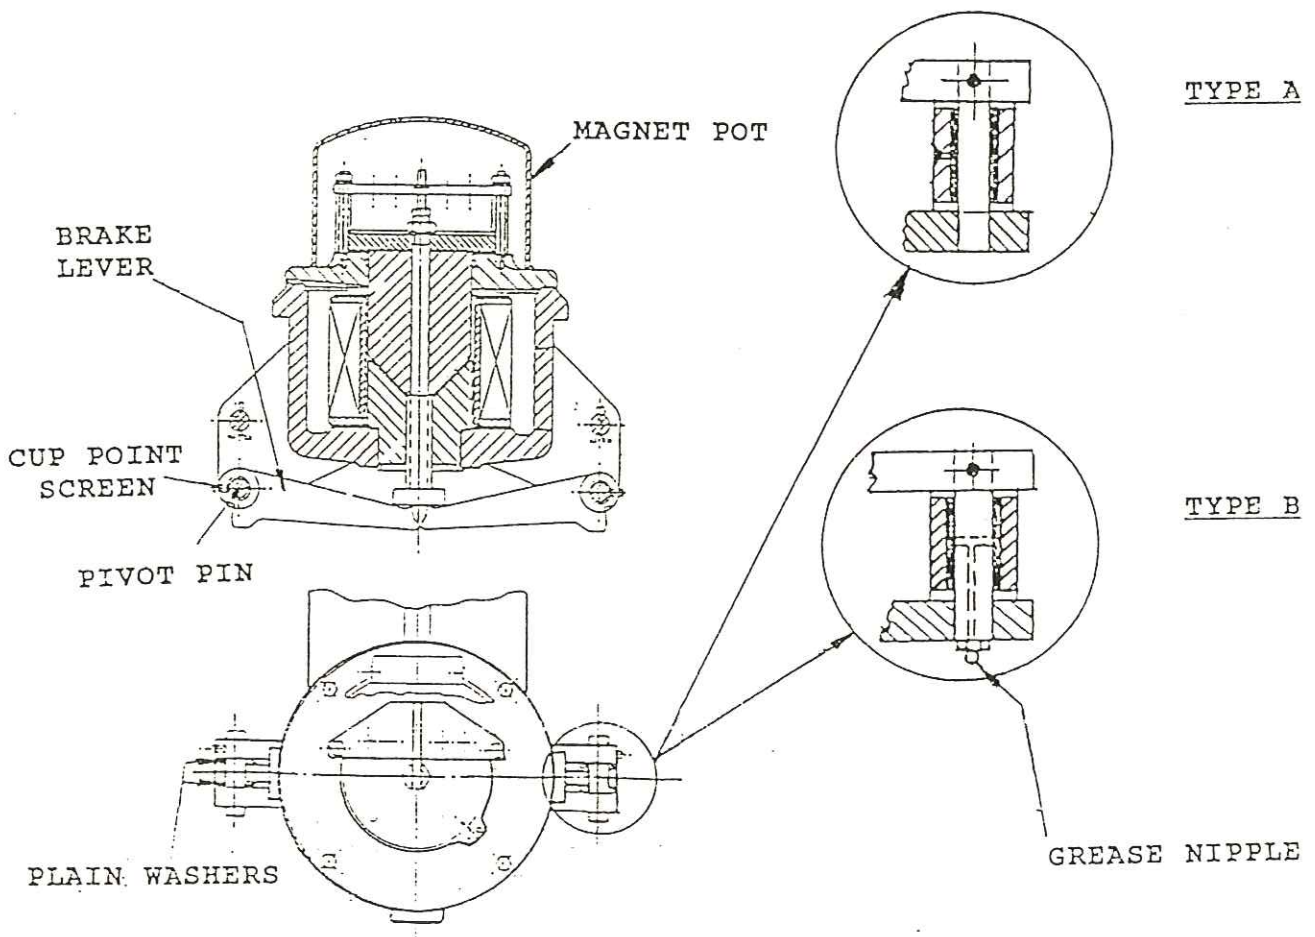
The lubrication of the brake pivot pins on early designs of Express Lift gearless machines has been found to be limited in some instances. Lubrication of these pivot pins can be improved by the fitting of the latest design which incorporates cross holes and a grease nipple in the end of the pin.

We recommend that the brake lever arms are inspected at the next routine service visit and any gearless machines with the earlier design (Type A) are changed to the latest design (Type B).

Details and parts for this change can be obtained from Lift Components Ltd.
