National Association of Lift Makers

**Express 'C' Machine Brake Lever Pivot Pins
A & P Stevens Landing Door Lock**

RE: EXPRESS 'C' MACHINE BRAKE LEVER PIVOT PINS

RE: A & P STEVENS LANDING DOOR LOCK

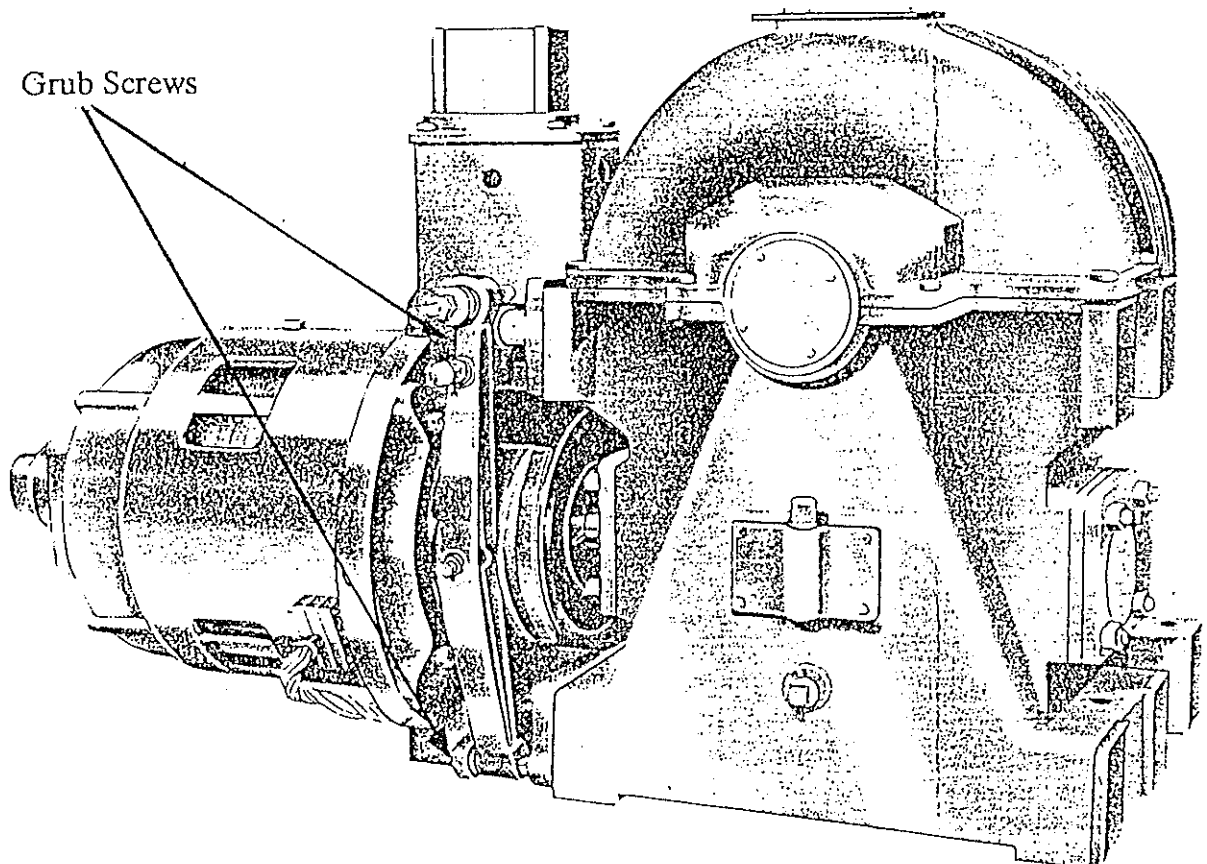
A brake failure has recently occurred resulting in the lift descending down the shaft and buffering. The cause of the failure was the brake lever pivot pin fixing screw not being sufficiently tightened to lock the pivot pin in position.

Further investigation has shown that the grub screw locating hole had not been fully drilled and tapped resulting in the screw not holding the pin.

To prevent a recurrence of the incident every C machine pivot pin grub screw fixing must be checked as shown below and modified as necessary as soon as is practically possible.

1. Check that the grub screws are tight and attempt to turn the pivot pins by inserting a 3/16" rod in a hole at the end of the pin.
2. If the pin does not turn release the grub screw to check that the pin is not binding and then re-tighten the grub screw so that the pin will not turn.
3. If the pin can be turned when the grub screw is tight then remove the grub screw and drill the hole fully through the casting and re-tap 1/4" BSF thread. Re-tighten the grub screw and check the pin does not turn.
4. If check (2) indicates that the pin is binding then it must be freed and cleaned to ensure that it will turn and then checks (1), (2) and (3) should be repeated as necessary.
5. Check each brake arm and brake lever pivot pin.

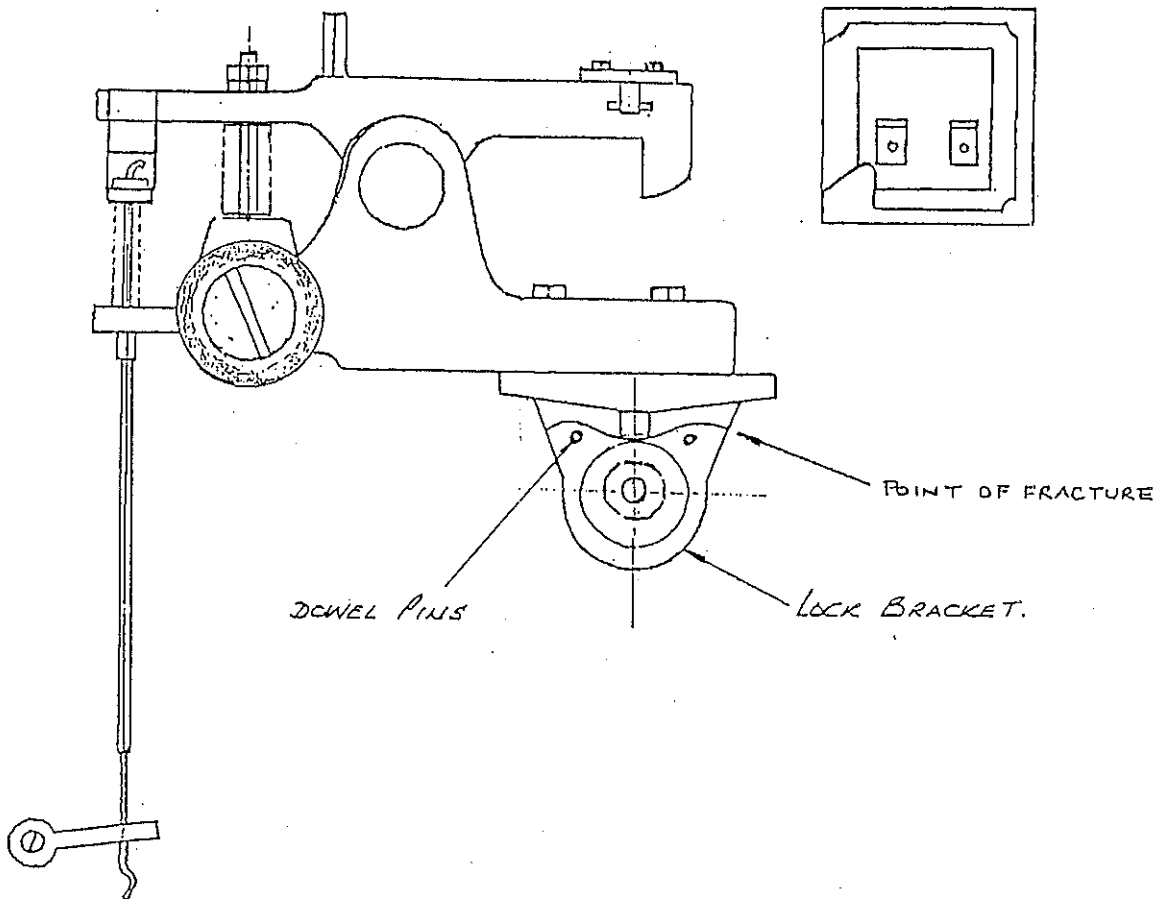
An incident occurred recently where the lock bracket fractured but allowed the beak to drop into the lock box thus completing the safety circuit. The lift moved away from the floor and stopped when the beak dis-lodged (approximately 1½ floors away).

A replacement lock bracket was manufactured from mild steel and fitted with no other adjustment and the lift returned to service.

EVERY LOCK BRACKET MUST BE CHECKED TO ENSURE THERE ARE NO FRACTURES OR HAIR LINE CRACKS AND REMEDIAL ACTION TAKEN AS NECESSARY
