**Re: Otis Product Improvement Notice – 003.**

**Over Speed Governor  
Tension Weight Switch**

<b>OTIS</b>	<b>Product Improvement Notice Parts Ordering Form</b>	<b>Ref : 003</b>	
	<b>Over Speed Governor Tension Weight Switch</b>	54-10-01	
		Date issued	12/01/2011
		Expiry Date	01/05/2011

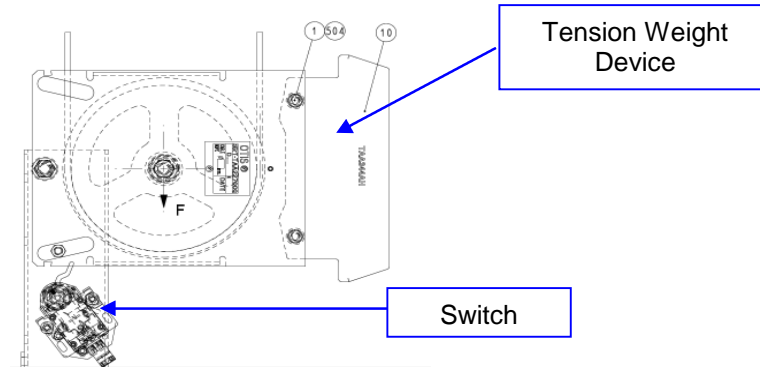
If the over speed governor rope stretches excessively and is not detected during routine servicing there is a possibility that the safety switch that is designed to isolate the lift will in certain circumstances fail to do so.

If the switch is subjected to excessive dust or the the mobility of the switch mechanism decreases for any other reason the actuation of the switch arm may cause excessive movement in the support bracket which could result in the switch failing to operate electrically.

1. Check the operation of the Governor Tension Weight Switch to determine if there is excessive movement of the support bracket.
2. If the answer is yes then the product improvement retrofit support kit should be installed by following the fitting instructions within the special instructions section.
