Stannah Lifts Technical Bulletin - Safety

Issue No: M8

LIFT TYPE:- STANNAH HOMELIFT

Re:- Adjustment of Stannah Homelift Concertina Panels.

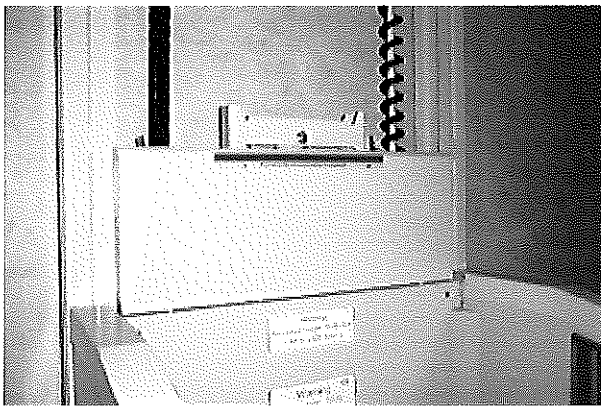
Fig a. Label shown positioned on the bottom concertina panel.

It has come to our notice that some of the Stannah Homelifts in the field have not been maintained with the correct adjustment/overlap of the rear concertina panels.

A safety label has been made available and we would recommend that this be fitted as shown to all units in the field to ensure that the overlap does not exceed the minimum dimension shown.

Should any Homelifts be found with insufficient overlap, the panels should be adjusted so that equal overlap is achieved.

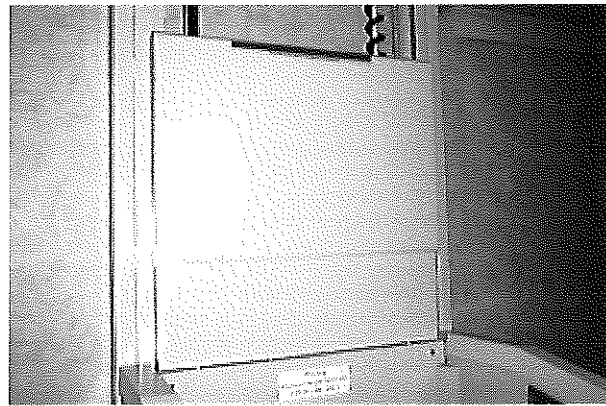
Fig b. Label shown positioned on the middle concertina panel.
