From Steven Reynolds  
Telephone 01932 758 100  
E-mail tech.support@gb.schindler.com  
Reference no. FI 483/IG/FL  
Date 01/07/2011  
Subject **Schindler QKS Telescopic Doors: Missing Emergency Coupling.**

### 1) Potential Problem:

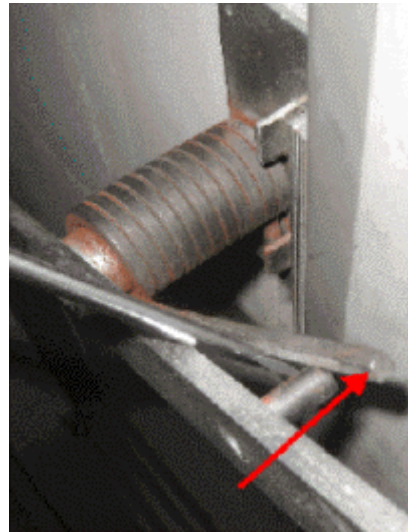
We have identified a potential problem which could affect the Schindler telescopic landing door types QKS6, QKS9 and QKS10 manufactured before 1993.

If the pin on the door closing spring lever were to break (see photo), the slow door panel could remain open when the fast door panel closes.

All installations with Schindler telescopic QKS6, QKS9 or QKS10 landing doors must be checked during the next routine service visit to ensure an emergency coupling is in place.

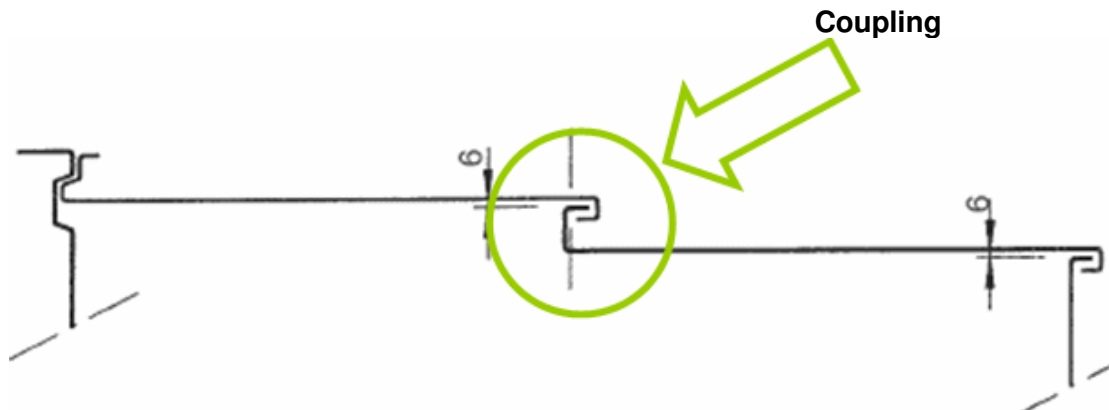
B) On fire rated doors the panels are bent to form a chicane. This construction also provides emergency coupling, so no retrofit action is required.
