Schindler Ltd.
Field Quality & Excellence

From Steven Reynolds
Telephone 01932 758 100
E-mail tech.support@gb.schindler.com
Reference no. FI 379/IG/FL
Date 04/07/2011
Subject **Schindler Smart MRL: Potential Problem with Counterweight Upper Yoke**

Date 04/07/2011
Page 2
Subject **Schindler Smart MRL: Problems With Counterweight Top Yoke**

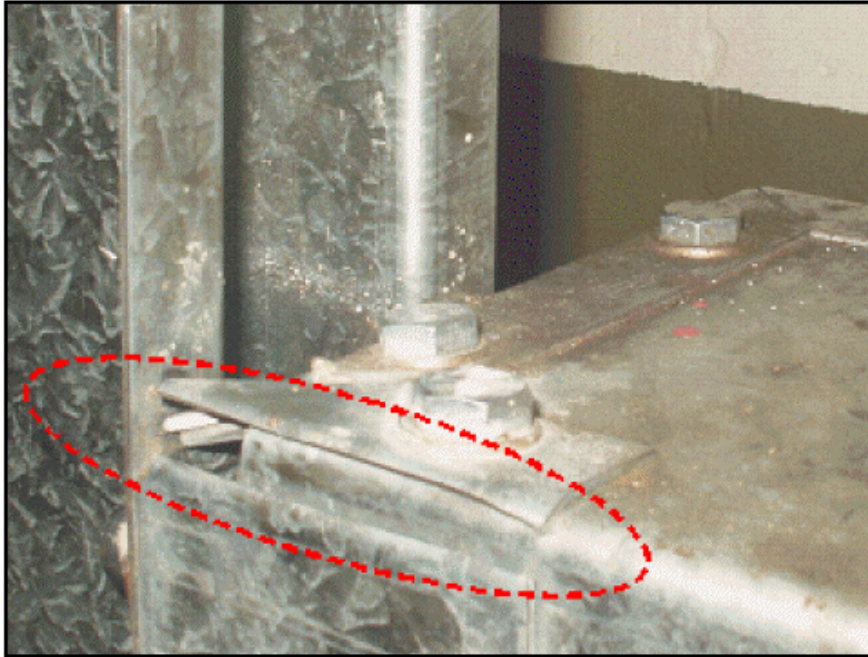
We have identified a potential problem with the counterweight frames on Schindler Smart MRL lifts with rated loads of 320, 450 and 630 Kg manufactured before Feb. 2001, i.e. counterweight frames with no reinforcement welding on the upper yoke.

Some of these counterweight frames may experience cracks and tears where the uprights are attached to the upper yoke, potentially leading to a mechanical failure of the upper yoke.

Check all relevant counterweight frames for cracks and tears where the uprights are attached to the upper yoke. Request a reinforcement kit (below) and installation instructions for all affected installations (regardless of whether cracks or tears are found) by completing and returning the enclosed reporting form to Schindler Ltd.
