## **Oakland Elevators Ltd, Ceiling Tray Locks**

Title :  
Ceiling tray locks

TI no: 002  
Issued by: D Holmes  
Approved by: PM Chamberlain

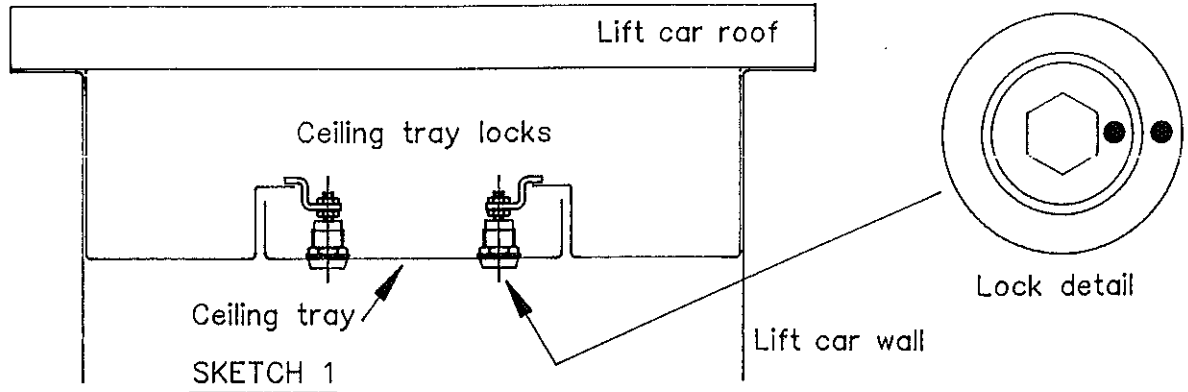
We have recently had an incident reported which was caused by a ceiling tray lock not being in the fully closed position.

The ceiling tray lock in question is incorporated into Oakland passenger lifts commissioned between September 1991 and September 1993.- subsequent installations incorporate modified brackets (see below). The assembly details are as shown in sketch 1.

The lock details show 2 dots which when aligned indicate that the lock is in the 'locked position'. Please carefully examine that the dots are aligned when locking the ceiling tray.

As a precautionary measure, longer clamping brackets are now available and we would advise that these should be fitted. Please contact Peter Masterson at Oakland stores with any requirements you may have.

Please examine any Oakland passenger lift that you may service which was commissioned between September 1991 and September 1993.

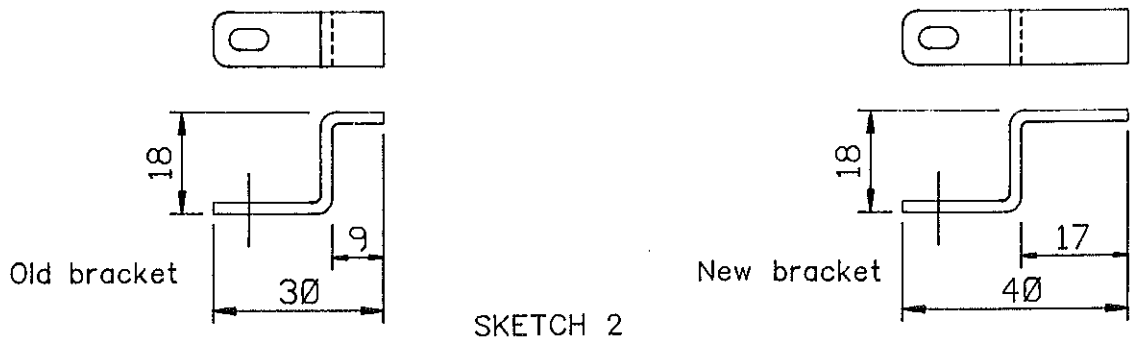
Sketch 2 shows the comparative sizes of the old and new brackets.
