Oakland Excelsior

Subject: Cantilever lift rope pick up tube

Date: 27th July 2011

Enclosed:
Technical memo TM037

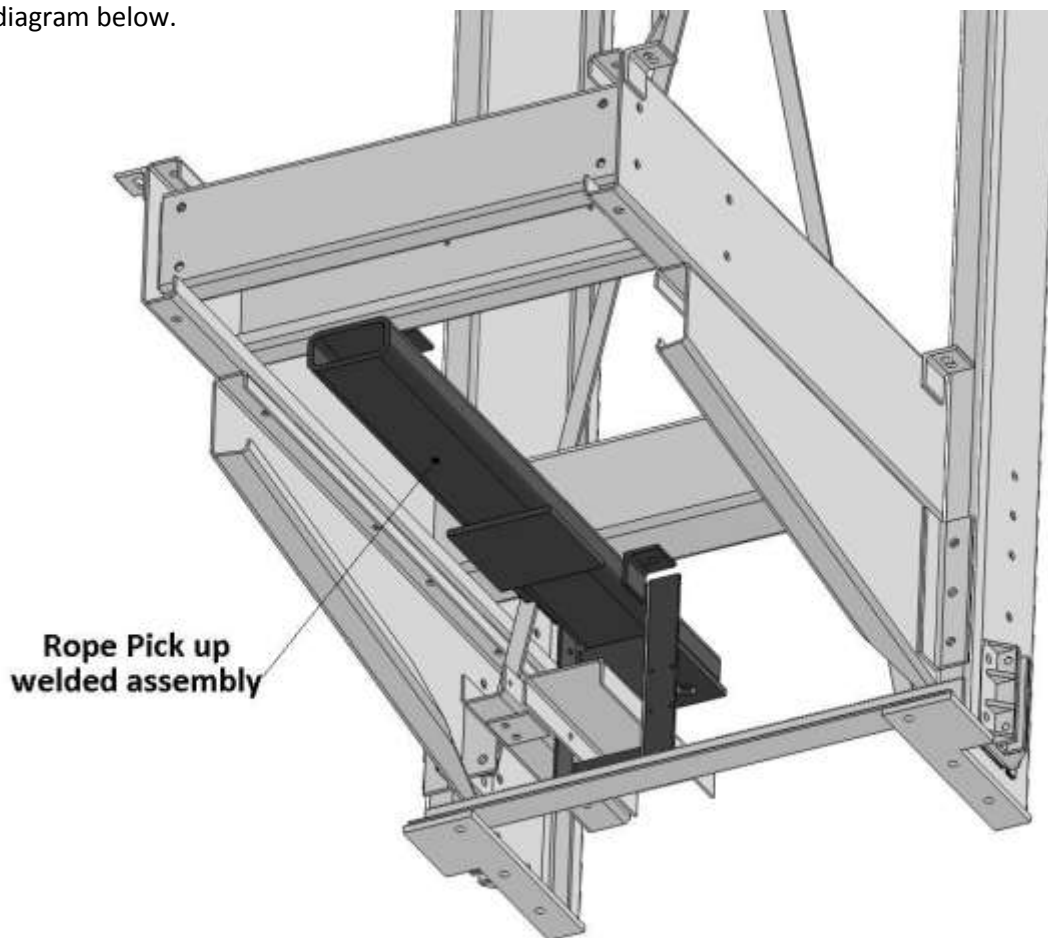
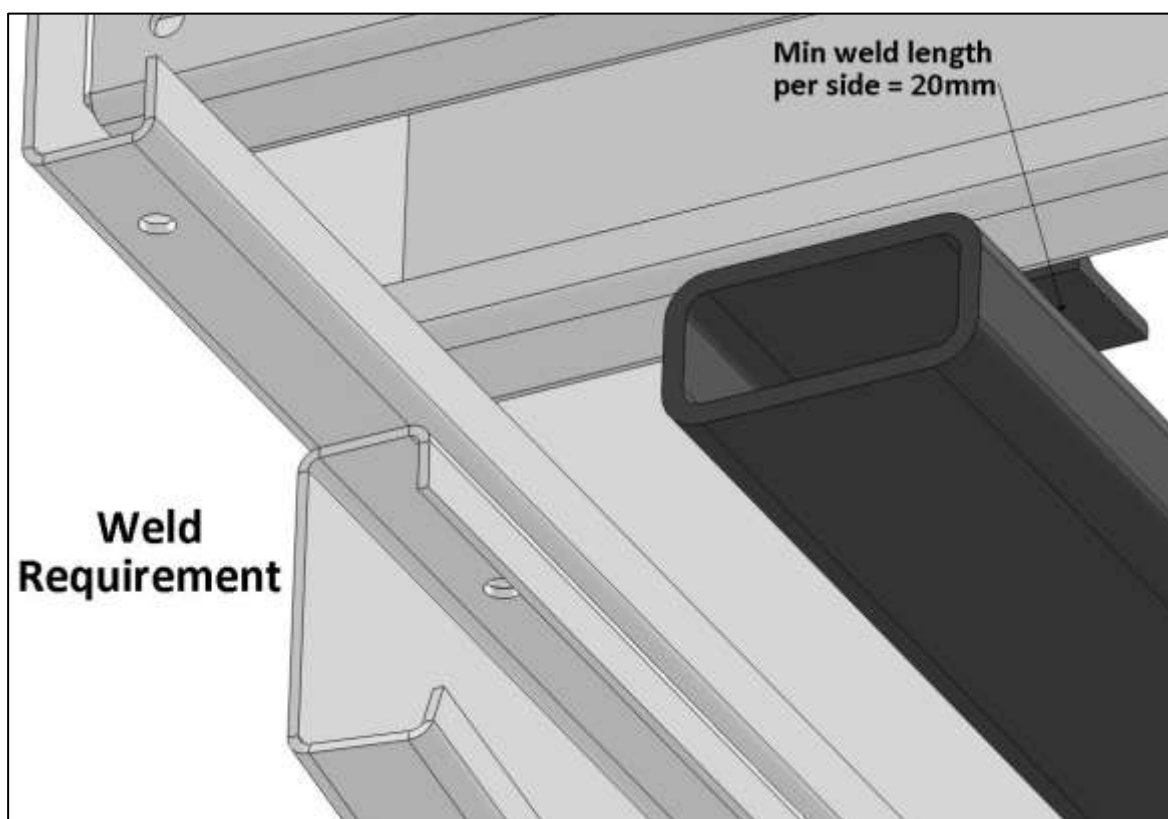
Cantilever Sling 2:1 Hydraulic

A problem has been identified with the rope pick up assembly on Oakland Excelsior 2:1 hydraulic lifts. Some batches of these have been manufactured with insufficient weld to the connecting cleat. This is shown in the diagram below.

Check the weld length in the area indicated. If the length of weld down each side of the cleat exceeds 20mm no action need be taken. In the event that the weld length is less than 20mm the Rope pick-up tube should be fastened to the folded cross plate by drilling and fixing using Grade 8.8 M12x40 Bolts as shown
