## RE : Preventive Maintenance of Counterweight Pulleys

In its continuing monitoring and development of its products, KONE has established that in **KONE CWF10PWS type of counterweights equipped with retainer rings in the ends of the pulley axle**, an unnoticed complete failure of the pulley bearing may cause unnecessary loading to the counterweight guiderails and in very rare and extreme cases lead to the counterweight becoming derailed from the counterweight guiderails.

## APPENDIX: CWF10PWS COUNTERWEIGHT UPGRADE

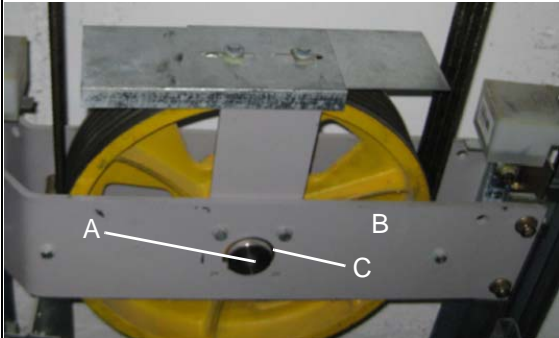
Condition	Illustration/Note
1	Unit has been delivered in the year 2004 or later (until August 2011).	The year of delivery is indicated in the car operating panel.
2	Elevator and machinery type combination is one of the following: <ul style="list-style-type: none"> <li>• KONE MonoSpace machineromless elevator with MX10 machinery.</li> <li>• KONE SMonoSpace and KONE SMiniSpace elevators with MX10 machinery</li> <li>• KONE XMiniSpace with MX06 or MX10 machinery.</li> </ul>	The motor type is marked to the motor data plate which is fixed into the motor.
3	On both sides, the pulley axle (A) extends outside of the pulley assembly side plate (B) with retainer ring (C) fitted.

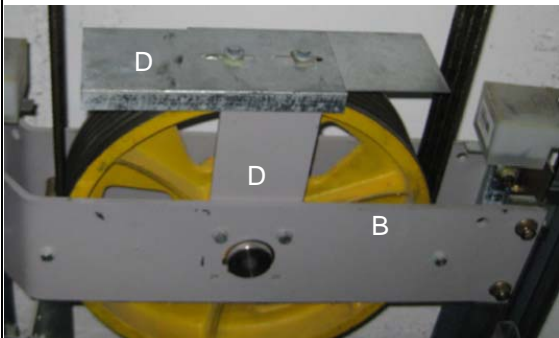
4	Counterweight has an integrated upper axle holder and rope cover plate (D) fitted inside the pulley assembly side plate (B). NOTE! Axle holder (D) can be on car roof side or shaft wall side.

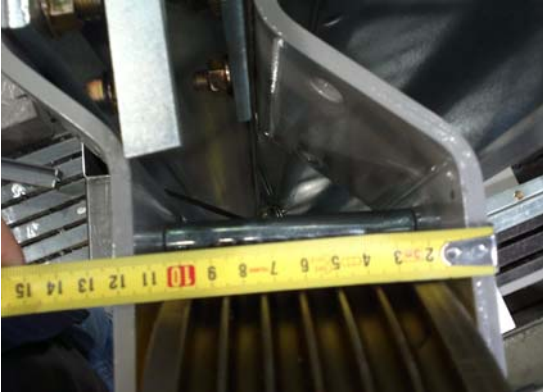
<b>Condition</b>	<b>Illustration/Note</b>
5	Counterweight pulley diameter and distance between guiderails is one of the following combinations: <ul style="list-style-type: none"><li>• the pulley diameter is 330mm and the distance between the guiderails is 570mm; or</li><li>• the pulley diameter is 410mm and the distance between the guiderails is 700mm.</li></ul>	
6	Distance between the pulley assembly side plates is 124 mm.

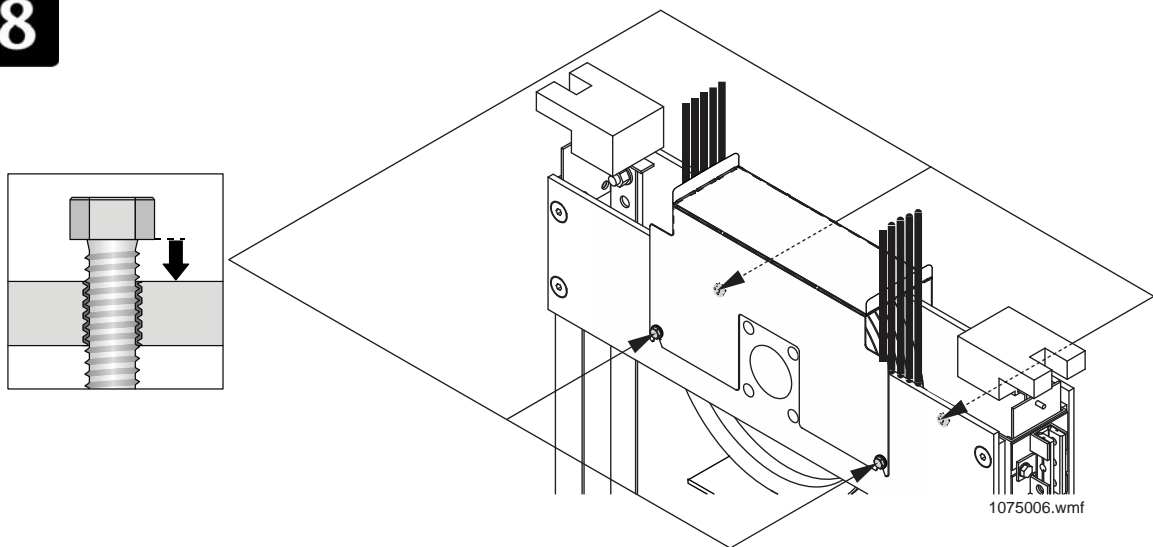
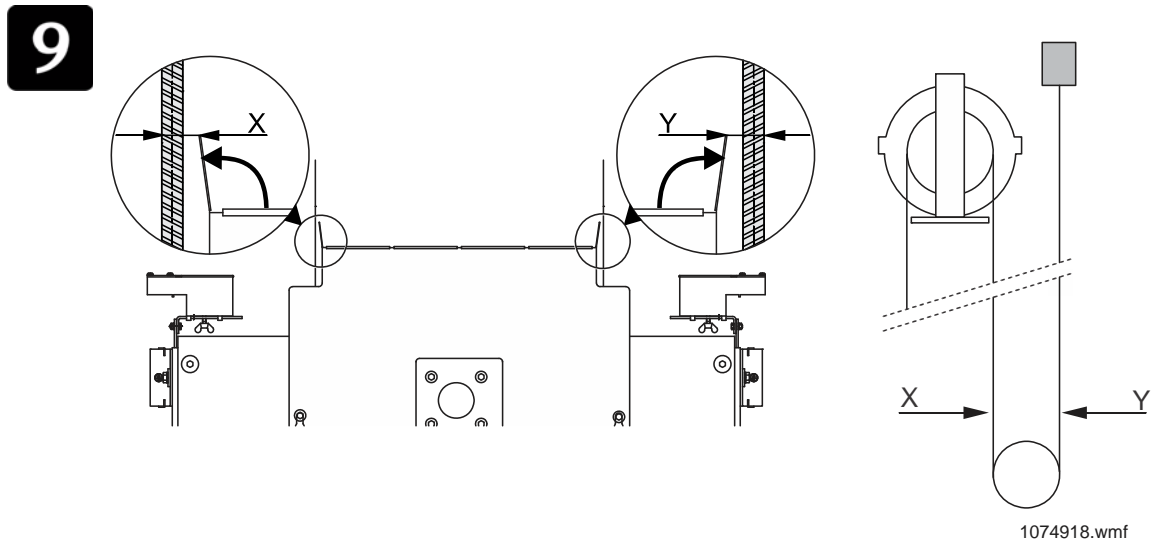
1074918.wmf

X (on machinery side) = 3 – 5 mm.  
 Y (on counterweight rope fixing side) = 8 – 10 mm.

**NOTE!** The gap from the cover plate to the rope is different in different parts of the shaft. Typically, the shortest distance is when the counterweight is in its higher position and on the rope fixing side.
