Liftmaterial - Safety Bulletin.

Sassi Brake Type 3040 Supplied Before October 1st 1993.

**SUBJECT: PROBLEMS CONCERNING THE MANUAL
BRAKE RELEASE MECHANISM ON BRAKE TYPE 3040
FITTED ON GEARS MB 82, MB 91, MB 92, MB 94, MB 95.**

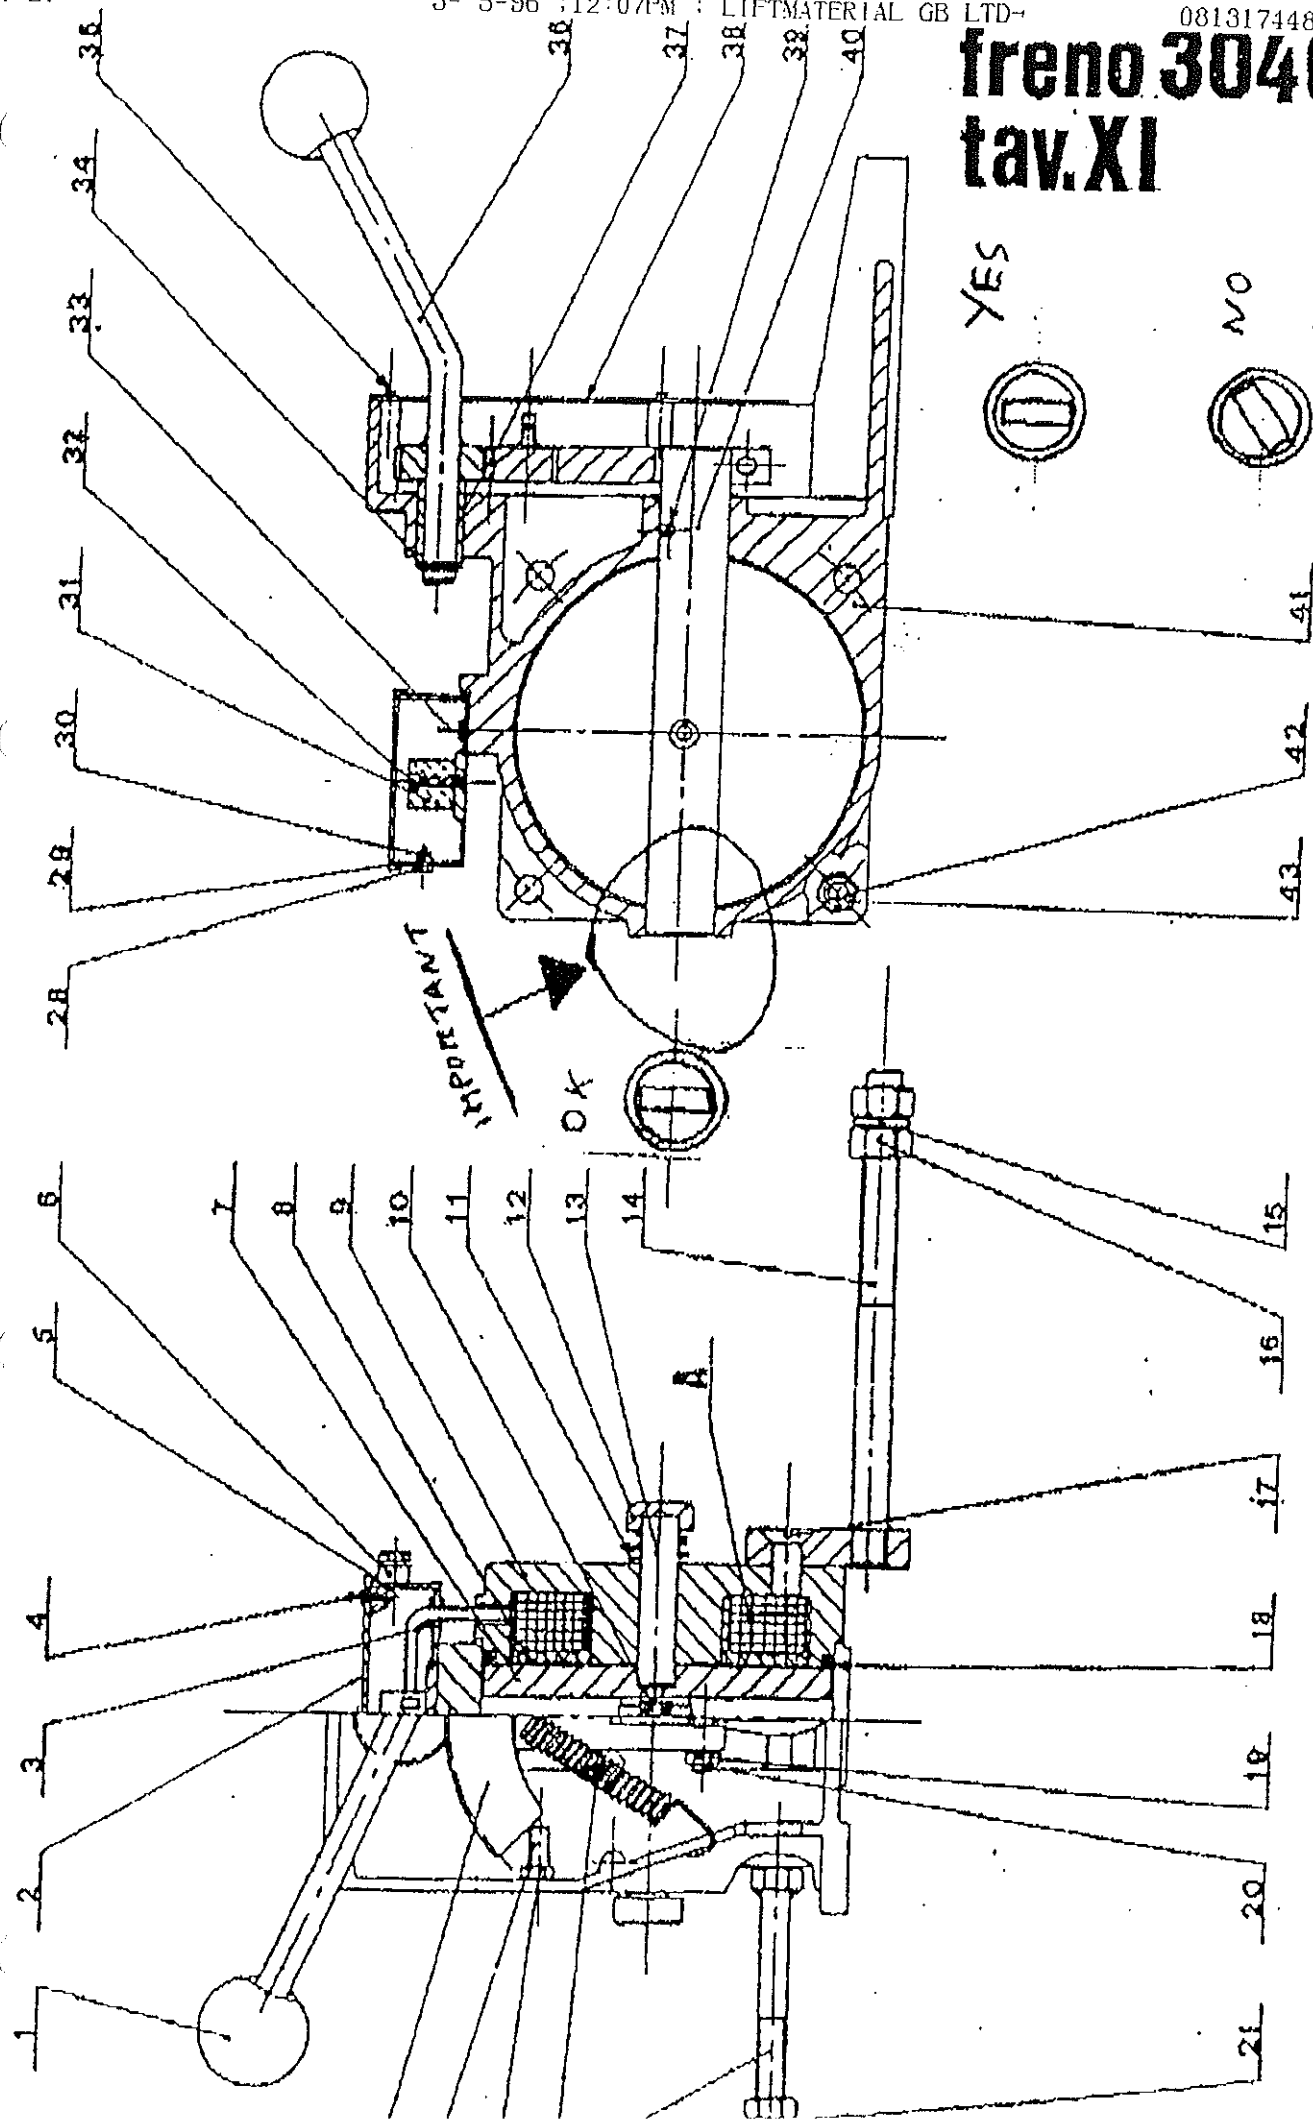
freno 3040 tav.XI

The above said problem is easily recognised by observing the position of the brake release lever (please see enclosed drawing).
By observing the hole it will be noticed (without touching the release handle) that the lever is either in the vertical or diagonal position. If indeed the latter is observed then the internal components of the release mechanism are deformed and must be replaced.

If replacement component parts are required A. SASSI S.p.A. have a component kit available through LIFTMATERIAL (GB) LTD, Braintree, to replace internal components on gear units supplied before October 1993.

Customers will need to supply information to LIFTMATERIAL (GB) of the gearbox model and the serial number, to receive the required modification kit along with the relative instructions and drawings.
