## Re : Product safety notice - Orion Alpha Hydraulic Power Units / High pressure Circuit

## SAFETY NOTICE

## This safety notice is applicable to Bucher Hydraulics Orion Alpha UD-470/600 hydraulic power units.

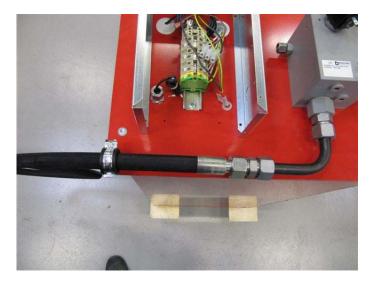
A failure occurred within the high pressure hydraulic circuit between accumulators and accumulator valve. A high pressure fitting at one end of the swept bend connecting valve to hose became detached. The high pressure hose disengaged spraying oil around the motor room.

We have identified the probable cause of the fitting failure as being the incorrect placement and press fit of the "olive" at one end of the pressure pipe bend during manufacturing.

The incident was exacerbated by the hose not being correctly clamped as recommended (every 1.5m between power unit and accumulators) The loose hose was therefore able to "thrash about" within a considerable radius, thereby causing additional damage.

1. The pipe bend should be fitted as shown above, with the long end pointing towards the back of the power unit. Bucher Hydraulics have provided a clamping fixture on the tank, as shown above, which is now standard on all new units, and is also available as a retrofit item.

2. Most importantly, and irrespective of the availability of a clamping fixture on the tank, the high pressure hose must be clamped (as is required by good hydraulics practice anyway) securely to a wall and or other fixture every 1.5m between power unit and accumulators. Bucher Hydraulics provide the required clamps with every delivery. These clamps are of course also available as retrofit items if they were not fitted or have been mislaid in the interim.
