Lift and Escalator Industry Association

KONE TYPE ADV AND ADT DOORS WITH CURTAIN OF LIGHT SAFETY EDGE

KONE LIFTS LTD	Subject				CODE: SN 03.17.01
	<u>ADV & ADT + CURTAIN OF LIGHT SAFETY RISK.</u>				Pages: Total 6 SAFETY CATEGORY A
DEPT. TECH.SUPP	DATE 3.6.98	COMPILED BY A J Shiner	CHECKED V J Kaura	APPROVED <i>ASh</i>	ISSUE B

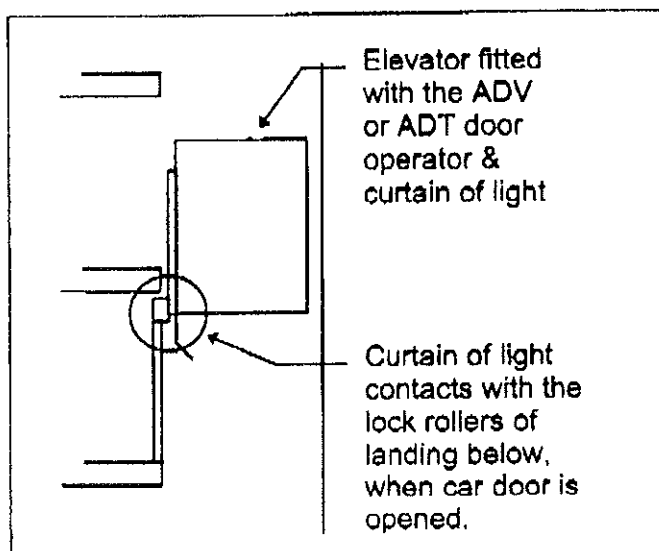
The COL safety edge has a theoretical 1mm gap between it and the landing door rollers, in many inspected elevators this gap does not exist. It is then possible that during maintenance or emergency evacuation, when the elevator car is positioned 1 meter or more under the landing level, the opening of the car door can also open the landing doors of the floor below. This exposes the empty shaft to users. Children are especially at risk in these situations.

Figure 1. Unintentional opening of the landing door

The opening of the landing door below exposes a real possibility of a member of the public falling into the pit. In the past 5 years there have been four reported cases (not with the ADV or ADT) when a user has walked into a darkened shaft without the elevator being at the level, three of these have been fatal.

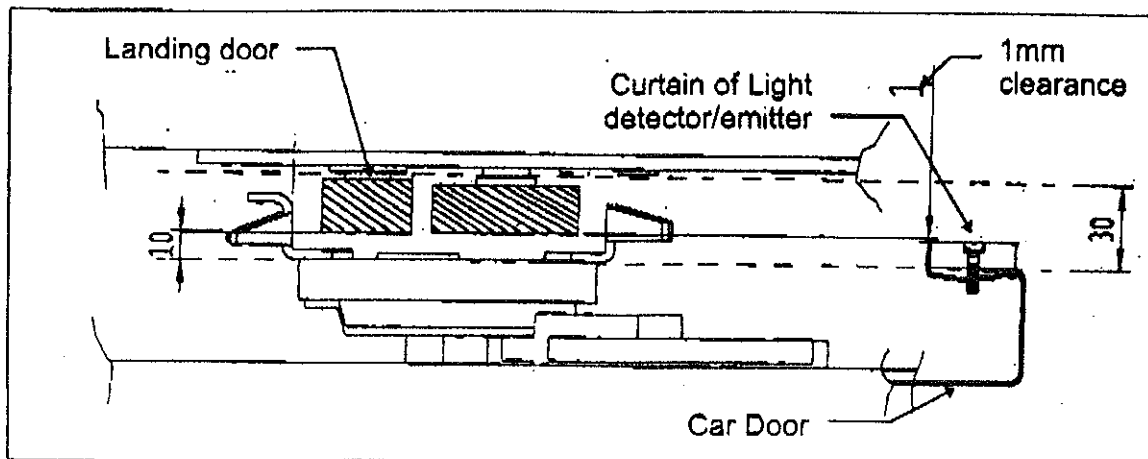
The clearance between the curtain of light emitter/detector unit and the landing door rollers is 1mm, and during installation, maintenance or natural wear and tear this clearance can be removed and lead to the safety risk.

Figure 2. Clearance between curtain of light and landing door rollers

All callout and maintenance employees must be made aware of this safety risk, and as part of the regular maintenance the clearance gap must be checked and maintained.

An employee can quickly check by carefully opening the car door by hand and seeing if the landing door rollers are hit by the curtain of light at each landing.

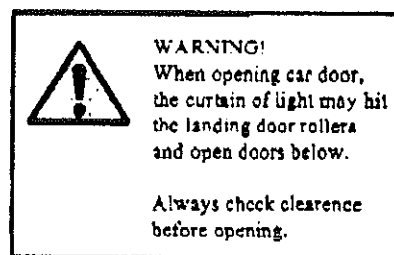
Figure 3. Warning sign for the car door header

It is recommended that a warning sign is produced locally, and stuck next to the car door maintenance test buttons. An example of a sign and text are shown below in Figure 3. The placing of the sign can be seen in Figure 4.

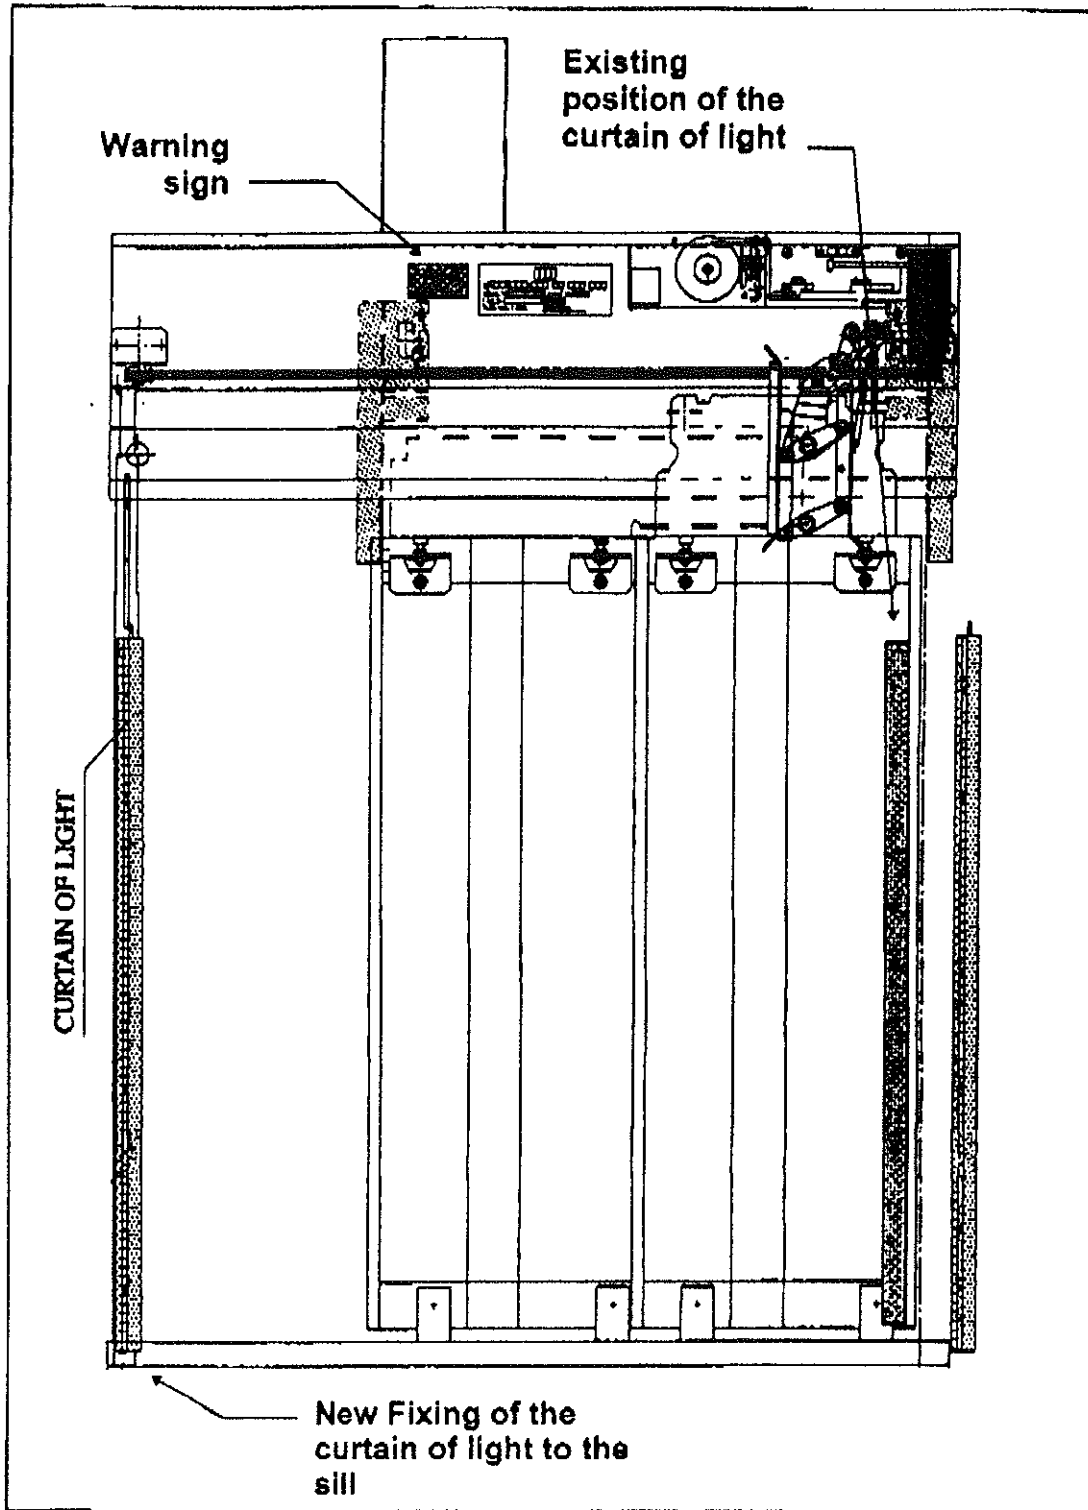
Figure 4. Fixing of curtain of light to the car doors and to the car sill

The position of the COL safety edge will be moved from the door leading edge to a fixing on the sill as seen in figure 4 below. The modification kit is available from the Pero factory and can be ordered using the form in Appendix 1.
