# National Association of Lift Makers

## **Hammond & Champness Single Speed SAPB Controllers**

**SUBJECT : H + C Single Speed , S.A.P.B Controllers.**

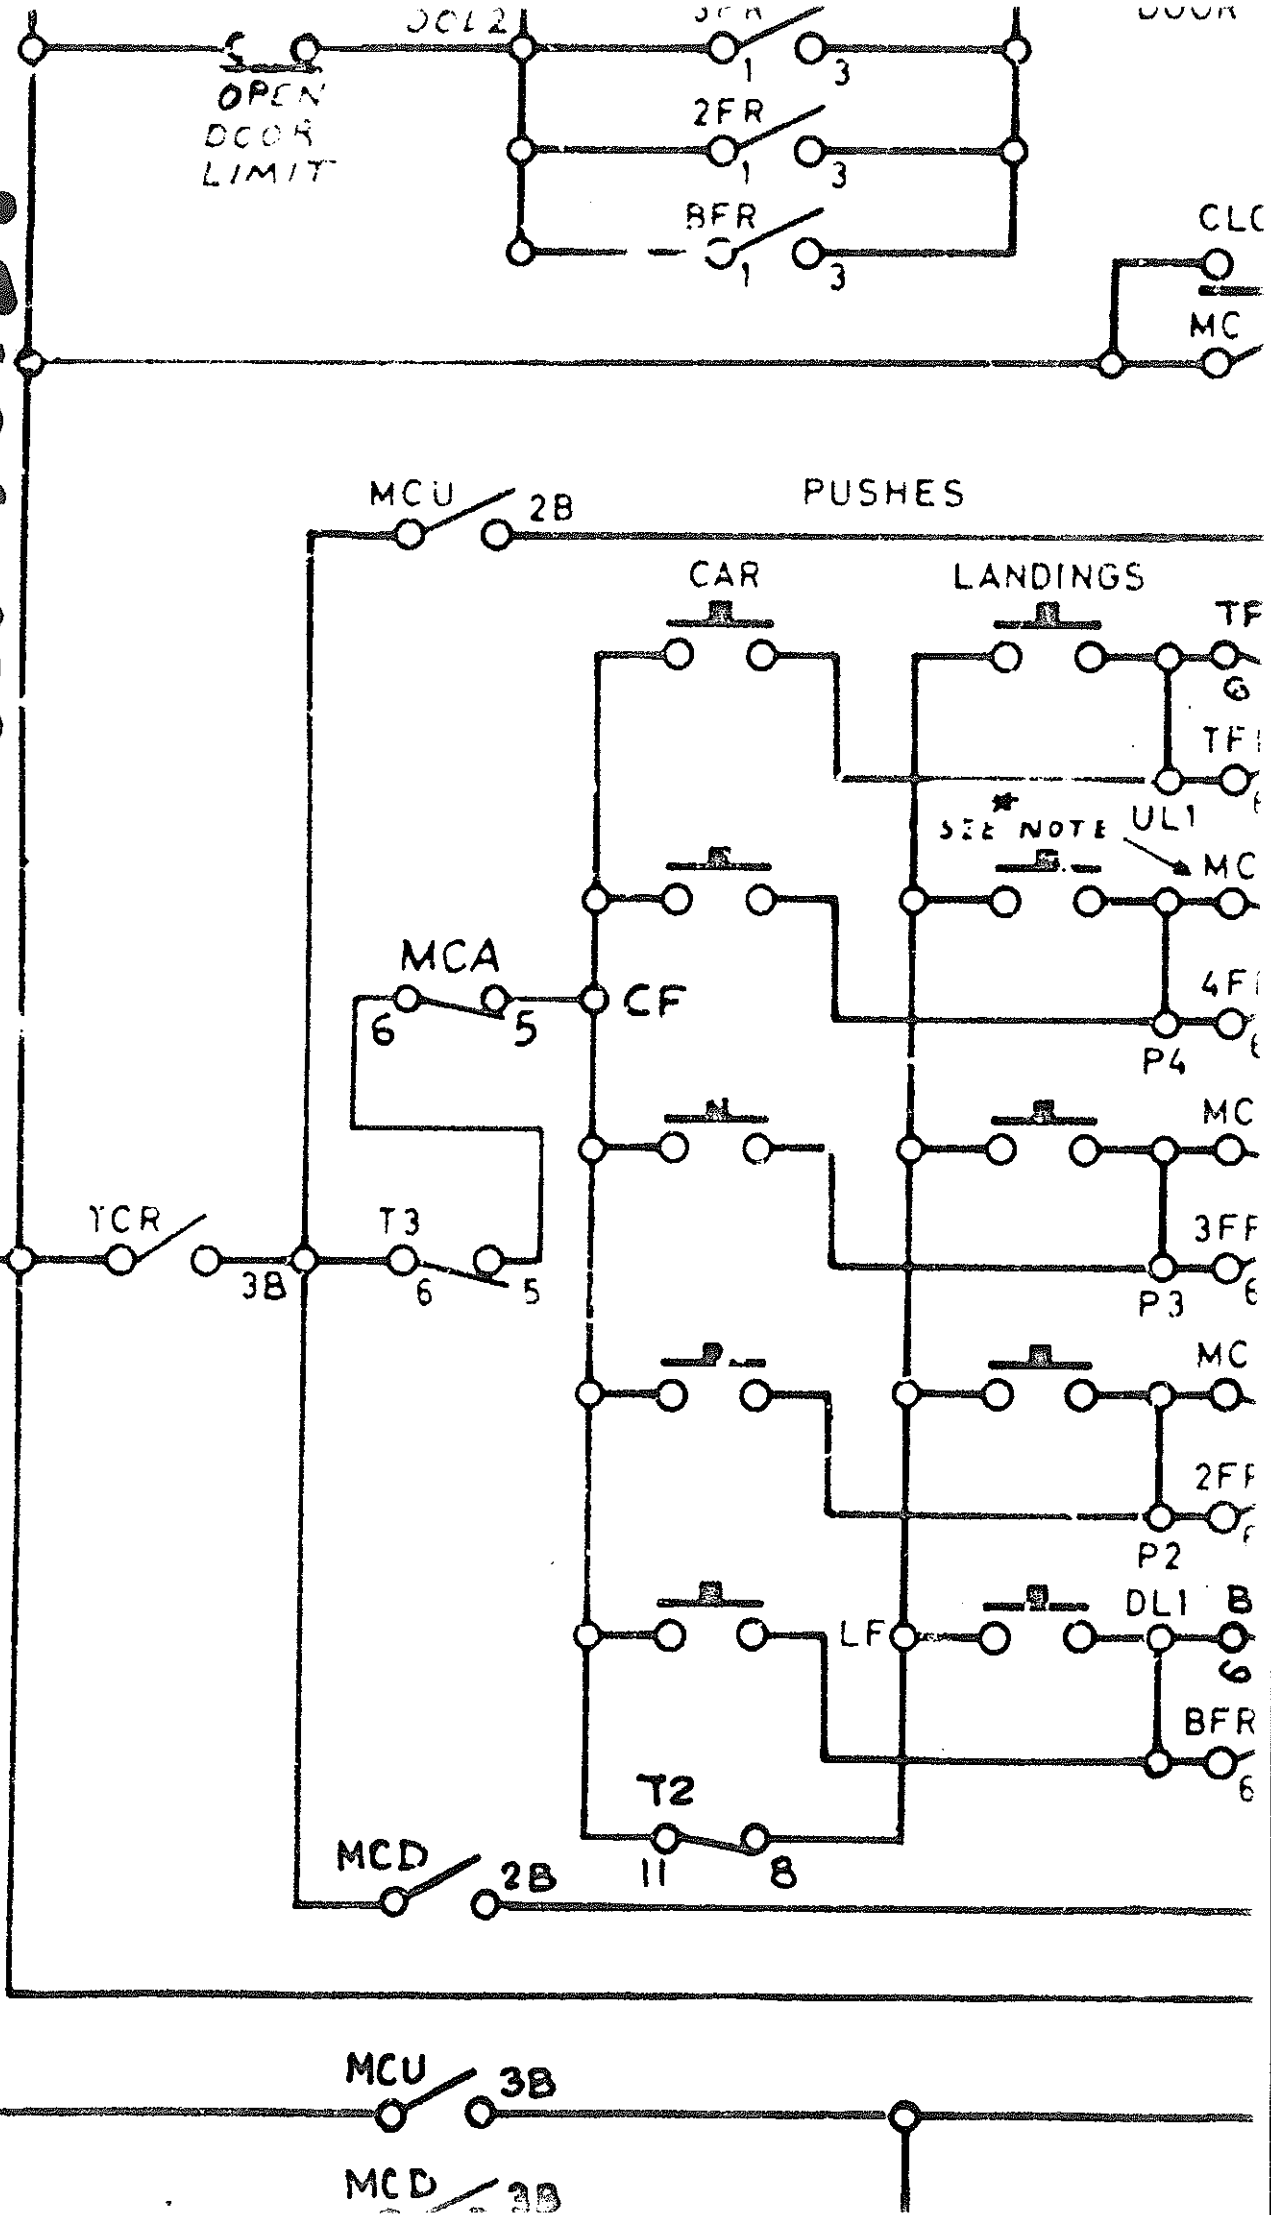
# EXTRACT FROM DIAGRAM W1002/D/1 Sheet 1 of 2.

A potential safety problem has been recognised on our single speed, S.A.P.B. controllers manufactured between 1976 and 1988 to wiring diagram nos. W1001, W1002, W1005, W1009, W1010 .

The problem could occur in the unlikely event that the Main Contactor partially jams and timer T3 times out allowing the lift to respond to calls whether the doors closed or open.

To correct the situation the circuit can be readily modified by inserting a MC/3Y contact between T3/5 and MCA/6. This will ensure that if the contactor jams, as described, no calls will be allowed to register. An extract of the original wiring diagram and the corresponding part of the diagram with the modifications added is enclosed..

Would you please advise your members to carry out this modification on all lifts which they currently service fitted with this type of controller .
