**UP-DATED SAFETY BULLETIN
STANNAH LIFTS LTD.**

Stannah Lifts Safety Bulletin - Update

Issue No: M20(a)

LIFT TYPE: - Stannah Hydraulic Passenger Lifts with 2:1 Roping

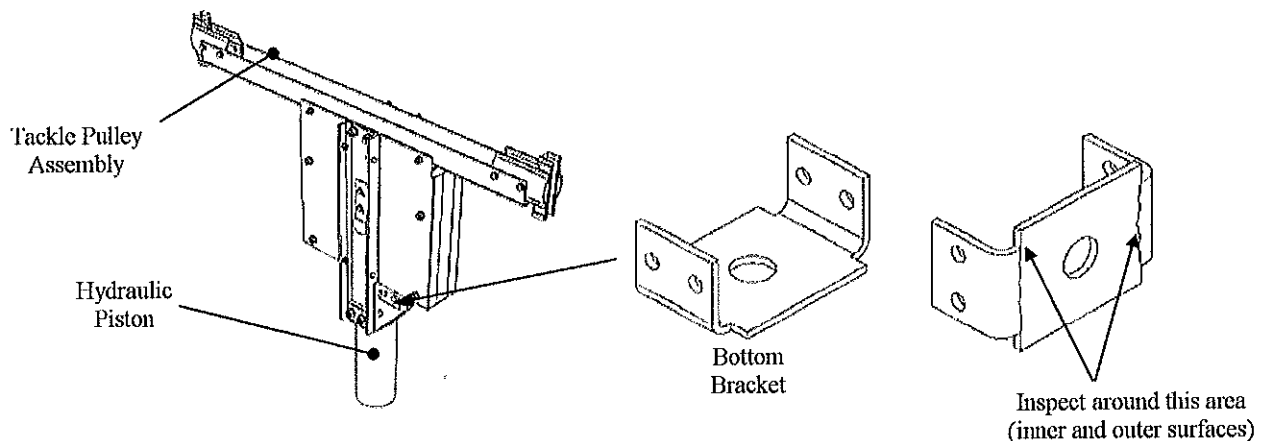
On 20/08/03 Stannah Lifts Ltd issued a Safety Bulletin, ref.no. M20, to inform that they had experienced a problem with a steel bracket on a 4 year old lift, which appeared to have cracked before eventually failing. The bracket design had been in use since 1986.

The bracket is 6mm thick and is fitted at the base of the tackle pulley assembly which supports the main suspension ropes and secures the top of the piston to the tackle pulley assembly (*see picture below*).

No further related incidents have been reported. However, as a precautionary measure, Stannah Lifts Ltd. have fabricated a clamp to strengthen the assembly. The clamp takes approximately 20 minutes to install and requires no specialist tools.

It is recommended that all tackle pulley assemblies incorporating the above bracket are fitted with this additional clamp.
