STANNAH LIFTS LTD, SAFETY BULLETIN

Re: HYDRAULIC PASSENGER LIFTS WITH 2:1 ROPING

Stannah Lifts Safety Bulletin

Issue No: M31(a)

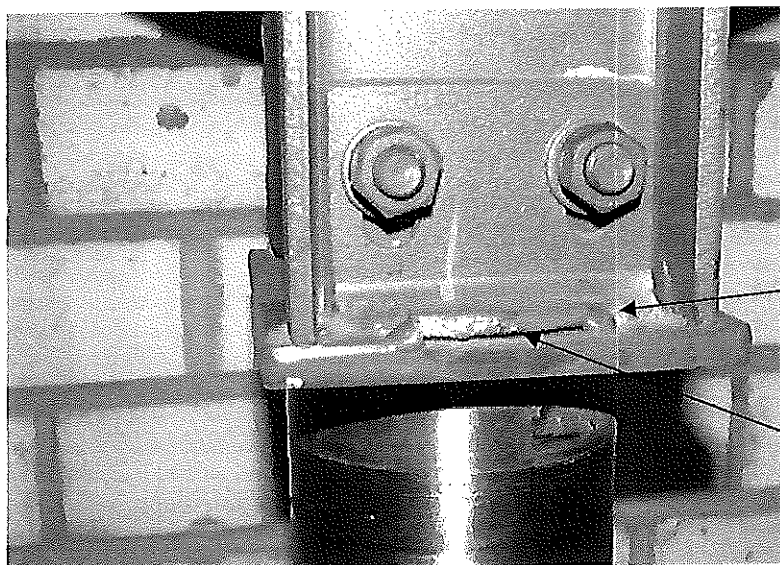
Fig 1
Replacement required

Stannah Lifts Ltd have experienced a problem with a welded steel bracket which failed due to welds breaking on one 18 year old lift, resulting in the safety gear engaging.

The welded bracket is fitted at the base of the tackle pulley assembly which supports the main suspension ropes and secures the top of the piston to the tackle pulley assembly (*see Fig 1 below*). It consists of a 10mm thick flat baseplate, to which are welded two notched angle brackets (approx 6mm thick).

Investigations indicate that this design of bracket was supplied on tackle pulleys between approx. 1986 and 1991. Evidence also suggests that the bracket which led to the incident was only partially welded and should have been fully welded as shown in Fig 2.

Stannah lifts Ltd have only identified 3 other brackets of identical design/manufacture to Fig 1 (partially welded) to date in the field. None of these showed any visible signs of potential weld failure but have been replaced as a precautionary measure.

Welded in notched corners of angle bracket only

No weld along this edge

To date only one incident has been reported. However, as a precautionary measure, it is recommended that all tackle pulley assemblies are inspected for any signs of deterioration and any found to incorporate brackets identical to that shown in Fig 1 above should be replaced with a different design.

It is strongly recommended that no full load rupture valve tests be undertaken (as required on LG1 test) on any brackets found to be to Fig 1 above.

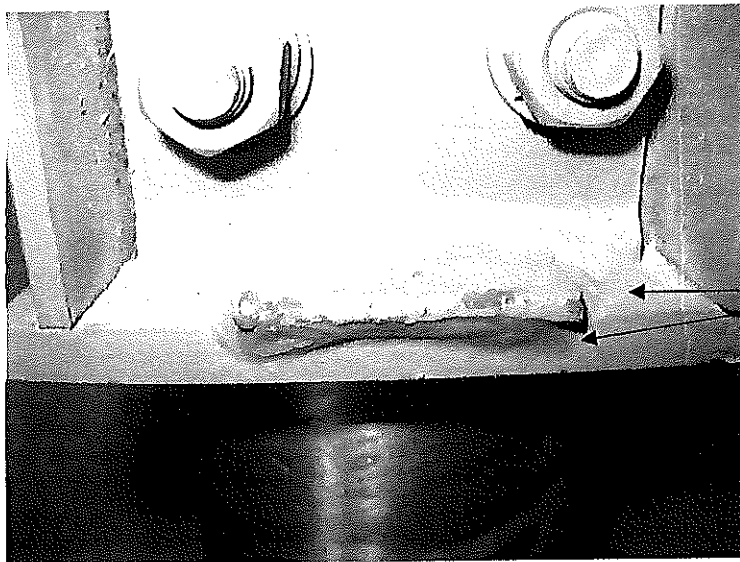
Fig 2
Replacement not required

Bracket as Fig 1
but fully welded -
in notched corners
+ along edge of
bracket.

Welded brackets of the types shown in Figs 2, 3 and 4 below do not require replacement.

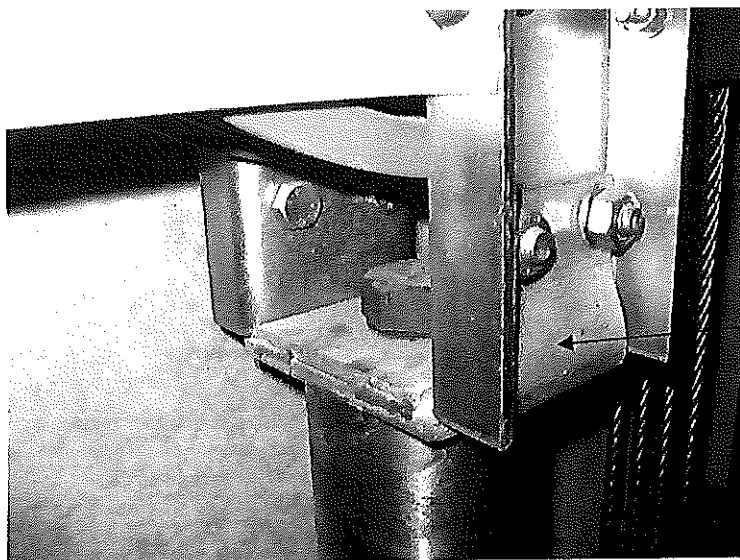
Fig 3
Replacement not required

Folded profile with
plate welded
inside.

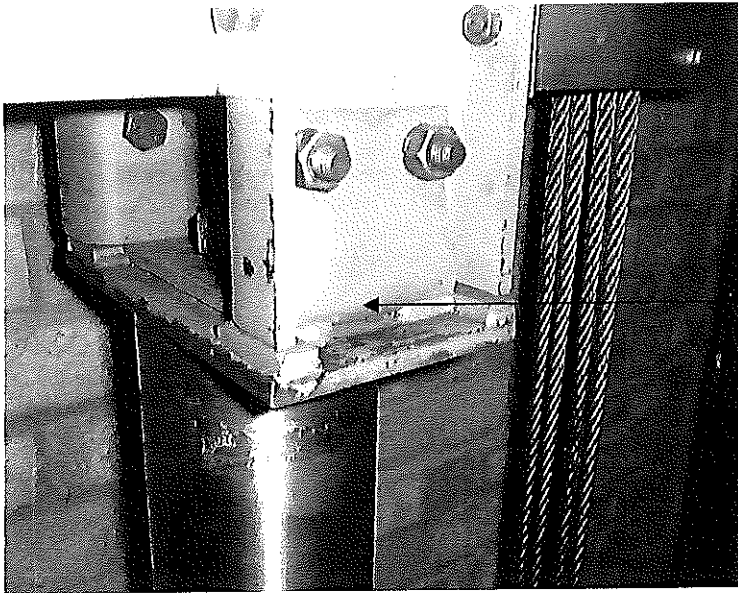
Fig 4
Replacement not
required

Bracket as Fig 3 but
with plate welded
underneath
incorporating 4 corner
spacers
