**STANNAH LIFTS TECHNICAL BULLETIN  
SYSTEM 21 LIFTS MANUFACTURED PRIOR TO 1995**

## Stannah Lifts Technical Bulletin

Issue No:E 11

System 21 lifts. Manufactured prior to 1995.

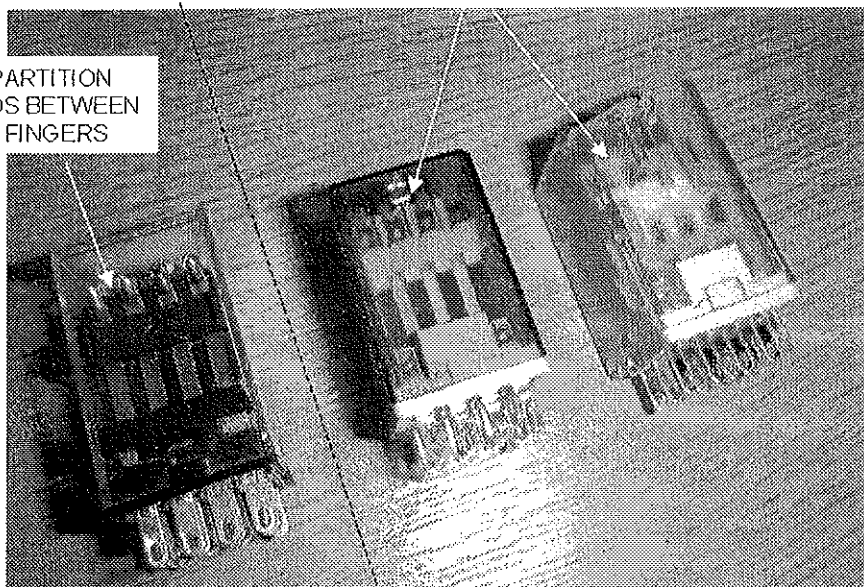
Through investigation and risk assessment we have identified that this fault has occurred on a very early version of IMO relay that may be found on lifts manufactured before 1995 (this is identified within the door of the control cabinet). The later versions, supplied by IMO, include additional arcing shields at the top of the 'fingers' that reduce the risk of this fault ever occurring. Therefore we request that at the next available service visit, any lift, hydraulic or traction that still contain an ACR relay of the 'older style' should be replaced with a newer version of relay. Please see attached diagram for further information on identification of relay.

ARC SHIELDS FITTED

NO PARTITION  
SHIELDS BETWEEN  
THE FINGERS

OLDER STYLE RELAY

NEWER TYPE OF  
RELAY
