TECHNICAL BULLETIN: BISON BEDE LTD.

TECHNICAL BULLETIN

Chassis Plate modification

Ref. Footrest fixing support boss Bison Bede Classic Straight Stairlift

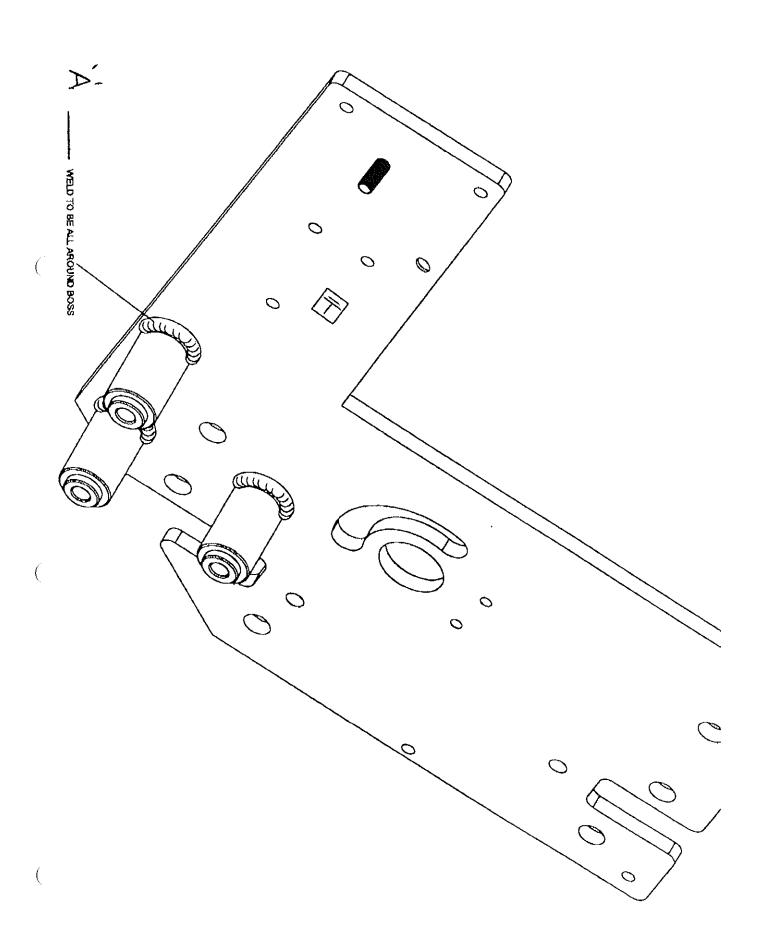
The original design did not have a full weld at "A" and no weld on the reverse side of the plate.

The MODIFIED boss has both a full weld at the front and a puddle weld on the reverse side, the latter being dressed back as indicated on page 4.

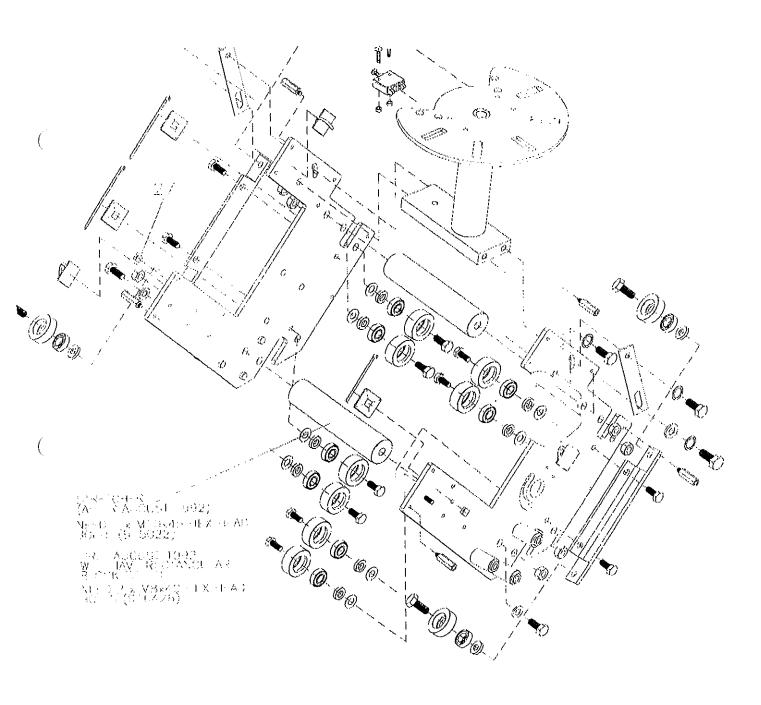
place Footrest Side Chassis Plate upon inspection if finding NO CONTINUOUS weld on front e. See page 2

pending upon age and quality of lift - Chassis Plate on the footrest side only is to be removed d recaced with either RD2069 or RD2070 (depending on handing) and a hole drilled to suit e age of plate.
