**Re: Notice of Potential Component Issue – 002.**

As part of Otis' commitment to share any potential safety warnings with the industry, please find herewith a corrective instruction for a possible wiring fault in the circuitry for Manual Recovery Operations (MRO)

<h1>OTIS</h1>	<h2>Notice of Potential Component Issue</h2>	<b>Ref : 002</b> (CI45-12-G03)	
		<b>Page : 1/3</b>	
	<h3>Manual Recovery Operation wiring examination</h3>		ISSUE 05/01/2012

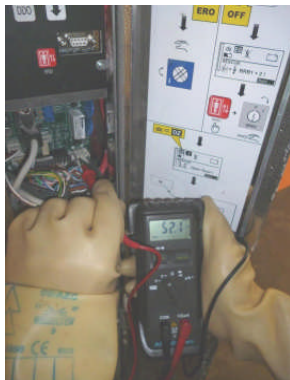
- Access the unit and secure on inspection to enable the car top and control panel to be accessed.
- Isolate the unit by removing the main power, leave the RPS supply live.
- Measure voltages on the P6 connector in the Emergency and Inspection (E&I) panel.

Voltages should be measured between;

**P6.1 and Ground**

**P6.2 and Ground**

**P6.3 and Ground**

If the values are as below the wiring is correct. MRO should work correctly.

P6.1/Gnd	48 to 55 VDC
P6.2/Gnd	0 V
P6.3/Gnd	0 V

If the values are as below (same voltage values measured on the 3 points), this means that the wiring is NOT correct. THE MRO MUST NOT BE USED AND THE FAULT RECTIFIED.

P6.1/Gnd	(48 to 55 VDC) or 0 V
P6.2/Gnd	48 to 55 VDC
P6.3/Gnd	48 to 55 VDC

If the examination results indicate the wiring connections are **correct** then verification of the MRO is required, proceed to steps 11-22 on page three.

If the examination results indicate the wiring connections are **incorrect** then follow the further field solution directions steps 1-22 on pages two and three. Until this solution has been completed the **MRO** function must not be used.

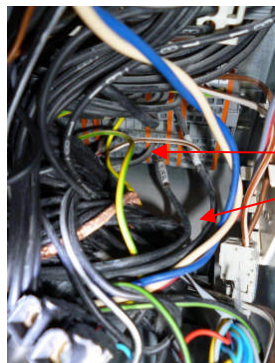
**Wires TB2-BAT(-) and TB2-BAT(+) incorrectly connected together on BAT(+) terminals.**

4. Inside the PSRB/PSRBD, identify the **TB2-BAT(-)** wire on PSRB/PSRBD terminals.

5. Disconnect **TB2-BAT(-)** wire from the terminal and check that this wire is the one connected to the **P6.3** in the E&I panel. This should be checked by using the multimeter (continuity test) and a test lead of suitable length.

6. Reconnect this **TB2-BAT(-) wire** in the correct terminal **BAT(-)**.
7. Switch **ON** RPS inside the PSRB/PSRBD and close the PBSB/PSRBD.
8. Egress from the car top.
