TB 121

TECHNICAL BULLETIN

Product : Midilift XL+ - Traction platform lift

Subject : Guide brackets

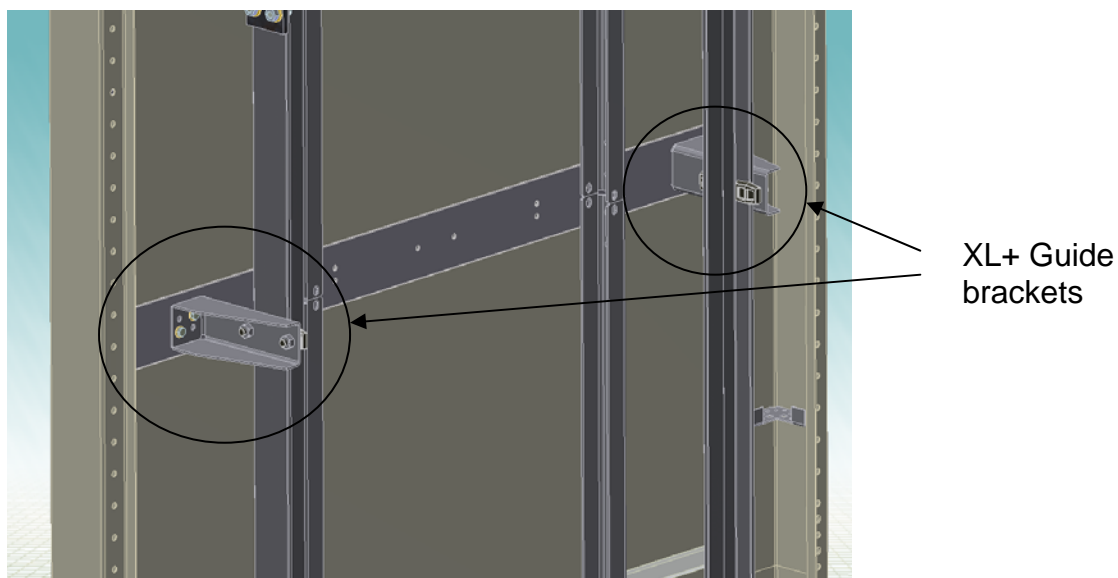
It has come to our attention that a quality issue has arisen on a batch of welded guide brackets fitted to the XL+ product. We have isolated the potentially defective parts to a given period of time, but require all lifts to be inspected.

- An unknown quantity of sub standard welded guide brackets has been fitted to the XL+ product.
- Please visually inspect the brackets during the next service to see if there are any signs of cracking.
- To request a replacement part please contact our spares department quoting part number 6205004. The replacement will be sent out as a warranty replacement free of charge.

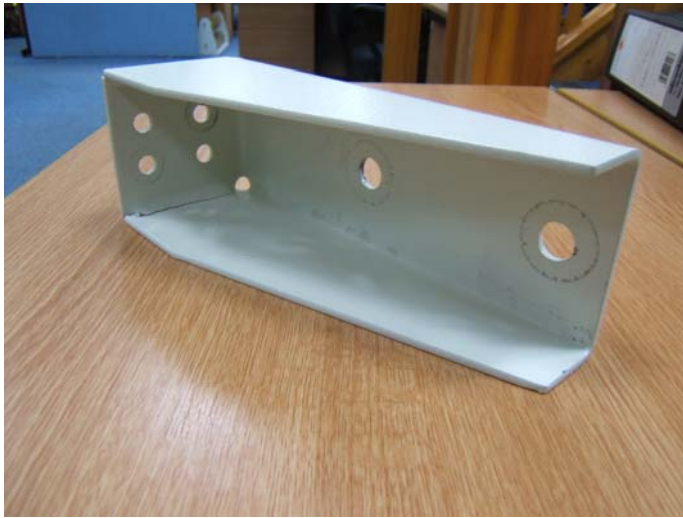
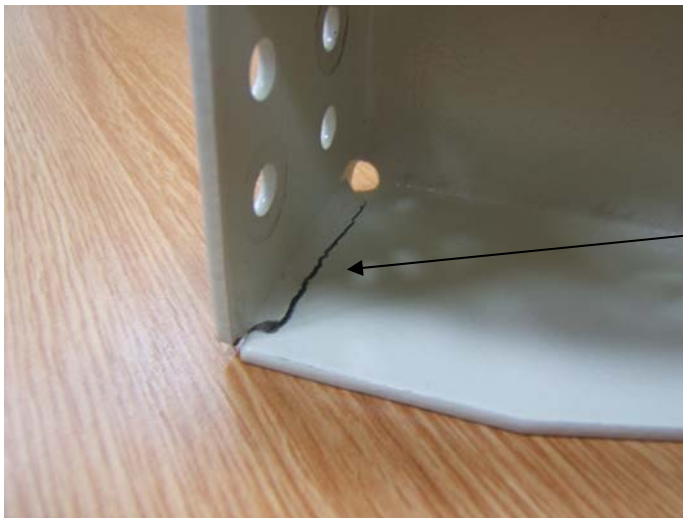
The weld failure is not critical to the operation of the lift after handover but if identified, should be replaced. A replacement part is available free of charge from our spares department.

Example
of weld
breaking
