**Bulletin No.
TB – MP0023A**

TECHNICAL BULLETIN

From: Pete Canning, Installations Manager, Stannah Lifts Ltd
Date : 17 March 2017 – Re-issued to LEIA 10 December 2017
Product : Xtralift 2.0 aka (MP Lifts Spain – MPGo)
Subject : **False Ceiling Stoppers**
Pages : 1 of 4

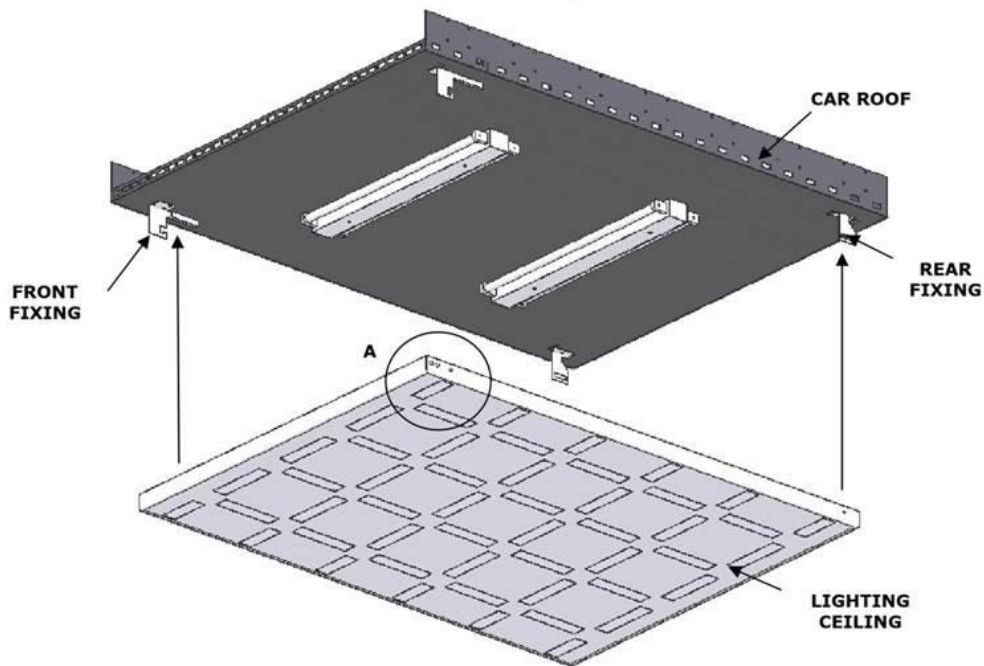
16.5. OPENING OF FOLDING LIGHTING CEILING, HEIGHT 80 mm

All, we have had 3 incidents over a three-year period with false ceiling falling with MP lifts. We don't believe they fall independently. Something such as furniture being moved in the lift car pushes the false ceiling back and it slips out of the fixing brackets (see diagram below). The rubber stoppers would prevent this movement. MP have advised that their lifts are provide from the factory with black rubber 'stoppers'. See pictures attached.

STEP 1: REMOVE THE SAFETY STOPPER

STEP 2: SMOOTHLY PUSH THE GRATING UPWARDS TO THE END

STEP 3: PUSH THE GRATING TOWARDS THE REAR PART

1. The MP false ceiling must have the stoppers in place;
2. If removed at any time during installation – they must be replaced;
3. If removed at any time during service – they must be replaced;

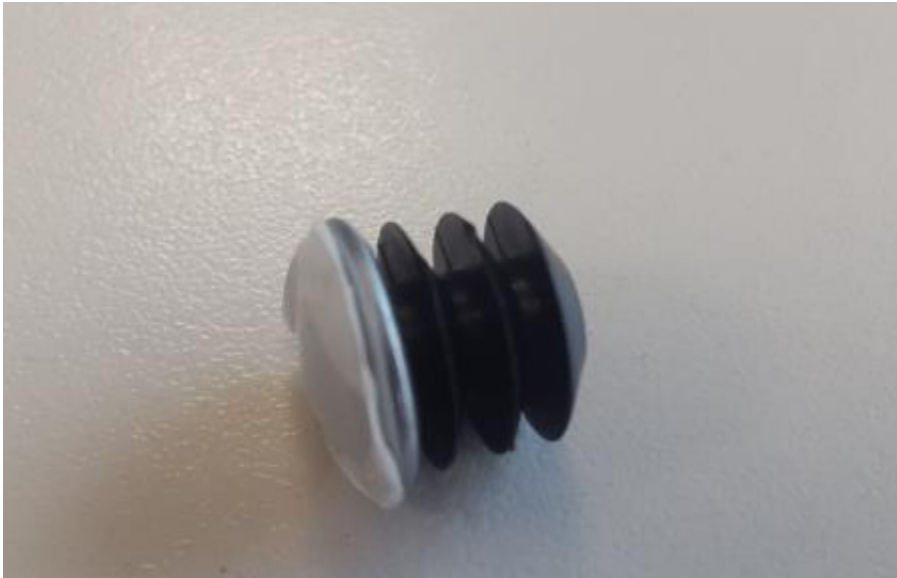
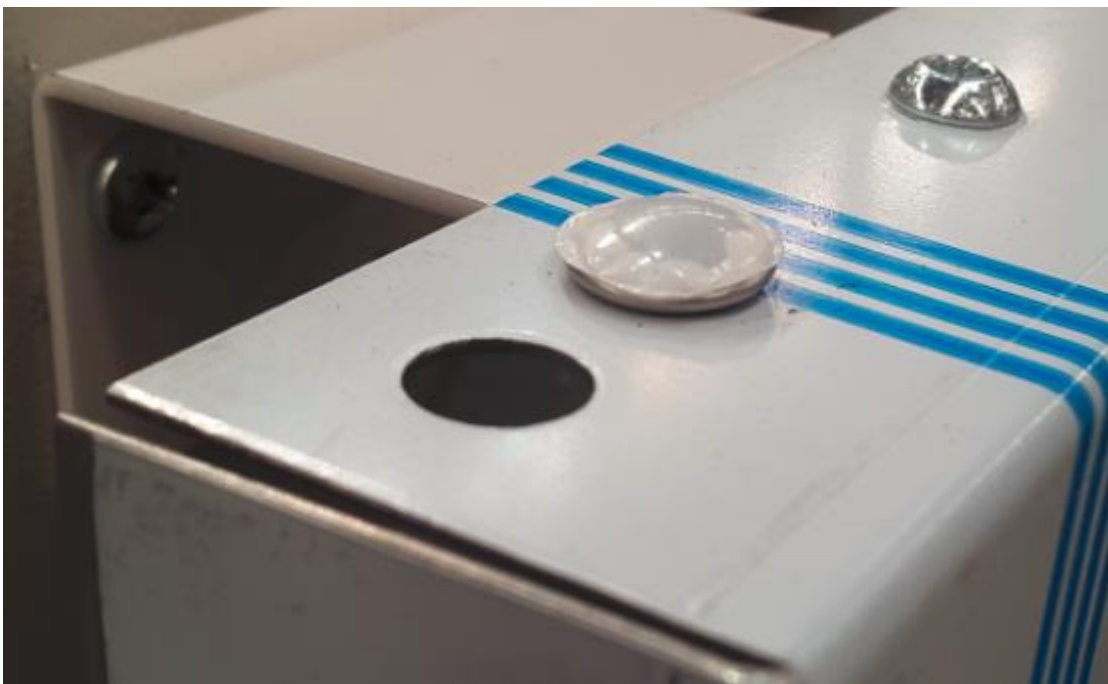
Pictures of rubber stoppers:

We believe this is happening – installers and/or service engineers are removing these stoppers when cleaning the ceiling or changing lights and failing to replace the rubber stoppers.
