TECHNICAL WARNING ISSUED BY LESTER CONTROL SYSEMS LIMITED issued 28-08-2018.

#### INSTRUCTION GUIDE TO REPLACING AN ALMEGA 2 SERIAL I/O CARD.

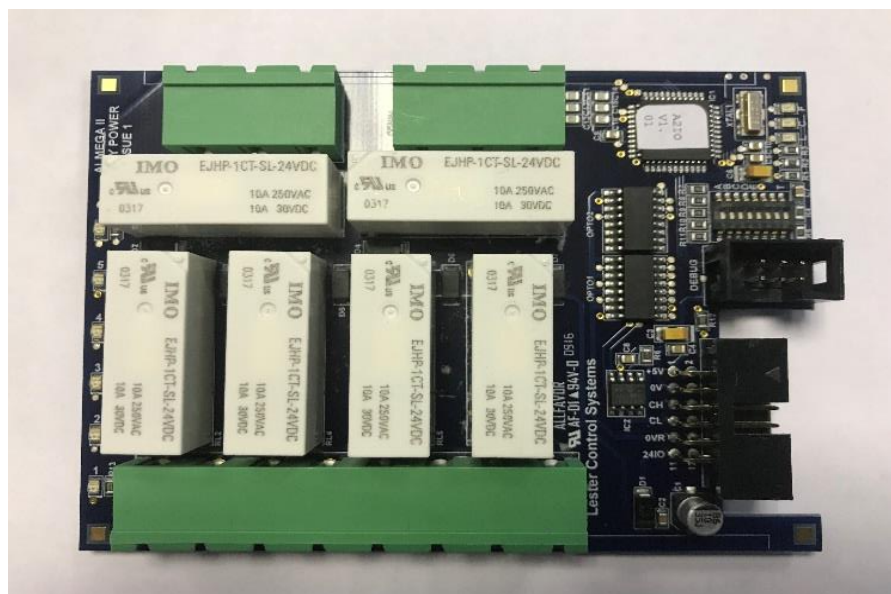
It has been discovered that the software within the Almega 2 power relay card can intermittently (between 12000 – 16000 operations) may have a delay in operating the output relays, in most cases this delay will have little or no impact on the lift operation, however on a small number of controllers it could possibly delay a slowdown signal causing the lift to stop out of level or even travel on to the over travel limit. This issue is common to ALL Almega 2 control systems.

As shown in photo below, the new slot card will have A2 IO V1.01 software version on the white I/D label.

If the controller does have this issue, Lester controls will send a replacement slot card which solves the issue with a pre-paid envelope to return the replaced card and full slot replacement instructions.
