SAFETY MATTERS

December 2020

Lift & Escalator Industry Association
33-34 Devonshire Street
London
W1G 6PY
Tel: 020 7935 3013
www.leia.co.uk

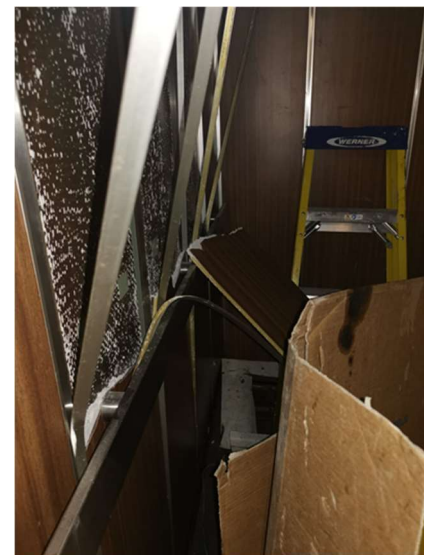
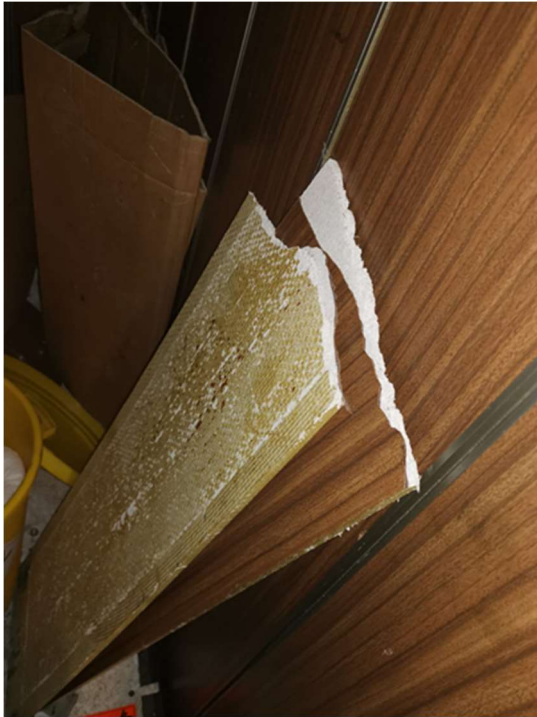
However, as the Engineers started to dismantle the lift car, they prised the inner car wall boards that appeared to be wood effect melamine laminate.

The boards snapped revealing white fibrous backing material.

The Client was immediately contacted, and an urgent asbestos survey was carried out confirming that the rear of the boards was asbestos containing chrysotile and amosite.

As a result of this incident the member company has introduced additional items that any asbestos survey should address including but not limited to:

- Rear of landing and car doors
- Materials used to build in landing doors
- Car wall panels
- Travelling cables
- Contactor flash guards
- Shaft switches
- Rubbish/dust in shaft and pit
- Car top units
- Shaft walls and ceilings
- Motor housing and gaskets
- Floor tiles and glues.

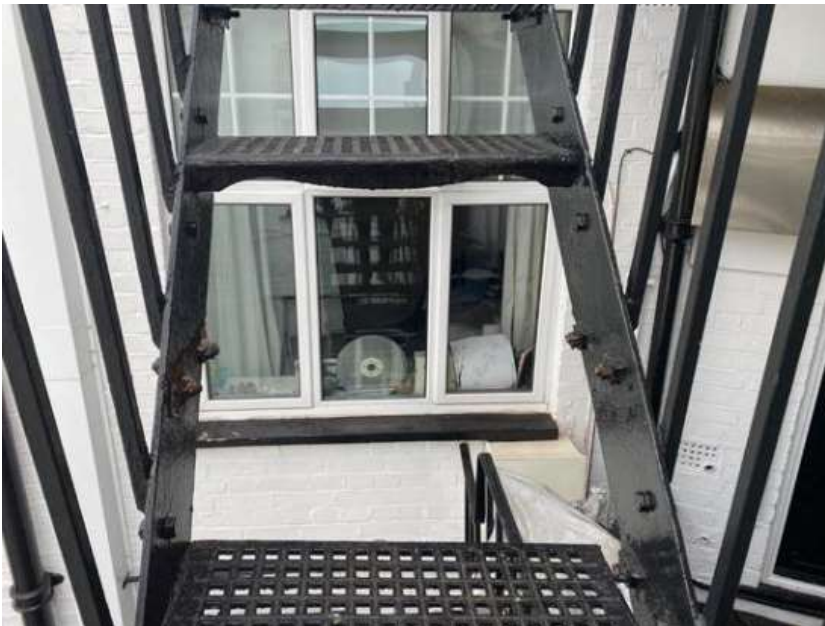
Talk about close calls then this is definitely one of them! The pictures below were provided by a LEIA member in October 2020 and show the failure of a stair tread on a cast iron external staircase that Engineers were using to access the roof level, seven floors up with nothing below it!

The picture on the left shows the wrought iron stair tread broken away from its fixing, the Engineer was incredibly fortunate that he did not go down with it.

If you maintain, repair or modernise lifts on sites where there is this type of staircase used for access, then please be extra vigilant when accessing any external staircase and report any issues immediately.

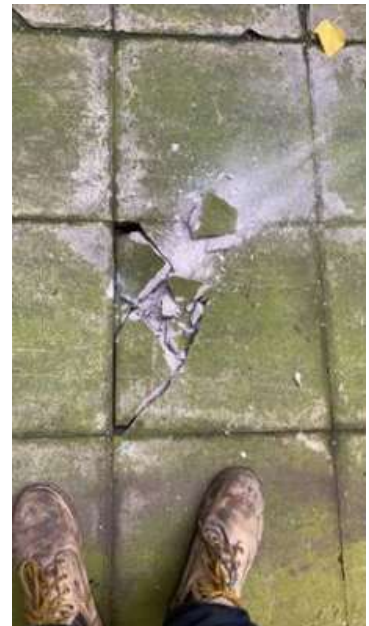
The picture on the right was the damage caused to the paving slab after the stair tread had fallen straight down, incredibly fortunate that no one was underneath.
