Re: Lifting Platforms – Vimec E10 EcoVimec

Maintenance Interventions - Technical note for maintenance engineers

Technical bulletin No. 02/2021

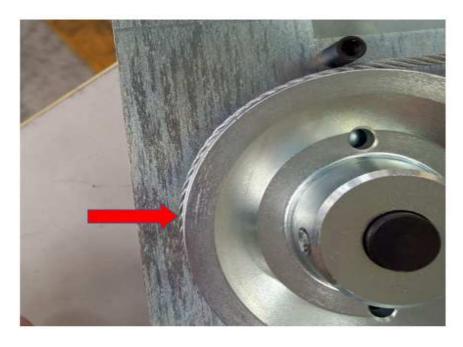
PHOTO 1

Example: Proof of appropriate condition is the protrusion of the steel cable with respect to pulley diameter (see picture1); on the other hand a wear index is the thickness of the pulley side shoulders (see picture 2 and picture 3).

In case of wear the unit must be stopped and you will have to contact your After Sale Dept. Manager to let you have the necessary replacement parts.

Considering that the pulley wear can have an impact on the correct working conditions of the unit, while waiting for instructions by Vimec, stop the unit, as a precautionary measure. As regards alluminium pulleys which are no more installed sicne 2013, please refer also to Technical Bulletin No. 04/2013 about checks of material wear.

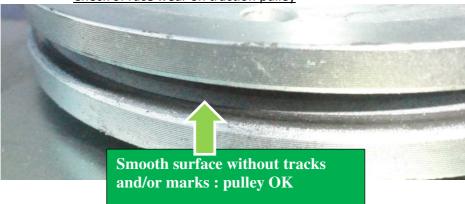
Check of race wear on traction pulley

Look carefully at the race surface in the contact area with the rope, it must be perfectly smooth without any mark left by the rope

In case you notice the rope track, replace the device.

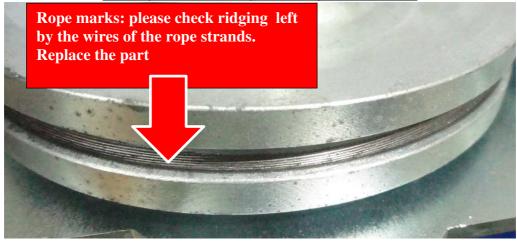
- If the surface is regular or smooth the pulley can be considered Ok
- If the surface shows hollows or you can touch the ridging lefts by the wires of the rope strands, the device must be replaced.

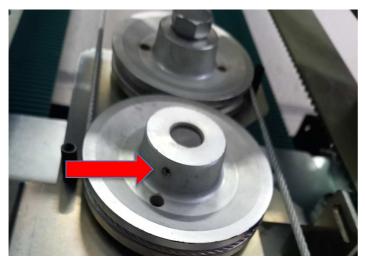
PHOTO 4

Should you find any difficulty in pulling the grub screw out or should you not be able do it that means that it could be damaged. If so the unit must be stopped and you will have to contact your Vimec Aftersale Dept. engineer for despatch and replacement of the necessary parts. As it is known and taking into consideration wear of this part could have an impact on the correct working condition of the unit, while waiting for instructions by Vimec, stop the unit as a precautionary measure

c) The lower traction pulley is fixed by a grub screw (see photo 4), pull it out with a 2,5 mm Allen key (see photo 5) and put in the new grub screw supplied to you. DO NOT USE any grub screw different by the one supplied by Vimec.

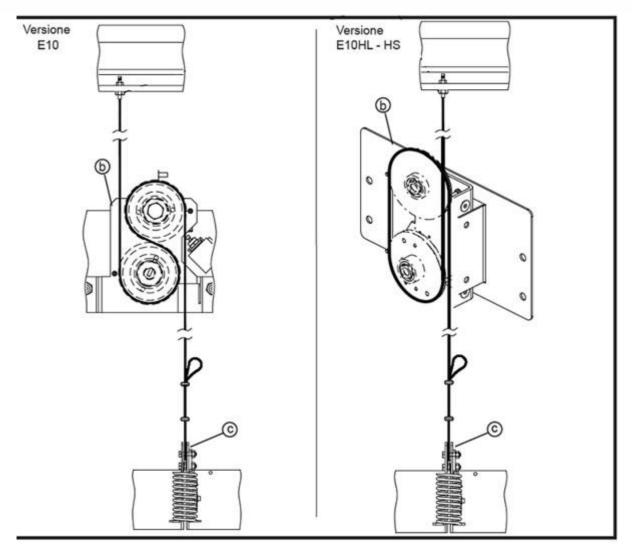
d) Service engineer has to check overspeed governor steel rope integrity and that its path is correct (see drawings below)

- 1) Without any broken wire
- 2) Without any fold
- 3) Without oxidation

In case the rope condition does not satisfy one of the above-mentioned points replace the rope

The rope must be tightened as per instructions in our use and maintenance manual of the unit. In case it is not stretched properly, tighten it as per our use and maintenance manual of the unit.

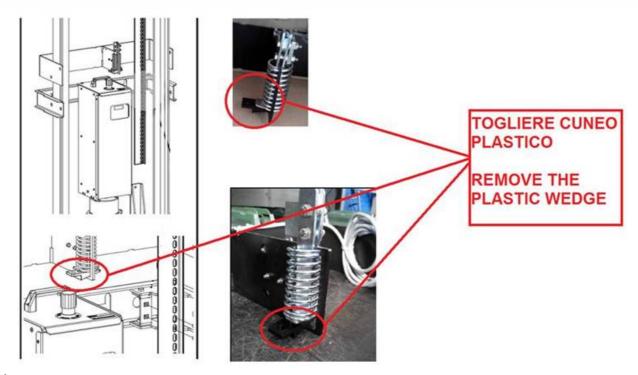
Photo 7

e) Check that the plastic shim under the spring of the overspeed governor, that was put to make installation easier, has been removed (see Photo 7)

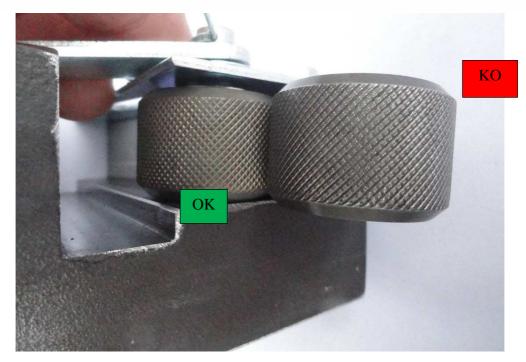
Service engineer has to check the roller of safety gear: that has to show a properly sharped and pointed knurling.

In case by touching it you find knurling has "flattened", replace the couple of devices.

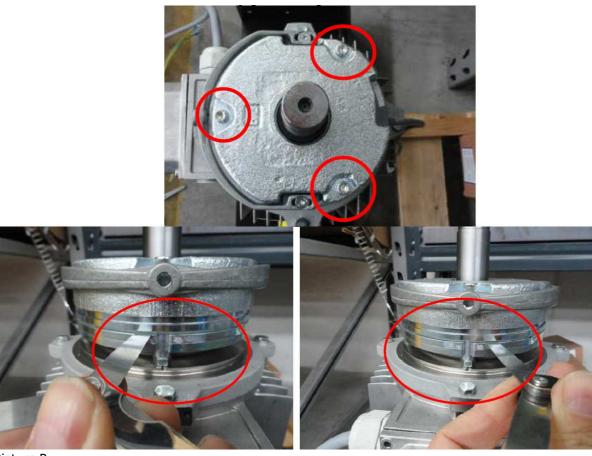
Picture B

b) Carry out the tests in three different positions as specified below

If the 0,45 mm thickness gauge goes through, the air gap must be set (SEE INSTRUCTIONS) If the 0,45 mm thickness gauge does not go through, the air gap must not be set

- Unloose nut 2 keeping screw 1 fixed
- Set the air gap by intervening on screw 1, 0,3 mm and 0,4 mm air gap GOES THROUGH (we remind you that 0,45 mm thickness gauge DOES NOT GO THROUGH (maximum allowed gap)
- At the end of setting, tighten nuts 2 by keeping screw 1 fixed
- Setting must be carried out UNIFORMLY on all 3 screws

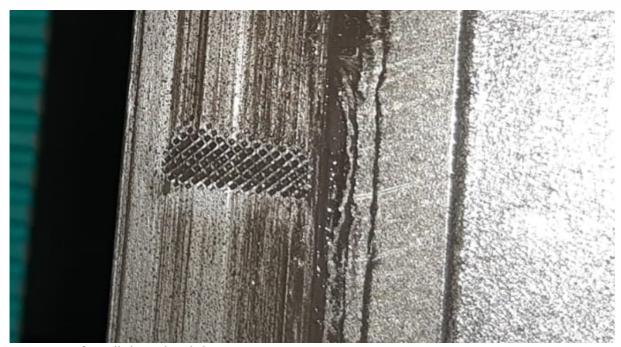
Correct mark, well shaped and short

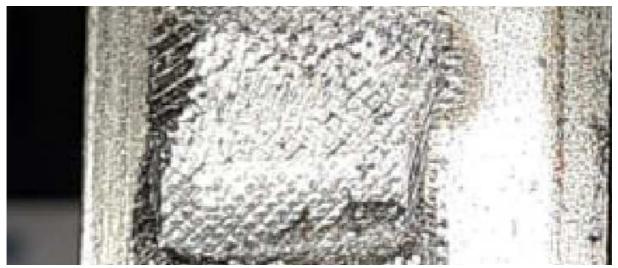
INCORRECT mark, knurling not well marked and with hollow on the rail.

In this case go on with safety gear setting and/or replacement.
