KLEEMANN Lifts UK Limited
Unit 8, Arena,
14 Charbridge Lane,
Bicester,
Oxfordshire
OX26 4SS

RE: SAFETY INFORMATION

This potential safety issue update concerns KLEEMANN traction lifts utilizing a UControl inverter/drive.

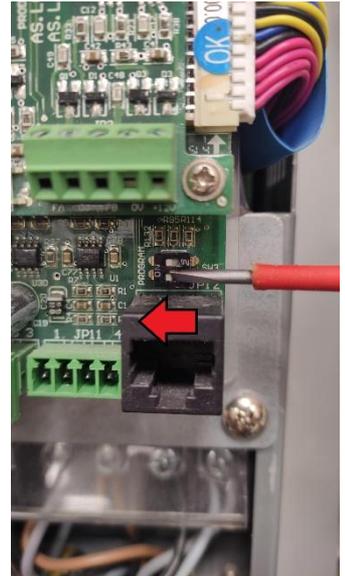
13. Activate the **SW3** dip switches by moving them to “**ON**” position (see picture).
14. Disconnect the USB cable from the Ucontrol hand terminal and connect the provided programming keypad to the USB cable.

Pay attention if there is any accumulated dust inside the inverter specially in the **SW3** area. Before performing step 13 make sure that the inverter is completely turned off, wait at least for 20 minutes in order to have a complete discharge of the inverter capacitors and with a dry cloth lightly wipe any dust on the dip switches. If there was dust and after it was cleaned, operate (ON-OFF-ON) the dip switches 2-3 times. In case the dip switches are not operating properly due to dust, after step 19 "**progress report connection fail**" will appear on the screen.
