TB 190

## TECHNICAL BULLETIN

<b>For the Attention of:</b>	Service Engineers, Installers, Trade Customers, Training Dept.
<b>Date:</b>	12 <sup>th</sup> December 2022
<b>Product:</b>	Stannah Midilift XL+
<b>Subject:</b>	Control unit front panel earth tab

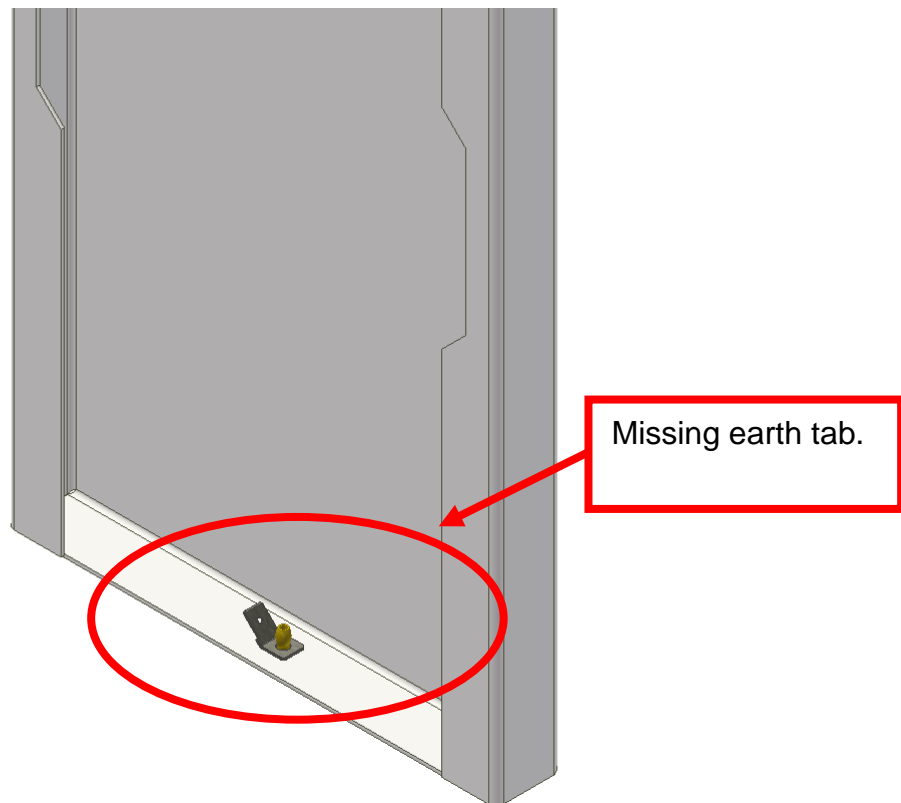
Figure 1

It has become apparent that some XL+ upper landing control unit front panels have been assembled without the earth stud (see Figure 1). If this panel remains unearthed there is an increased risk of an electric shock.

If inspection of the control panel confirms that no earth tab has been fitted an earth tab retrofit kit can be ordered through Stannah lifts spares department under part number 950531.
