**SAFETY BULLETIN : OTIS**

POTENTIAL SAFETY HAZARD

UK Corrective Instruction

OVF 30 drives on units without brake switches fitted

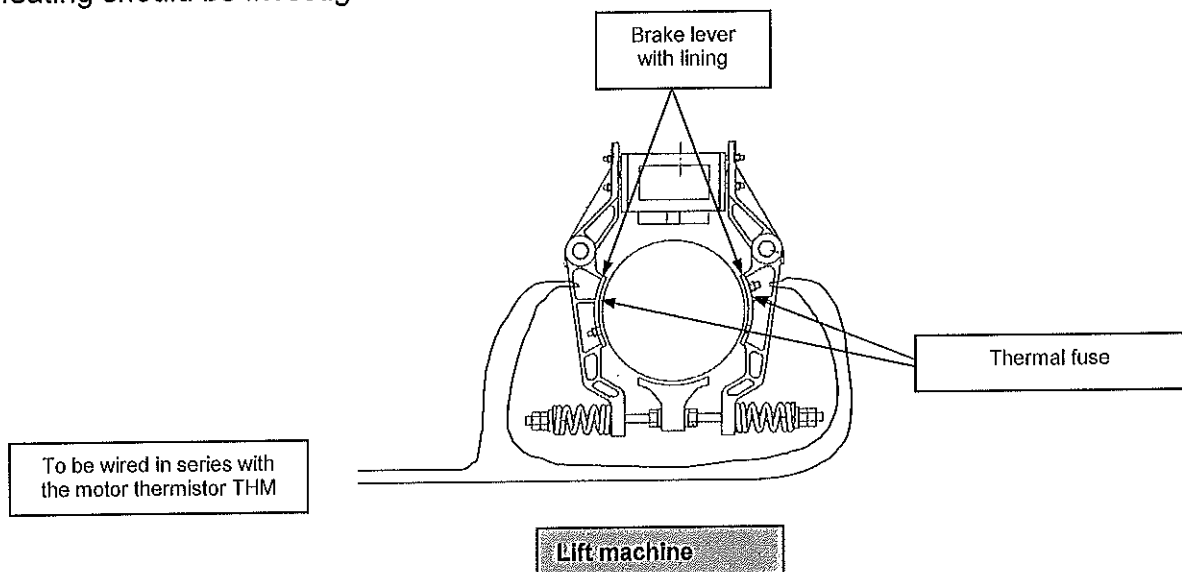
The thermal fuses are connected in series with the motor thermistor (THM). When activated it will render the lift out of service with the doors open

To fit thermal fuses to the brake shoes that will trip when the brake shoe temperature exceeds 71 C. This will render the lift out of service when it reaches its destination. The lift will be unable to go back into service until the thermal fuse is replaced before which the cause of the overheating should be investigated and rectified

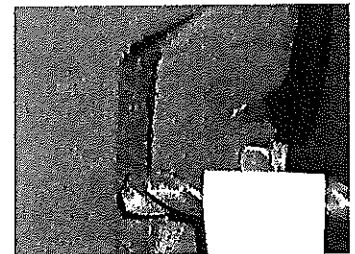
Pic 1: Depth

To assure the right depth, it should be marked on the drill (picture 1)  
This has to be done very carefully.

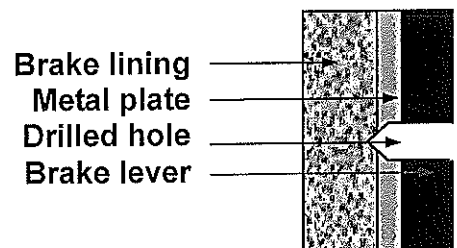
Pic 2: Drilled hole

- a) Main switch switched off and Locked and tagged out.
- b) Drill a hole 5,2-5,5 mm or 7,2-7,5 mm (according to depth) into brake shoe so that it only just penetrates the brake shoe lining (See picture 2).

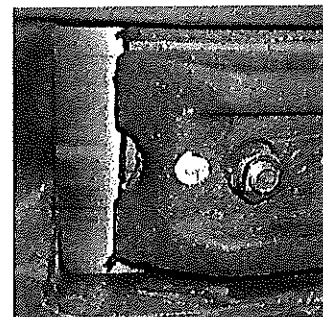
**Pic 3: Thermal conduction paste**

- c) Put some thermal conduction paste into the hole.  
(Picture 3)

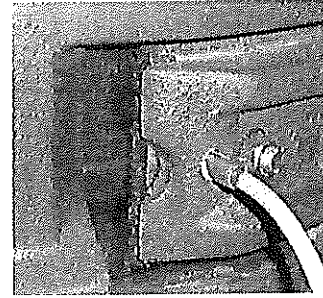
**Pic 4: Thermal fuse**

- d) Put the thermal fuses with rotating movement into the holes (See picture 4) to prevent the trapping of air.

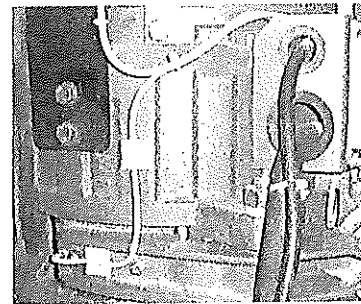
**Pic 5**

The leads of the thermal fuses have to be fastened to the machine using adhesive clips (picture 5).

To fix the adhesive clips, the positions have to be clean of grease and dust. The adhesive clips near the thermal fuse must not put unnecessary pressure onto the Thermal fuse. The cable is to be fastened with a cable tie to prevent movement.

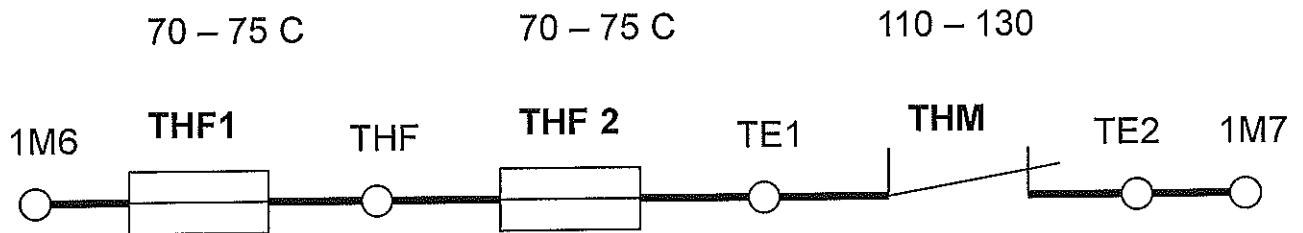
- f) The thermal fuses have to be connected in series with the motor thermistor (THM) in the connection box on the machine. The connections of the thermistor (THM) are marked as TE1 and TE2. Connect in series the thermal fuses to TE1. See typical wiring diagram below. Check on site wiring diagrams for connections

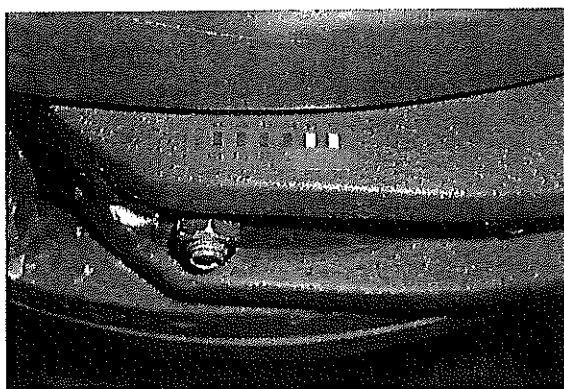
Pic 7

Decoloured fields (>44 degrees C) indicates  
Possible brake problems. This has to be  
checked (see picture 7)

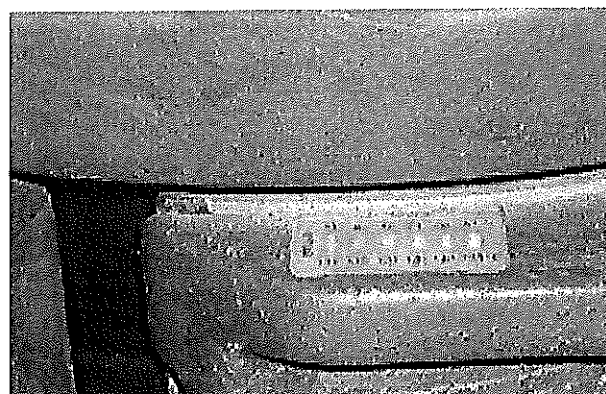
Pic 6

g) In addition a 6-step temperature sensor should be fixed near the brake linings  
(See picture 6)

In normal operation none of the temperature fields should have changed to a dark state  
(See picture 6).
