**SAFETY BULLETIN FROM STANNAH LIFT SERVICES LIMITED**

# IMPORTANT NEW SERVICE PROCEDURE FOR 240/250/260/300/400 WLS/SAXON CHAIR SWIVEL LOCK

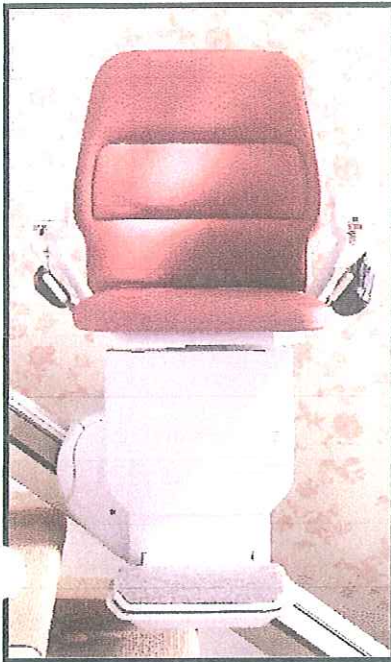
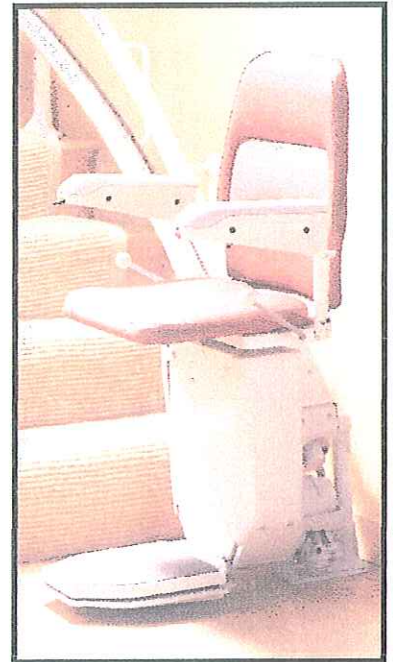
Step 2 Remove the four M8x12 socket cap head screws (see fig 1 and 2 overleaf) and position the chair so that you get clear vision of the bearing plate and swivel lever lock tab. Note the Bowden cables and looms do not need to be disconnected. Clean away any grease to get a good look at the metal surfaces. A mechanism that has been used correctly will have hardly any wear on its surfaces (see fig 3 overleaf). If you are satisfied with the condition of the components, apply fresh grease and re-assemble. Apply Loctite 243 (or equivalent) to the four M8 screws and tighten to 16Nm. If you are not satisfied with the condition of the locking tab (see figs 4 to 8 overleaf) then proceed to Step 3.

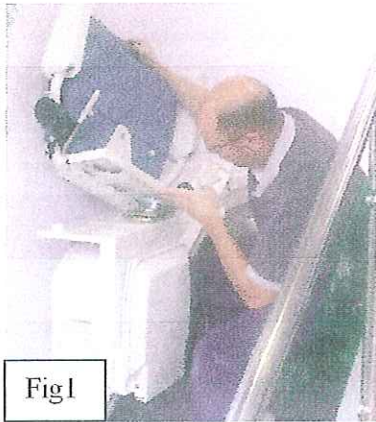
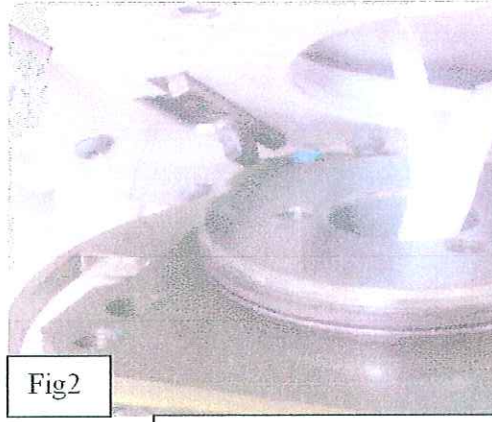
Example of a good lock tab. Slight scratching on surface is acceptable.

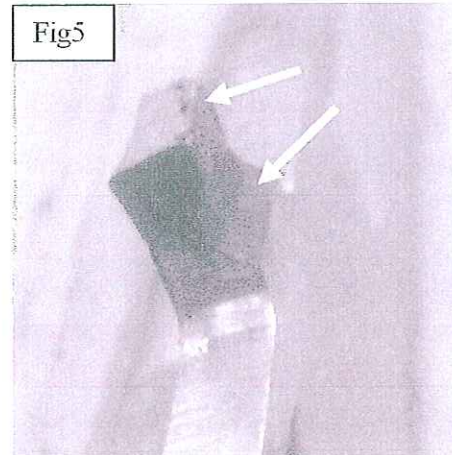
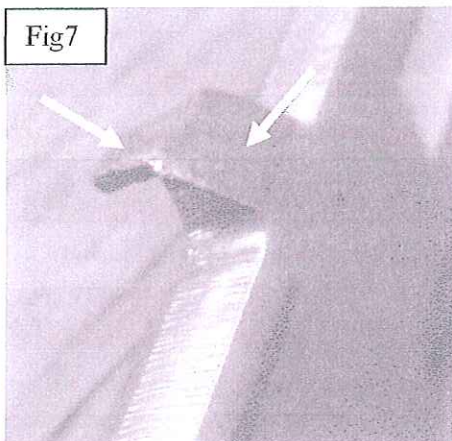
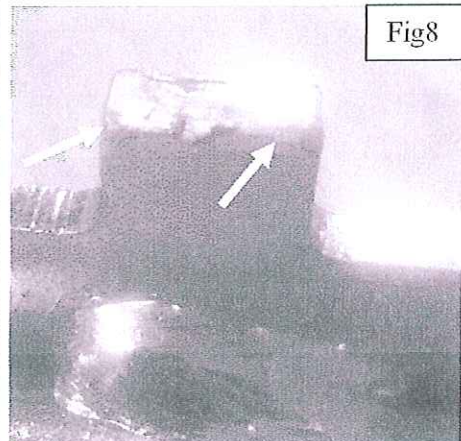
Examples of excess wear on the lock tab

Step 3 The worn parts must be replaced. Kits are available from our Spares Department and all the parts contained in this kit **must** be changed at the same time. The kit numbers are as follows :-

- 2401060 - Model 240/250 WLS Swivel Boss/lever assembly kit
- 2601080 - Model 260 Saxon Swivel Boss/lever assembly kit
- 40010661 - Model 300/400 Swivel Boss/lever assembly kit L/H
- 40010662 - Model 300/400 Swivel Boss/lever assembly kit R/H
- 4001068 - Model 300/400 Powered Swivel/lever assembly kit

For the safety of the customer, the product must not be used until this work is carried out.
