STANNAH 250/260 STAIRLIFTS WITH CURVED RAILS

SAFETY NOTICE

Important Safety Upgrade on New Stannah Curved Stairlifts Installed between June 2001 and June 2007

PDN 08/5759

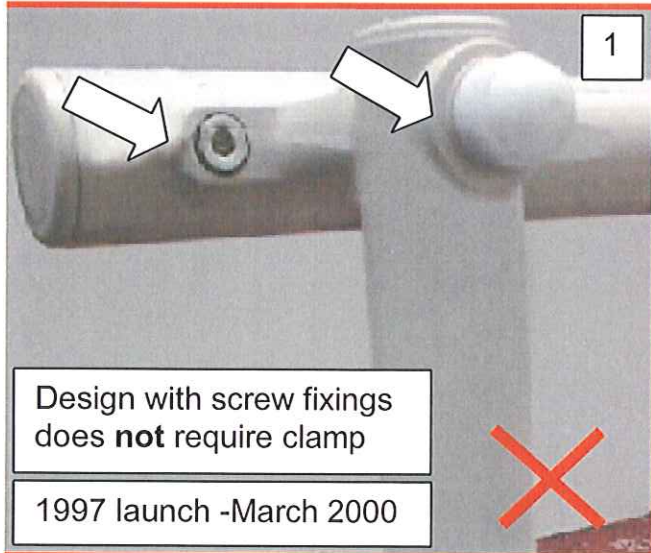
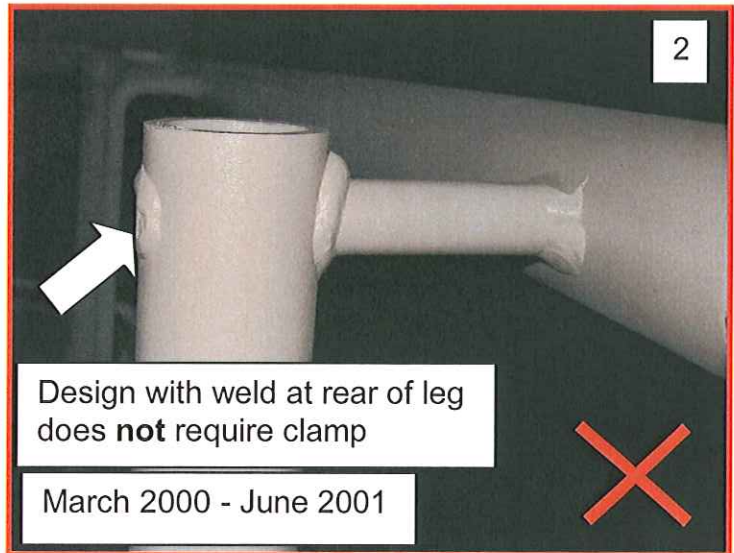
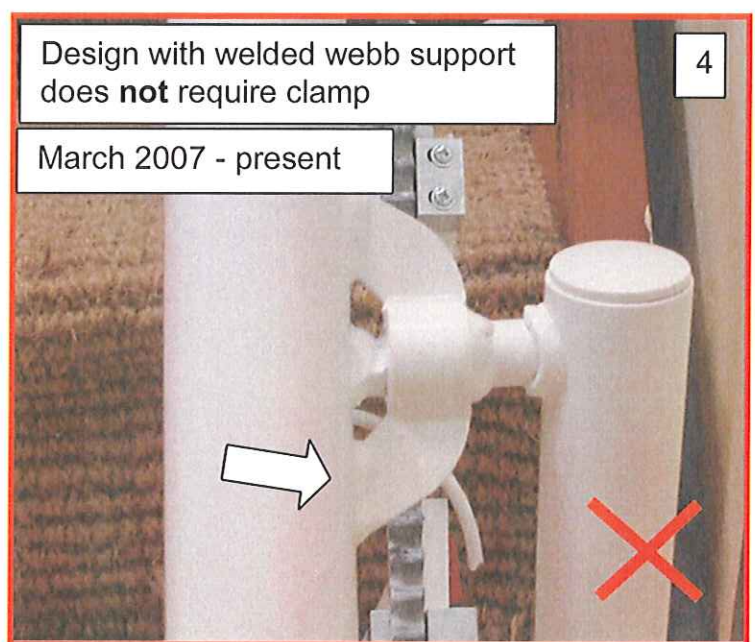
Since the introduction of the model 250 in 1997 to present day four types of leg design have been in production. The new clamp is only required for products manufactured between June 2001 to March 2007.

The images below show leg designs from 1997-2008. Only image 3 is suitable for the new clamp.
