MODIFICATION TO MARRYAT & SCOTT ELECTRO-HYDRAULIC F.A.P.B., TWO FLOOR U.S.E. PUMP AND MAXTON VALVE, STAR/DELTA STARTING, WITH HARRIS PREBLE SHUTTER GATES

Modification to Marryat & Scott Electro-Hydraulic F.A.P.B. Two Floor U.S.E. Pump & Maxton Valve, Star/Delta Starting, with Harris Preble Shutter				CODE: SN 10.01.05  Pages: 1 OF 5  SAFETY CATEGORY A		
DEPT. TECH.SUPP	DATE 22.1.98		CHECKED V J Kaura	APPROVED	ISSUE	A

## Modification to Electro-Hydraulic F.A.P.B. Two Floor U.S.E. Pump & Maxton Valve, Star / Delta Starting, with Harris Preble Shutter Gates. Ref to Drawing LO 3673.

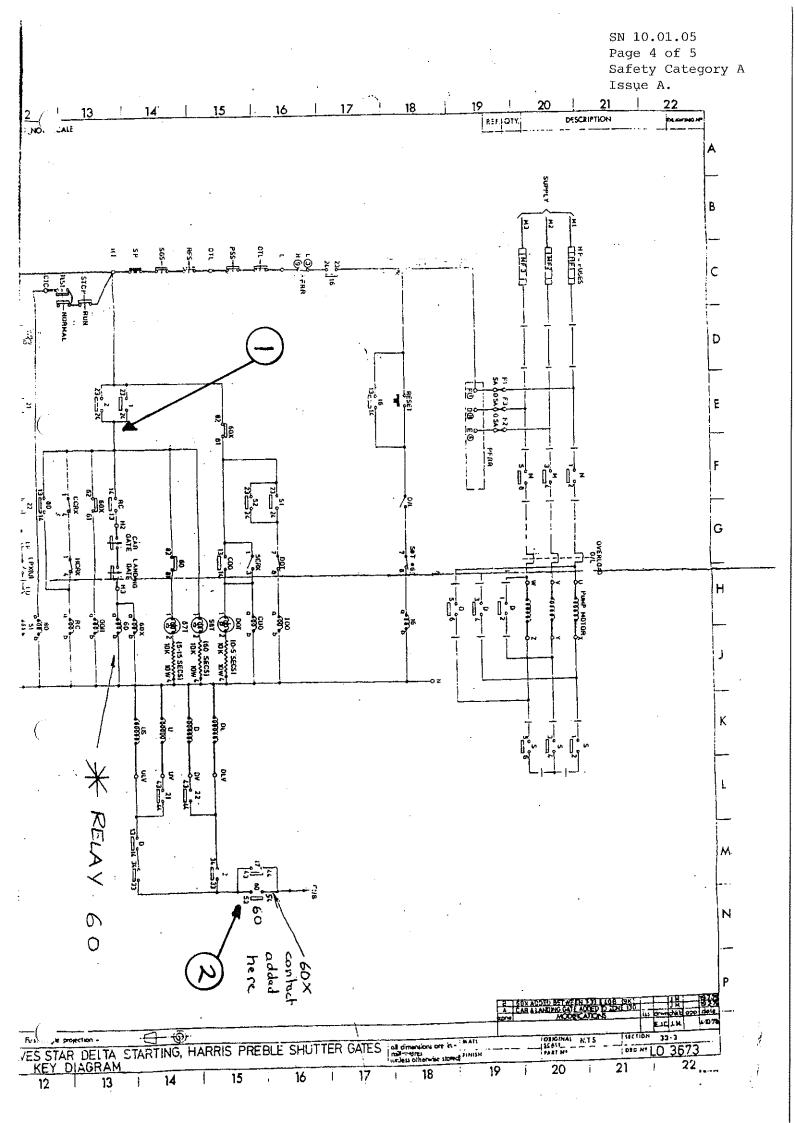
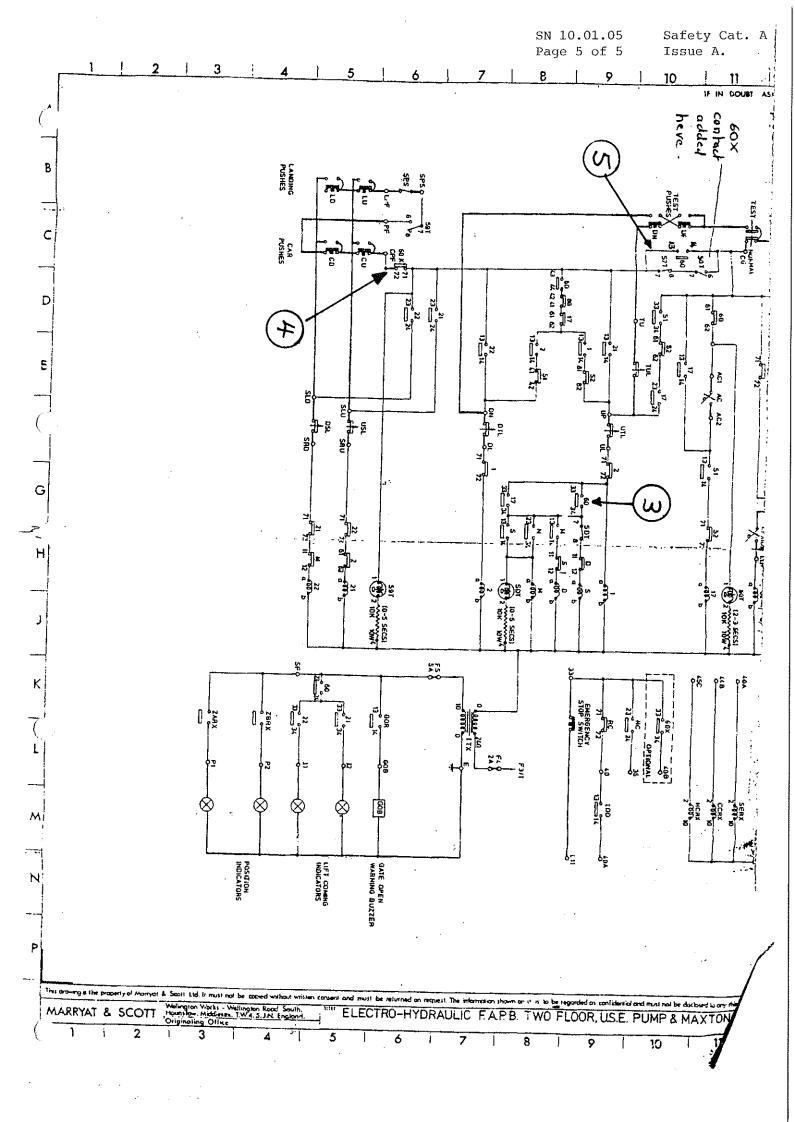
These controllers have fitted a Harris Preble Shutter Gate, a fault was reported where the Lift ran normally with the Doors Open, caused by the relay 60 sticking IN.

This modification results in the requirement that two contacts of seperate relays need to fail before a similar fault could occur.

Stage 1 Addition to the circuit feeding Relays 60 & 60X.
